Practical Design, Numerical Analysis, and Site Monitoring for Huge Arching Effect during Massive Excavation of Undercut Slope in Open-Pit Mine

KEYWORDS: Slope Stability, Undercutting, Arching, Open-Pit Mines

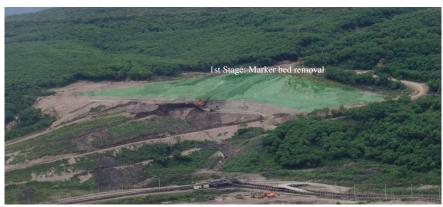
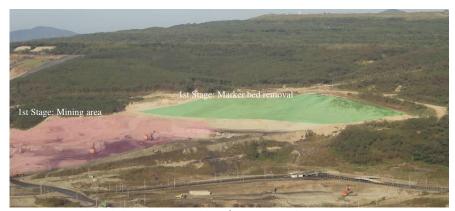
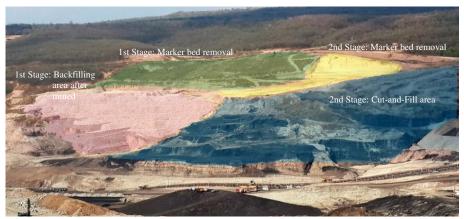
The undercutting in Area 4.1 was periodically photographed for archival purposes; some of the photographs are presented in Figure 12. The mine equipment was moved to Area 4.1 and the site preparation began in April 2011. Three months later, in July 2011, the Marker bed was ready to be excavated; by August 2011, it had been totally removed. The undercutting of the northern part of Area 4.1 began in August and reached an elevation of 170 msl by January 2012. The undercut span was approximately 80 m. The undercutting continued and reached an elevation of 137 msl by April 2012. The undercut width was approximately 90 m. Between May and June 2012, the backfill, comprising 30,000 cubic meters, was placed from an elevation of 115-192 msl. The undercut width was then shortened to 30 m. The undercutting was restarted and continued in the southern direction in August 2012. The 1st Stage was completed in May 2014. Finally, the undercut width had been extended to approximately 100 m by the end of the 1st Stage.

(a) Access road and Marker bed removal in 1st Stage (as of August 2011)

(b) Mining elev 170 m in 1st Stage (as of January 2012)

(c) Marker bed removal and 2nd Stage preparation in 1st Stage (as of April 2014)

Figure 12. Photographs of the 1st Stage in Area 4.1.

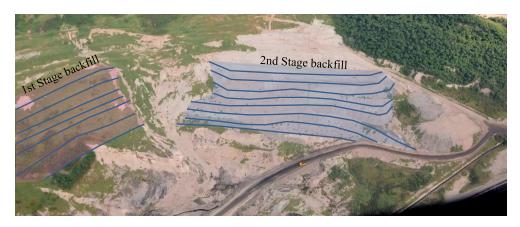
(d) Aerial view at end of 2nd Stage (as of October 2017)

Figure 13. Sequential excavation of the 2nd Stage in Area 4.1.
