# Segmental Retaining Wall Reinforced with Geogrids, in New Hospital Works (Salamanca, Spain)

**ABSTRACT:** *The construction of a new hospital, located by the river Tormes in the Spanish city of Salamanca, involved the expansion of roads and the construction of a new way of access to the complex, as well as a large retaining wall to bridge the gap between them and the river level. The project original solution was in situ foundations and precast concrete walls. However, at both ends of the alignment of Transición Española Avenue, there were several construction constraints (such as the existence of rainwater chambers for discharging into the river, a large-diameter drainage pipe at the back of the walls, communications, and gas services). The need to maintain steady access to the old hospital in service during the COVID-19 pandemic was furthermore required. The wall was founded on fills with low bearing capacity in other sections. Finally, a reinforced segmental retaining wall (SRW) was adopted as the optimum choice. It consists of concrete block (segmental) facing with a high-quality fill reinforced backfill, reinforced with polyester (PET) geogrids. The facing required a variab

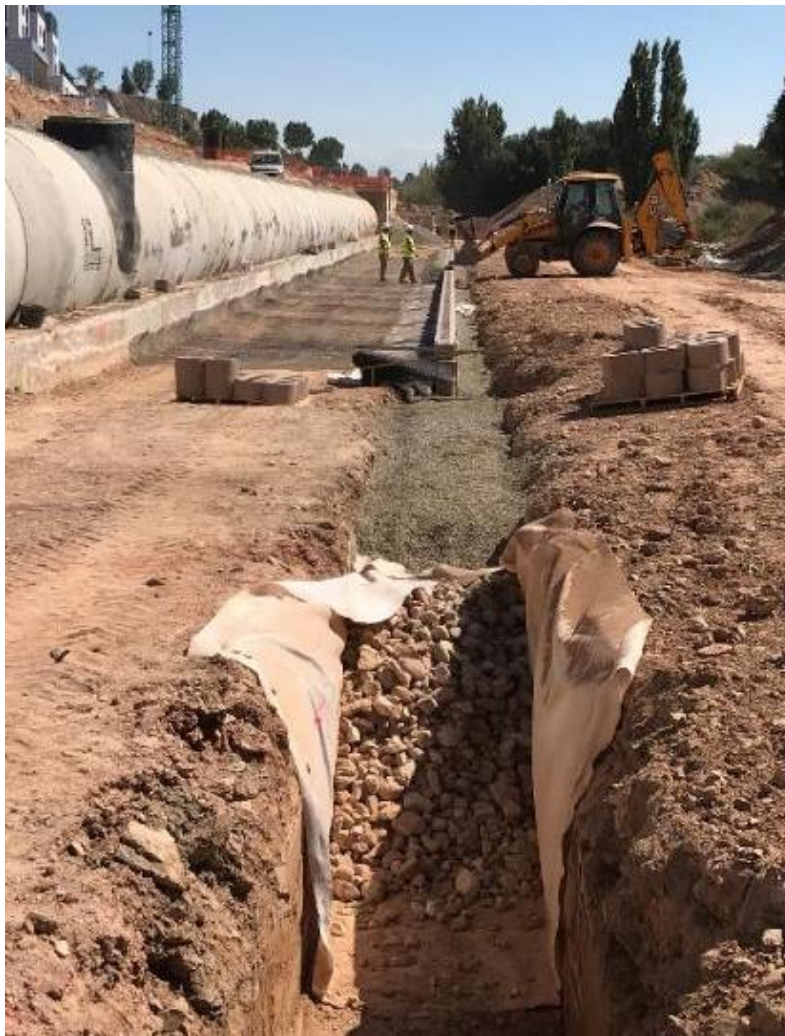
*Figure 2. Different phases of the erection of Wall 1*

To prepare the structure for foreseeable seasonal floods, a riprap was designed at the level of the wall, as scour protection of the foundations. To support the blocks on the facing, a foundation trench of approximately 1 x 1 m was built, filled with gravel, and wrapped in a non-woven geotextile filter. Behind the block face, a generous one m wide backfill of crushed gravel was installed (see Figure 2), as well as the drainpipe collector surround. Both drainage systems were completed with corrugated HDPE drainage pipes passing through the block face towards the river, arranged perpendicular to the line of the wall. Light- and medium-sized compactors were used to minimize the long-term facing deformation to reduce the lateral forces against the wall (Bathurst et al. 2010).

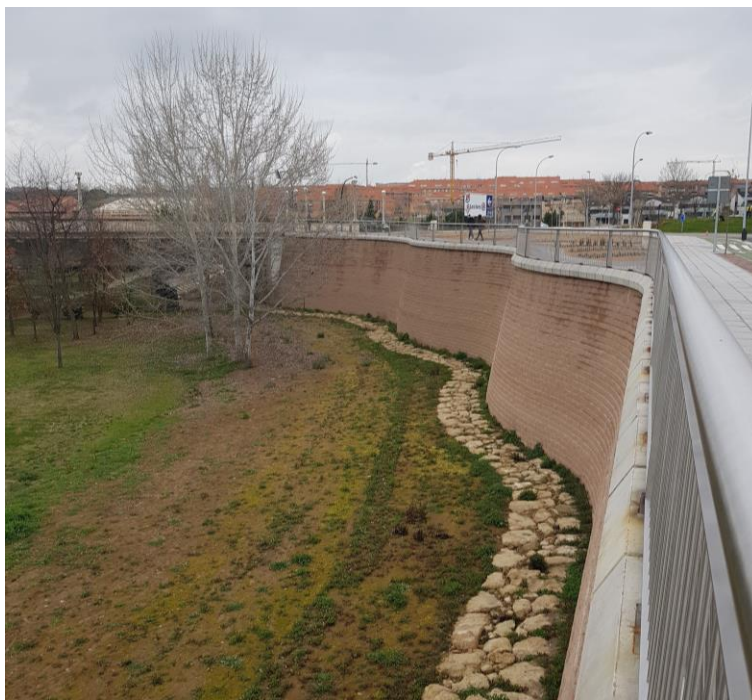
*Figure 7. Wall 1 at the present time (Huesker geosintéticos).*

owner representative engineer. In addition, a professional team of installers with more than 20 years of experience in the installation of block walls was on site, and the good results are evident (see Figure 7).
