Segmental Retaining Wall Reinforced with Geogrids, in New Hospital Works (Salamanca, Spain)

Reference: Rodríguez, M.T. and Amo, P. (2022). Segmental retaining wall reinforced with geogrids, in new hospital works (Salamanca, Spain). International Journal of Geoengineering Case Histories, Volume 7, Issue 2, pp. 62-71, doi: 10.4417/IJGCH-07-02-05

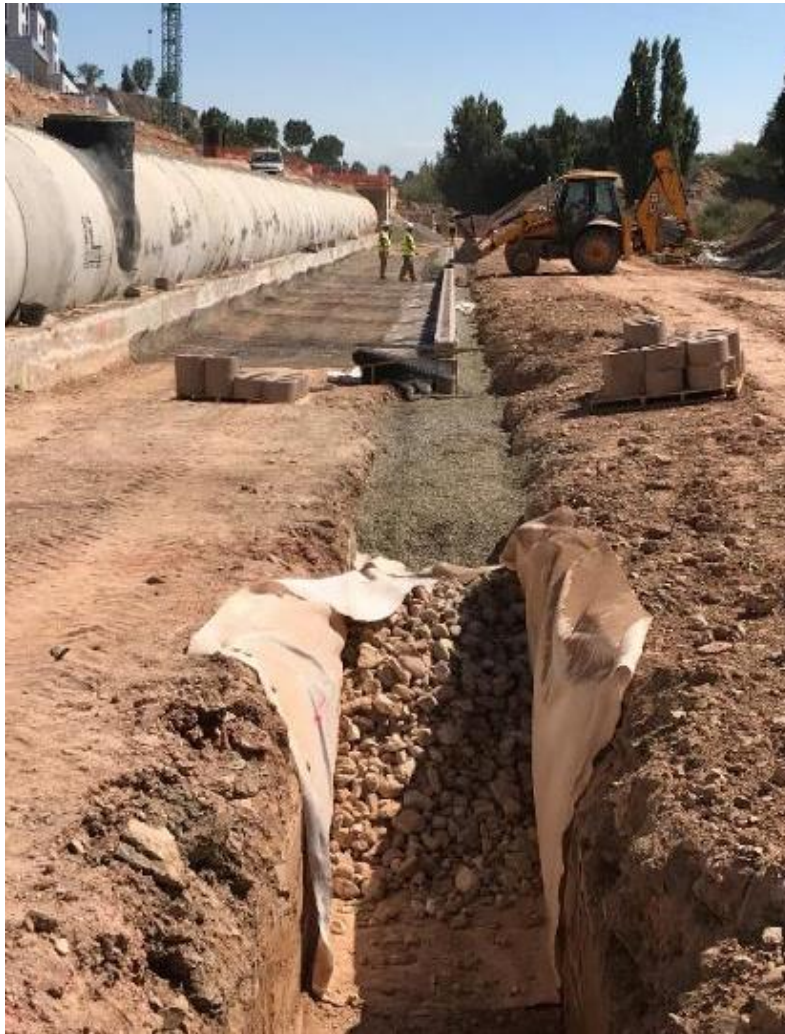
Figure 2. Different phases of the erection of Wall 1

To prepare the structure for foreseeable seasonal floods, a riprap was designed at the level of the wall, as scour protection of the foundations. To support the blocks on the facing, a foundation trench of approximately 1 x 1 m was built, filled with gravel, and wrapped in a non-woven geotextile filter. Behind the block face, a generous one m wide backfill of crushed gravel was installed (see Figure 2), as well as the drainpipe collector surround. Both drainage systems were completed with corrugated HDPE drainage pipes passing through the block face towards the river, arranged perpendicular to the line of the wall. Light- and medium-sized compactors were used to minimize the long-term facing deformation to reduce the lateral forces against the wall (Bathurst et al. 2010).

The section was discretized into several representative design sections. The maximum section height was 7.67 m above the foundations. The surcharge loading was 5 kN/m in the first five meters from the facing for the pedestrian zone, and a second of 10 kN/m for traffic thereafter. The length of the first layers of geogrids was limited by the presence of the collector and the two chambers (see Figure 3). It resulted in a trapezoidal section with less geogrid length at the base than at the crest in some sections. The minimum distance found was 2.6 m for a section of 6.5 m in height. The vertical distribution of geogrids was at 380 mm layers (two blocks) approximately up to 60% of the total height in most cases, and 570 mm (three blocks) for the rest of the wall. Furthermore, the transient situation was checked for maximum flooding and rapid drawdown, with favorable results. The geogrids used were flexible PET geogrids with PVC-free coating, with nominal strengths ranging from 35 kN/m to 80 kN/m.
