# Segmental Retaining Wall Reinforced with Geogrids, in New Hospital Works (Salamanca, Spain)

**ABSTRACT:** *The construction of a new hospital, located by the river Tormes in the Spanish city of Salamanca, involved the expansion of roads and the construction of a new way of access to the complex, as well as a large retaining wall to bridge the gap between them and the river level. The project original solution was in situ foundations and precast concrete walls. However, at both ends of the alignment of Transición Española Avenue, there were several construction constraints (such as the existence of rainwater chambers for discharging into the river, a large-diameter drainage pipe at the back of the walls, communications, and gas services). The need to maintain steady access to the old hospital in service during the COVID-19 pandemic was furthermore required. The wall was founded on fills with low bearing capacity in other sections. Finally, a reinforced segmental retaining wall (SRW) was adopted as the optimum choice. It consists of concrete block (segmental) facing with a high-quality fill reinforced backfill, reinforced with polyester (PET) geogrids. The facing required a variab

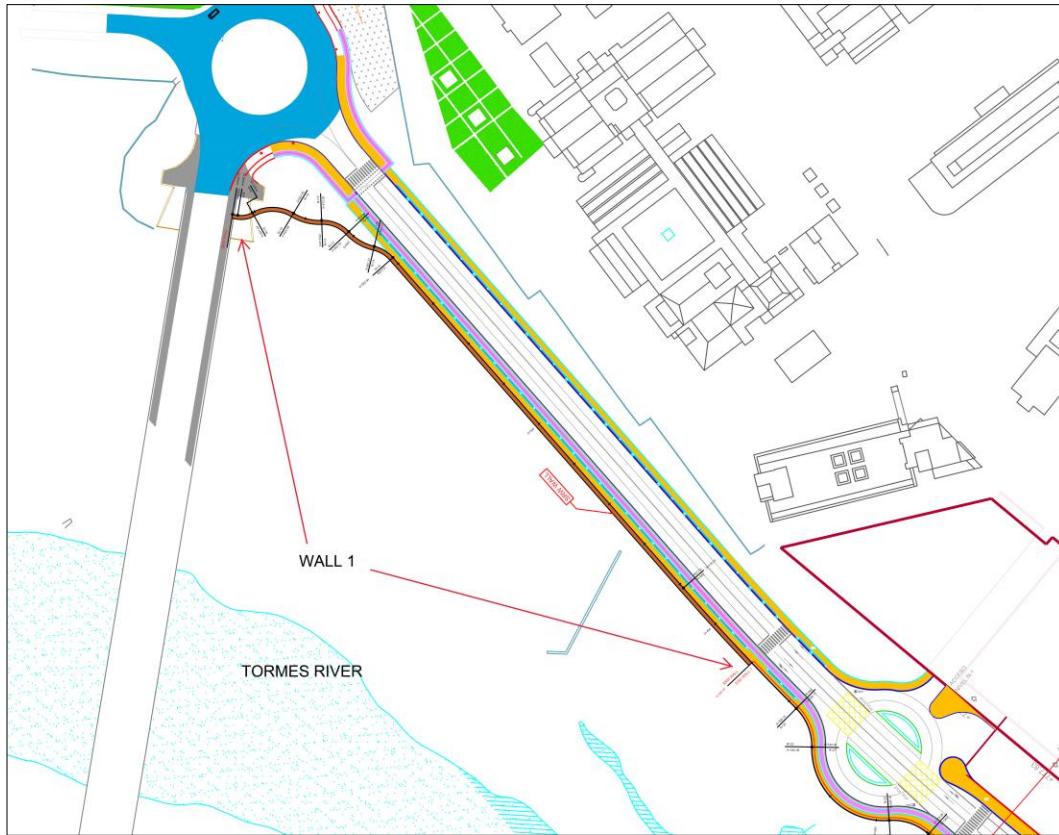
Figure 1. Plan view of wall 1 (Orbe Técnicas y Medioambiente).

The west wall is located between the abutment of the University Bridge and the central roundabout of the Transición Española Avenue (Figure 1), where it hits the precast concrete structure.

The length of this section is about 185 m with a maximum height of 7.67 m (40 blocks of 190 mm high plus the additional coping block) above the foundations and an inclination of the exposed face of 80°. The inclination was achieved by a simple setback of 30 mm at each line of block. Pedestrian and cycle lane areas were planned above the crown and behind them the new road with two lanes in each direction. In front of the wall, a green area was planned, although it is a floodable zone within in the 100 and 500 years of return period.

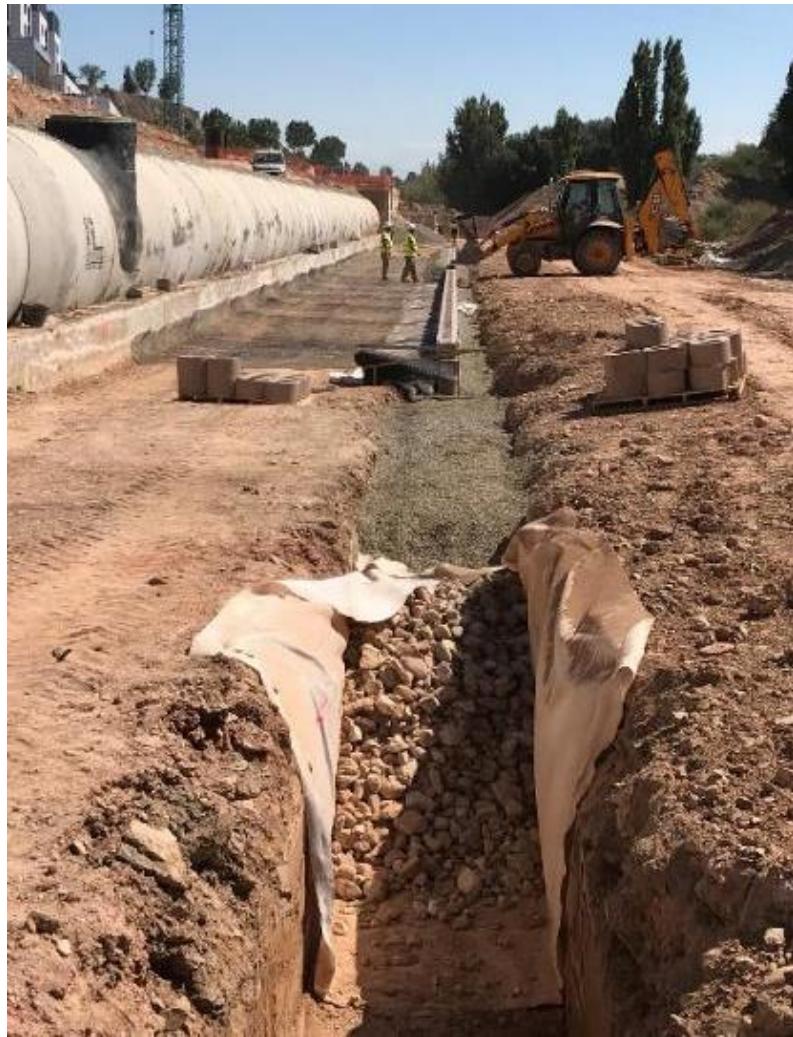
*Figure 2. Different phases of the erection of Wall 1*

To prepare the structure for foreseeable seasonal floods, a riprap was designed at the level of the wall, as scour protection of the foundations. To support the blocks on the facing, a foundation trench of approximately 1 x 1 m was built, filled with gravel, and wrapped in a non-woven geotextile filter. Behind the block face, a generous one m wide backfill of crushed gravel was installed (see Figure 2), as well as the drainpipe collector surround. Both drainage systems were completed with corrugated HDPE drainage pipes passing through the block face towards the river, arranged perpendicular to the line of the wall. Light- and medium-sized compactors were used to minimize the long-term facing deformation to reduce the lateral forces against the wall (Bathurst et al. 2010).

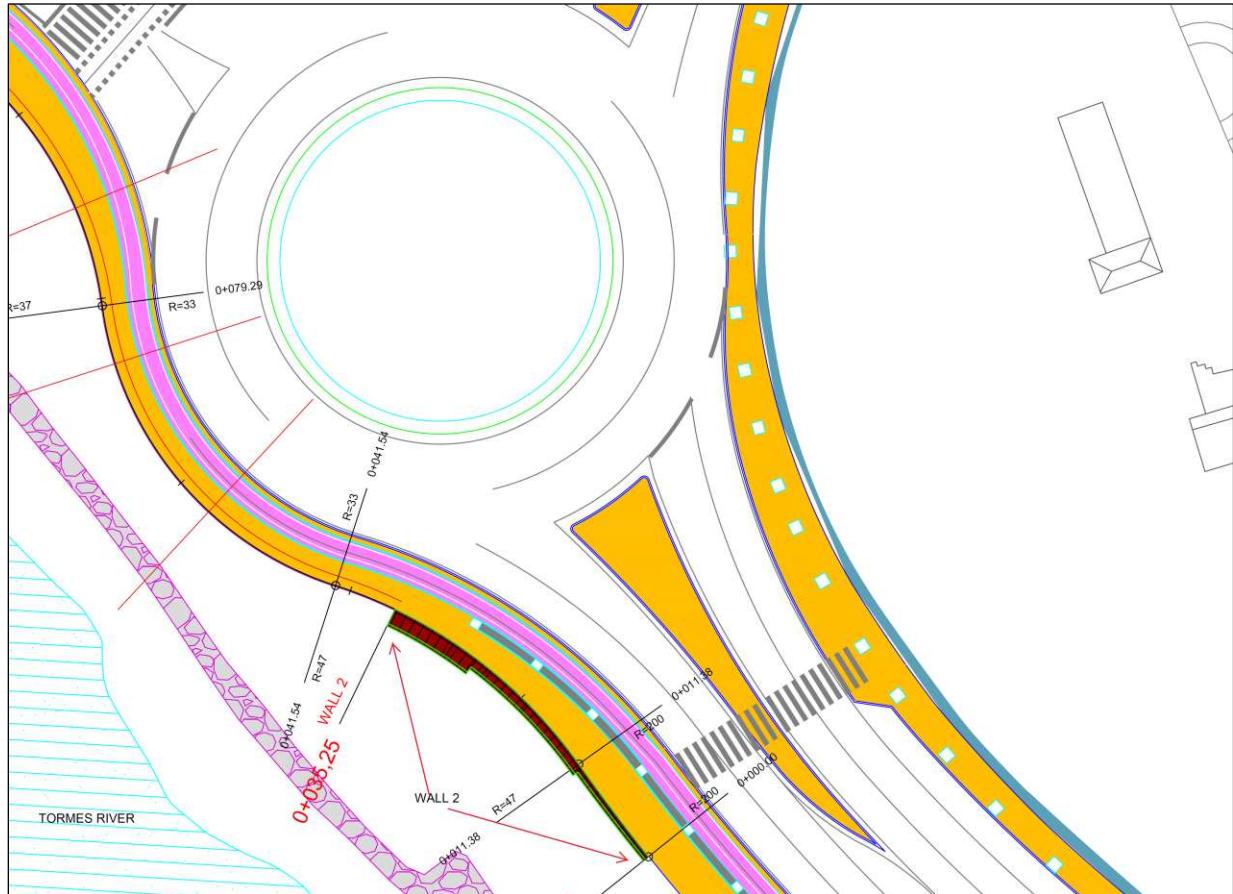
Figure 4. Plan view of Wall 2 (Orbe Técnicas y Medioambiente).

This section covers the development of the access roundabout to the new emergency area of the hospital and links the new Transición Española Avenue with San Vicente Avenue (see Figure 4). The wall had a length of 35 m with a maximum height of 9.2 m at the joint with the prefabricated wall, decreasing to a height of 2.7 m at the opposite end.

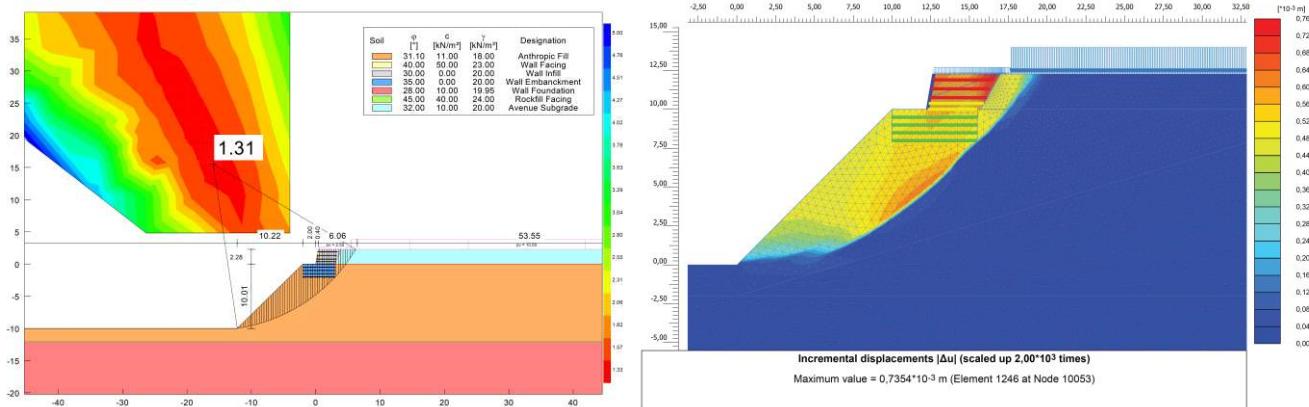
Figure 5. Section 0+24 preliminary analysis of global stability failure: (a) Bishop and (b) FEM (Huesker Geosintéticos, 2020).

Three sections were discretized and analyzed (one every 10 m) with special attention to the most unfavorable section at 0+24 at mid-slope. The stability analysis was carried out by using GGU Stability software following the Simplified Bishop Method. In addition, a simplified model in finite element was checked using Plaxis 2D software (see Figure 5). A 15 Node and Plane Strain Model was used. The soil model was a Mohr-Coulomb type in drained conditions, and an elastoplastic one for geogrids. No interfaces were used around geogrids because of their great interaction with soil particles. The finite element model detected failure surfaces coinciding with those obtained in the ultimate limit state and with factors of safety in the same range. It also confirmed the existence of surfaces susceptible to surface landslides throughout the embankment under the wall. Thus, a reduction in the slope inclination to increase the factor of safety against failure was necessary. Values of less than 10 mm of settlement were estimated in the model, which were assumed to be acceptable for the project.
