# Liquefaction and Non-liquefaction Cases from the Mataquito Bridge, Chile, after the $M_w$ 8.8 (2010) and $M_w$ 6.6 (2019) Earthquakes

**ABSTRACT:** *This paper describes field investigations and soil foundation performance of the Mataquito Bridge with respect to the 2010  $M_w$  8.8 and 2019  $M_w$  6.6 Chilean earthquakes. The Mataquito Bridge was constructed at the site prior to both earthquakes using a pile foundation designed against liquefaction and lateral spreading. The foundation system performed correctly during both earthquakes, and in the case of the 2010 event it withstood surface manifestation of liquefaction and lateral spreading loads. Different liquefaction severity indices are used to assess the liquefaction hazard with data from in-situ measurements. This paper provides a collection of data (Vs, CPT, SPT) for liquefaction and non-liquefaction cases at the same site under two different levels of shaking, and valuable case history data for future triggering and severity index models. Lateral displacements are also calculated and compared with those observed on the field after the 2010 earthquake.*

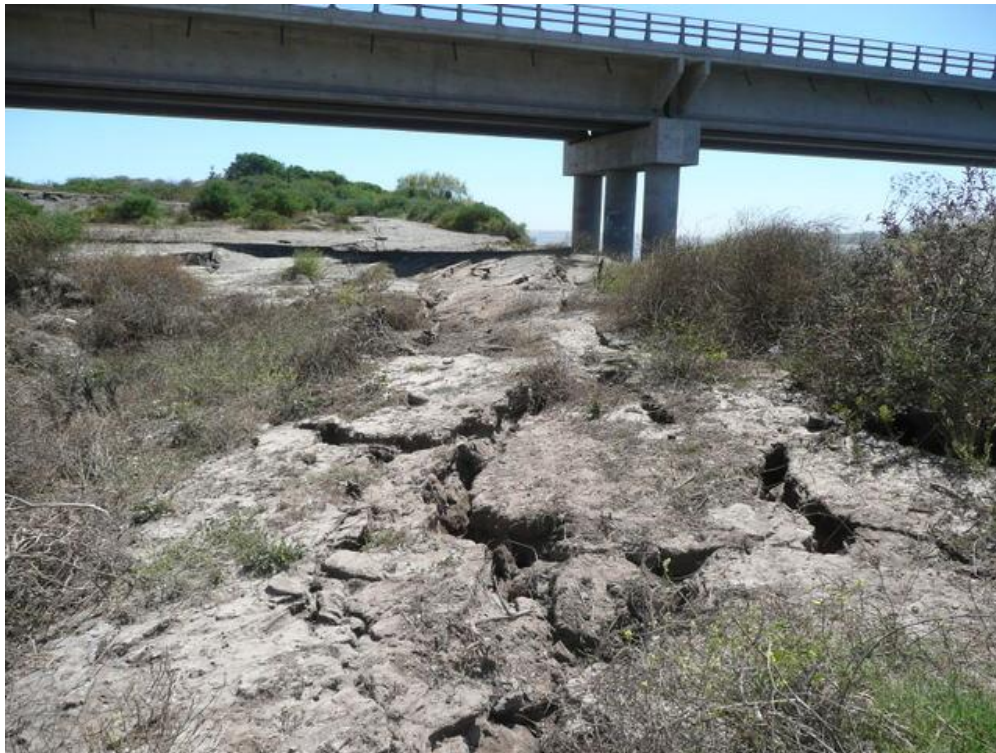
*Figure 4. Liquefaction effects along the south side of the bridge (Bray et al., 2010).*

Reconnaissance of the bridge found large lateral spreads towards the river at the north and south abutments in adjacent fields and directly below the bridge deck. Figures 3, 4, and 5 show photos of the settlement and lateral spreading (with sand boils) on the north and south sides of the bridge. Lateral spreading on the south side appeared to be confined to the border of the river, with deformations decreasing rapidly around 20 m from the river's edge to the south. On the north side, due to the relatively flat topography, it was observed to extend up to 250 m from the river's edge. Evidence of settlement was observed on the approach embankment and the rows of piers. Cracking of the asphalt on the north side was also observed along a distance of 200 m from the river's edge along the road.

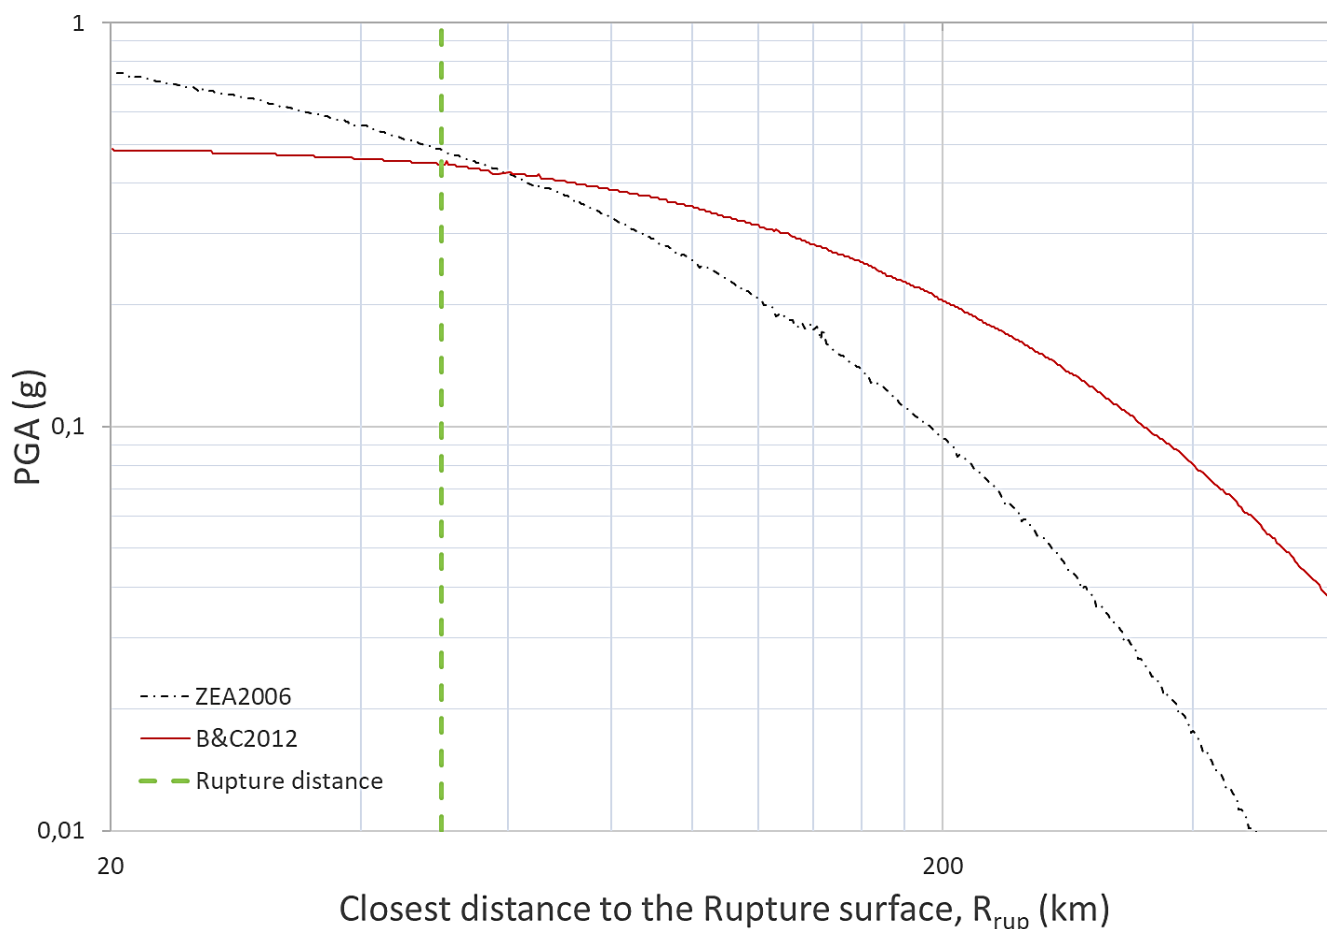
Figure 10. Attenuation relation for horizontal accelerations modified from Boroschek et al. (2012).
