Liquefaction and Non-liquefaction Cases from the Mataquito Bridge, Chile, after the M_w 8.8 (2010) and M_w 6.6 (2019) Earthquakes

ABSTRACT: This paper describes field investigations and soil foundation performance of the Mataquito Bridge with respect to the 2010 M_w 8.8 and 2019 M_w 6.6 Chilean earthquakes. The Mataquito Bridge was constructed at the site prior to both earthquakes using a pile foundation designed against liquefaction and lateral spreading. The foundation system performed correctly during both earthquakes, and in the case of the 2010 event it withstood surface manifestation of liquefaction and lateral spreading loads. Different liquefaction severity indices are used to assess the liquefaction hazard with data from in-situ measurements. This paper provides a collection of data (Vs, CPT, SPT) for liquefaction and non-liquefaction cases at the same site under two different levels of shaking, and valuable case history data for future triggering and severity index models. Lateral displacements are also calculated and compared with those observed on the field after the 2010 earthquake.

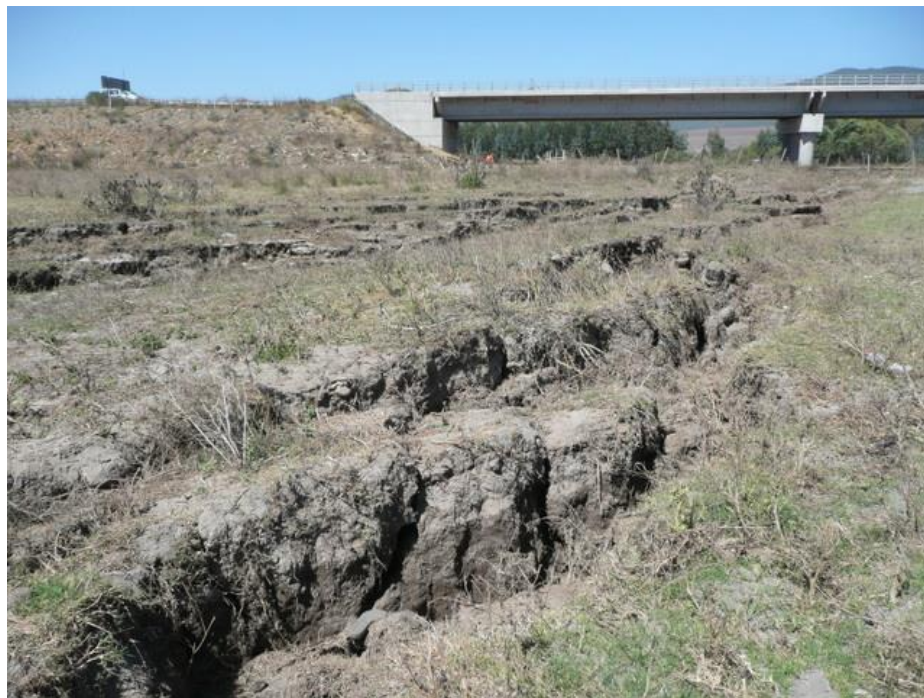
Figure 3. Lateral spreading at the north side of the bridge. Cracking showing roughly 0.6 m of vertical and 0.8 m of lateral displacement toward the river (Bray et al., 2010).

Reconnaissance of the bridge found large lateral spreads towards the river at the north and south abutments in adjacent fields and directly below the bridge deck. Figures 3, 4, and 5 show photos of the settlement and lateral spreading (with sand boils) on the north and south sides of the bridge. Lateral spreading on the south side appeared to be confined to the border of the river, with deformations decreasing rapidly around 20 m from the river's edge to the south. On the north side, due to the relatively flat topography, it was observed to extend up to 250 m from the river's edge. Evidence of settlement was observed on the approach embankment and the rows of piers. Cracking of the asphalt on the north side was also observed along a distance of 200 m from the river's edge along the road.

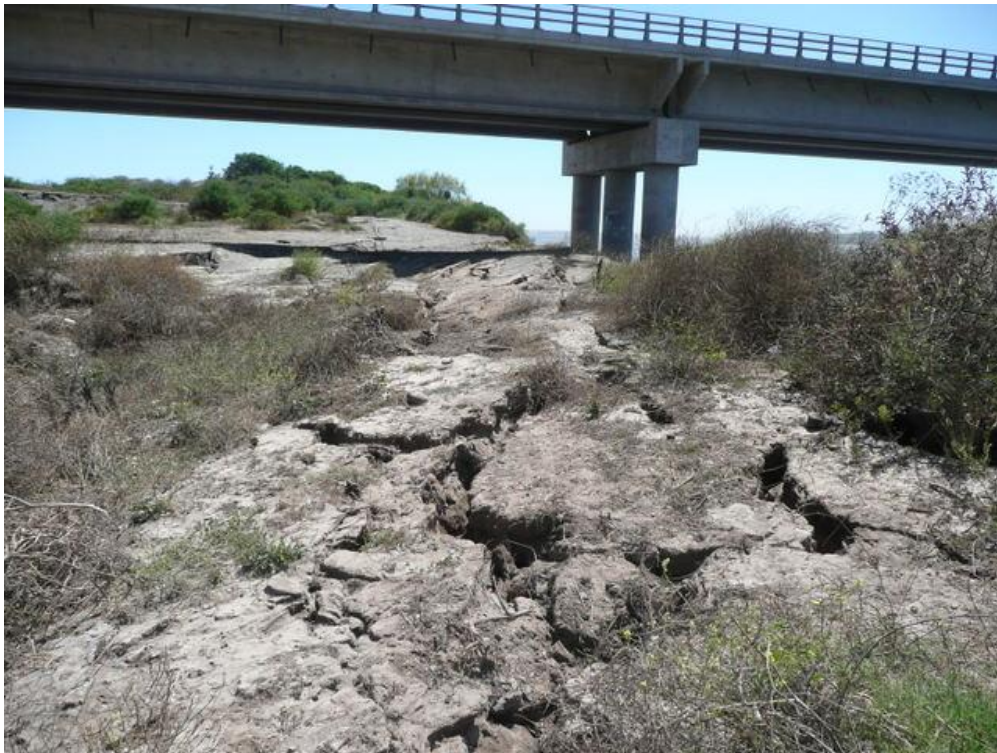
Figure 4. Liquefaction effects along the south side of the bridge (Bray et al., 2010).

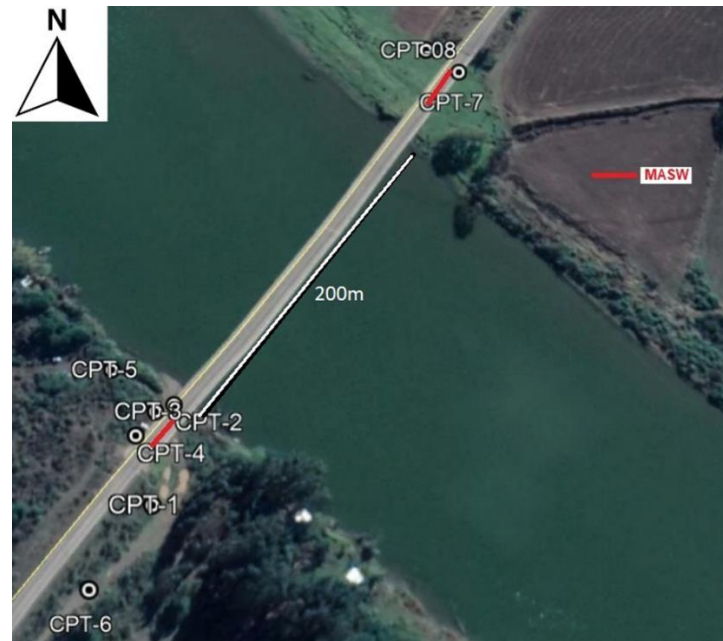
Figure 11. Posterior subsurface investigation locations from the 2019 field campaign.

A new subsurface investigation campaign was performed at the end of 2019. This campaign consisted of seismic CPT soundings, multichannel analysis of surface waves (MASW), and soil sampling using the CPT rigs. CPT soundings were performed using a 22-ton truck (www.lmmg.cl) with a seismic piezocone penetrometer arrangement (Figure 6). The cones with a base area of 15 cm² and friction sleeve area of 225 cm² were used in this campaign, and were calibrated by Gregg Drilling in accordance to ASTM D5778-12 (2012). Pore pressure transducers were located behind the cone tip on the standard (u₂) location. A geophone located inside the cone was used to collect seismic shear wave data. A total of 8 CPT soundings were performed to depths that varied between 7 m and just over 17 m where a dense gravel layer was encountered. The locations of CPT and MASW testing are shown in Figure 11.

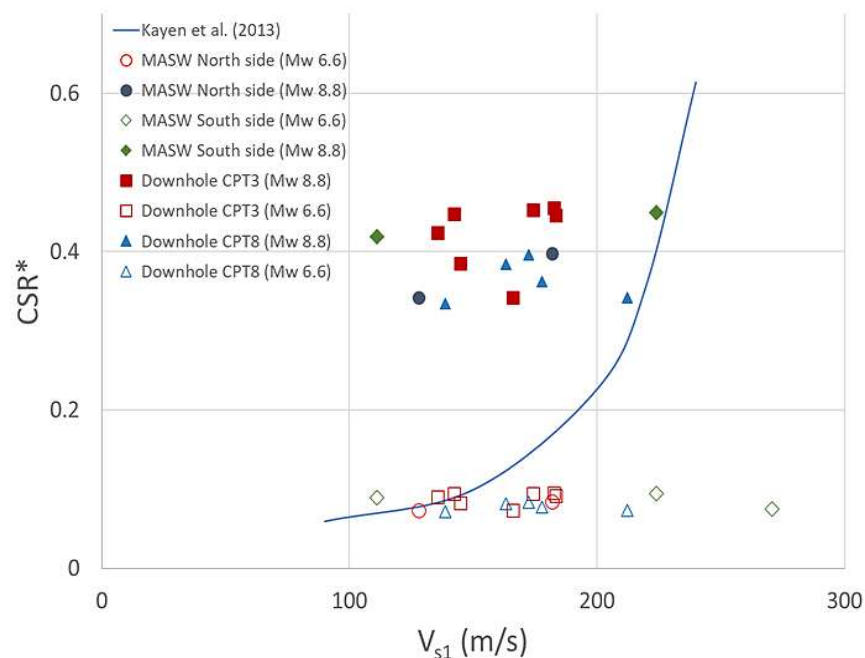
Figure 12. Liquefaction assessment using V_s from MASW and SCPT.

Liquefaction triggering was studied for both MASW profiles and downhole SCPT measurements using the procedure explained at Kayen et al. (2013). A 15% probability contour for initial liquefaction was considered as the deterministic boundary curve shown in Fig. 12. The results of this analysis, using MASW data, are shown in Fig. 12, where liquefaction is deduced from 3 m to 6 m at both sides of the river. Downhole CPT 3 is located at the south side of the bridge, and downhole CPT 8 is located at the north side. The analysis was performed for both earthquakes, where CPT 3 data was for depths between 1.5 m to 8.3 m, and CPT 8 was from 1.5 m to 6.3 m. The MASW and downhole shear wave velocity analysis seemed to correlate adequately with the observations from both earthquakes.

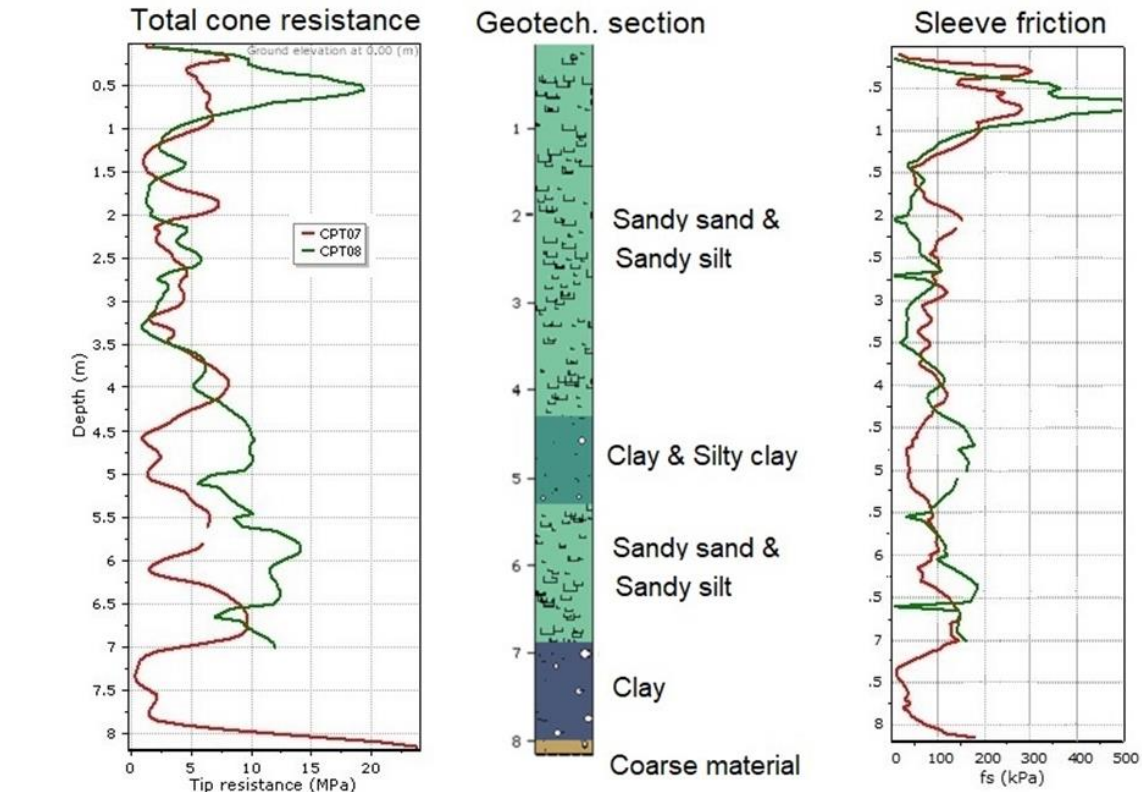
Figure 13. CPT soundings on the north side with the water table located at roughly at 2.5 m.

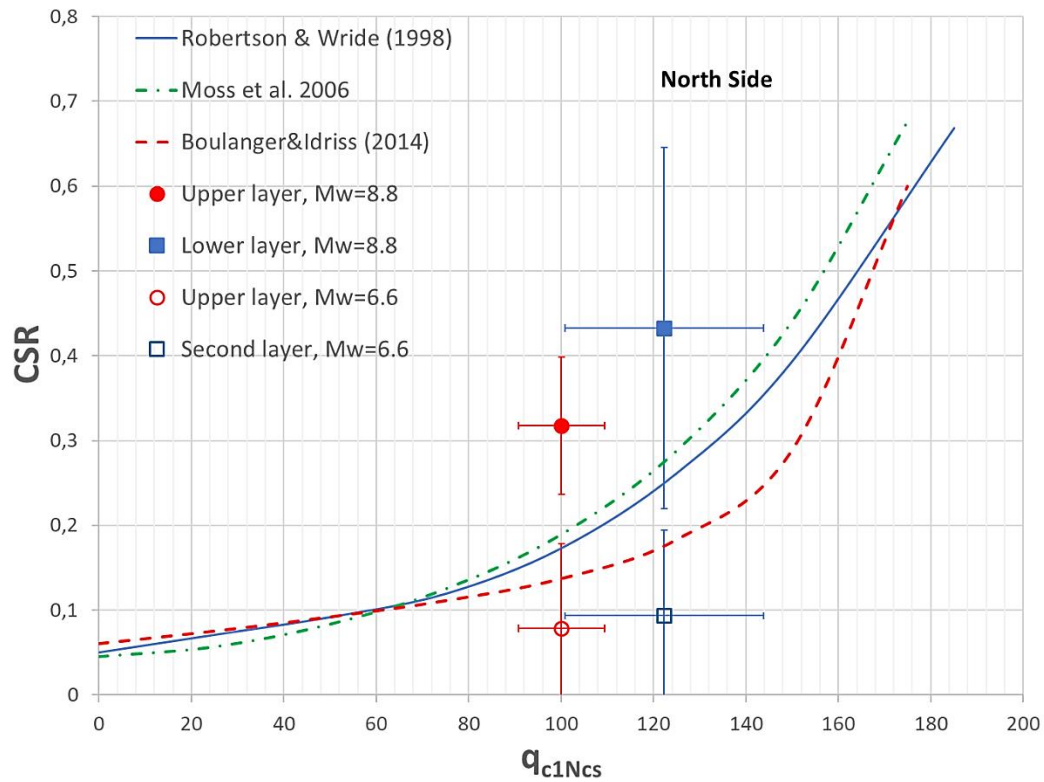
Figure 16. Liquefaction analysis on the north side; average values for CPTs 7 and 8 along with plus/minus one standard deviation.

Figure 16 shows the average values for an upper layer (between 2.5 m and 3.5 m) and lower layer (between 3.5 m and 6.5 m). In addition to the mean values shown in Figure 16, the standard deviation for calculated values of CSR and q_{c1Ncs} are also shown. The standard deviation of CSR was calculated following the methodology recommended by Cetin et al. (2018). As aforementioned, horizontal accelerations deduced from the attenuation relations and data from strong motion records relatively close to the Mataquito Bridge are consistent, and the coefficient of variation of maximum acceleration is assumed equal to 0.1. Ground water table standard deviation was assumed equal to 1 m. Moist and saturated unit weight were assumed to have a standard deviation equal to 0.5 kN/m³. Standard deviation of the participation factor (r_d) was calculated according to Cetin and Seed (2004). On the other hand, standard deviation of q_{c1Ncs} was calculated from the actual data from CPT sounding measurements in each critical layer considered for the analysis. The results are consistent with what was observed on the field: liquefaction occurred during the 2010 earthquake, and no effects happened during the 2019 earthquake. The Zhang et al. (2002) method was used to estimate, from CPT data, the vertical settlements due to liquefaction. In order to obtain vertical settlement similar to what was observed on the field (20 to 30 cm), it is necessary to consider that both layers liquefied. Similarly, it will be shown later that lateral spreading would also need both layers to liquefy in order for the models to match the observed horizontal displacement.

The liquefaction analysis performed with data from CPTs 1 to 3 on the south side matches what was observed in the field. Special attention is given to the upper layer, as it is very close to the liquefaction triggering curve for the 2019 earthquake. Both Figures 16 and 17 show the standard deviation of CSR and q_{c1Ncs} , as previously explained.
