# Liquefaction and Non-liquefaction Cases from the Mataquito Bridge, Chile, after the $M_w$ 8.8 (2010) and $M_w$ 6.6 (2019) Earthquakes

**ABSTRACT:** *This paper describes field investigations and soil foundation performance of the Mataquito Bridge with respect to the 2010  $M_w$  8.8 and 2019  $M_w$  6.6 Chilean earthquakes. The Mataquito Bridge was constructed at the site prior to both earthquakes using a pile foundation designed against liquefaction and lateral spreading. The foundation system performed correctly during both earthquakes, and in the case of the 2010 event it withstood surface manifestation of liquefaction and lateral spreading loads. Different liquefaction severity indices are used to assess the liquefaction hazard with data from in-situ measurements. This paper provides a collection of data (Vs, CPT, SPT) for liquefaction and non-liquefaction cases at the same site under two different levels of shaking, and valuable case history data for future triggering and severity index models. Lateral displacements are also calculated and compared with those observed on the field after the 2010 earthquake.*

Reference: Moffat, R., and Moss, R. (2022). Liquefaction and Non-

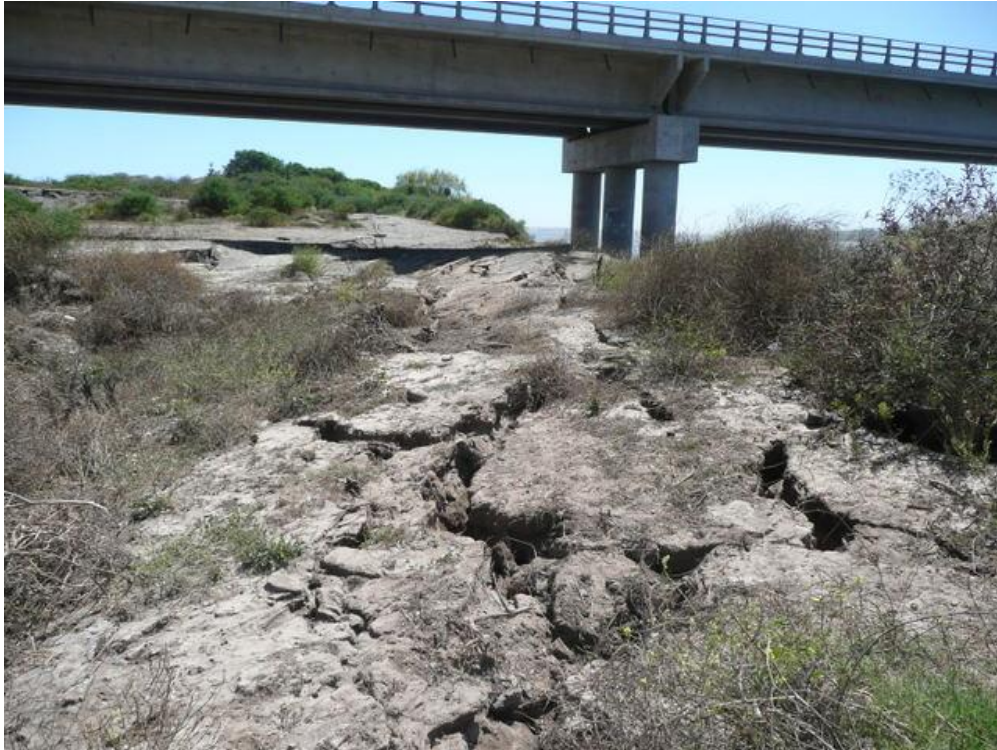
*Figure 4. Liquefaction effects along the south side of the bridge (Bray et al., 2010).*

Reconnaissance of the bridge found large lateral spreads towards the river at the north and south abutments in adjacent fields and directly below the bridge deck. Figures 3, 4, and 5 show photos of the settlement and lateral spreading (with sand boils) on the north and south sides of the bridge. Lateral spreading on the south side appeared to be confined to the border of the river, with deformations decreasing rapidly around 20 m from the river's edge to the south. On the north side, due to the relatively flat topography, it was observed to extend up to 250 m from the river's edge. Evidence of settlement was observed on the approach embankment and the rows of piers. Cracking of the asphalt on the north side was also observed along a distance of 200 m from the river's edge along the road.
