# Liquefaction and Non-liquefaction Cases from the Mataquito Bridge, Chile, after the $M_w$ 8.8 (2010) and $M_w$ 6.6 (2019) Earthquakes

**ABSTRACT:** *This paper describes field investigations and soil foundation performance of the Mataquito Bridge with respect to the 2010  $M_w$  8.8 and 2019  $M_w$  6.6 Chilean earthquakes. The Mataquito Bridge was constructed at the site prior to both earthquakes using a pile foundation designed against liquefaction and lateral spreading. The foundation system performed correctly during both earthquakes, and in the case of the 2010 event it withstood surface manifestation of liquefaction and lateral spreading loads. Different liquefaction severity indices are used to assess the liquefaction hazard with data from in-situ measurements. This paper provides a collection of data (Vs, CPT, SPT) for liquefaction and non-liquefaction cases at the same site under two different levels of shaking, and valuable case history data for future triggering and severity index models. Lateral displacements are also calculated and compared with those observed on the field after the 2010 earthquake.*

Reference: Moffat, R., and Moss, R. (2022). Liquefaction and Non-

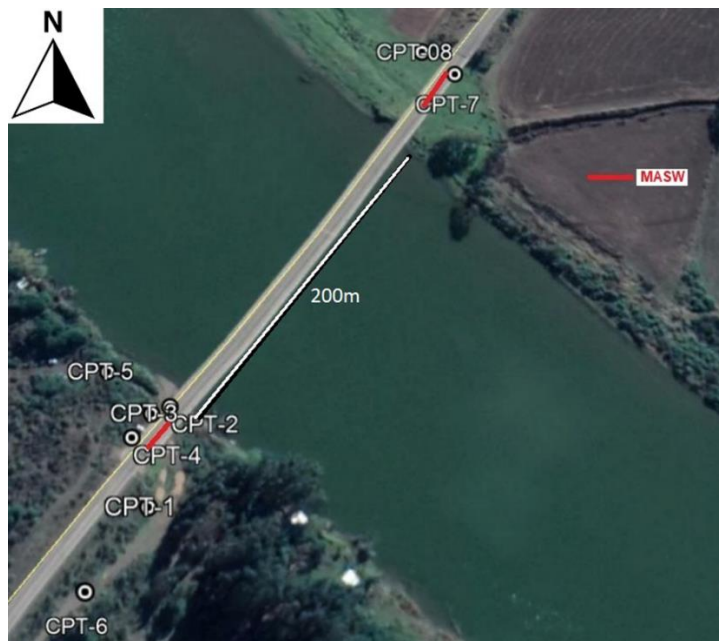
Figure 11. Posterior subsurface investigation locations from the 2019 field campaign.

A new subsurface investigation campaign was performed at the end of 2019. This campaign consisted of seismic CPT soundings, multichannel analysis of surface waves (MASW), and soil sampling using the CPT rigs. CPT soundings were performed using a 22-ton truck ([www.lmmg.cl](http://www.lmmg.cl)) with a seismic piezocone penetrometer arrangement (Figure 6). The cones with a base area of 15 cm<sup>2</sup> and friction sleeve area of 225 cm<sup>2</sup> were used in this campaign, and were calibrated by Gregg Drilling in accordance to ASTM D5778-12 (2012). Pore pressure transducers were located behind the cone tip on the standard ( $u_2$ ) location. A geophone located inside the cone was used to collect seismic shear wave data. A total of 8 CPT soundings were performed to depths that varied between 7 m and just over 17 m where a dense gravel layer was encountered. The locations of CPT and MASW testing are shown in Figure 11.
