# Liquefaction and Non-liquefaction Cases from the Mataquito Bridge, Chile, after the $M_w$ 8.8 (2010) and $M_w$ 6.6 (2019) Earthquakes

**ABSTRACT:** *This paper describes field investigations and soil foundation performance of the Mataquito Bridge with respect to the 2010  $M_w$  8.8 and 2019  $M_w$  6.6 Chilean earthquakes. The Mataquito Bridge was constructed at the site prior to both earthquakes using a pile foundation designed against liquefaction and lateral spreading. The foundation system performed correctly during both earthquakes, and in the case of the 2010 event it withstood surface manifestation of liquefaction and lateral spreading loads. Different liquefaction severity indices are used to assess the liquefaction hazard with data from in-situ measurements. This paper provides a collection of data (Vs, CPT, SPT) for liquefaction and non-liquefaction cases at the same site under two different levels of shaking, and valuable case history data for future triggering and severity index models. Lateral displacements are also calculated and compared with those observed on the field after the 2010 earthquake.*

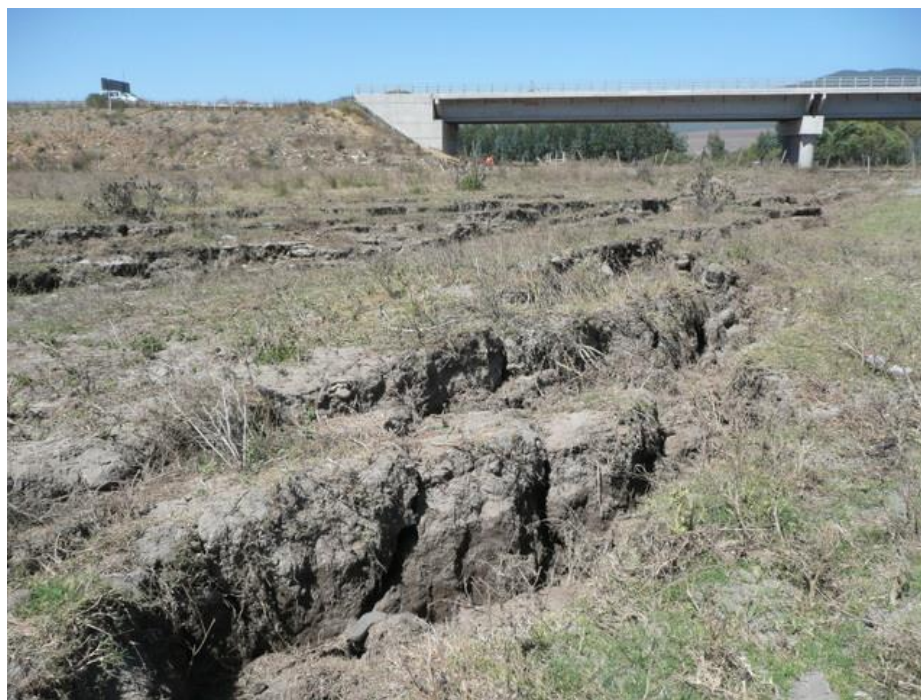
Figure 3. Lateral spreading at the north side of the bridge. Cracking showing roughly 0.6 m of vertical and 0.8 m of lateral displacement toward the river (Bray et al., 2010).

Reconnaissance of the bridge found large lateral spreads towards the river at the north and south abutments in adjacent fields and directly below the bridge deck. Figures 3, 4, and 5 show photos of the settlement and lateral spreading (with sand boils) on the north and south sides of the bridge. Lateral spreading on the south side appeared to be confined to the border of the river, with deformations decreasing rapidly around 20 m from the river's edge to the south. On the north side, due to the relatively flat topography, it was observed to extend up to 250 m from the river's edge. Evidence of settlement was observed on the approach embankment and the rows of piers. Cracking of the asphalt on the north side was also observed along a distance of 200 m from the river's edge along the road.
