## Coastal Road Slope Collapses Behind a Retaining Wall Due to Scour and Erosion

**ABSTRACT:** *The present study investigates the coastal road slope disasters that took place in December 2014 and in November 2021 in Hokkaido, Japan. The coastal disasters represent collapses behind the retaining walls under high wave conditions. The results of the field investigations demonstrate that the extent of the damages was significantly larger in the 2014 disaster than in the 2021 disaster, and this difference was closely related with the presence and absence of overtopping. Based on the estimated offshore waves, a series of hydraulic wave flume experiments were conducted so as to gain insights into the disaster mechanisms. The combined field and experimental results show that the collapses were the consequence of coupled surface erosion, scour, and internal erosion beneath and behind the retaining walls. The overtopping enlarged the extent of the collapses. The paper also discusses an effective countermeasure meant to suppress such coastal road slope disasters behind retaining walls.*

Reference: Tsubokawa, R., Iida, Y., Ushiwatari, Y., Matsuda, T., Ochi, M., Miyatake, M. and Sassa, S. (2

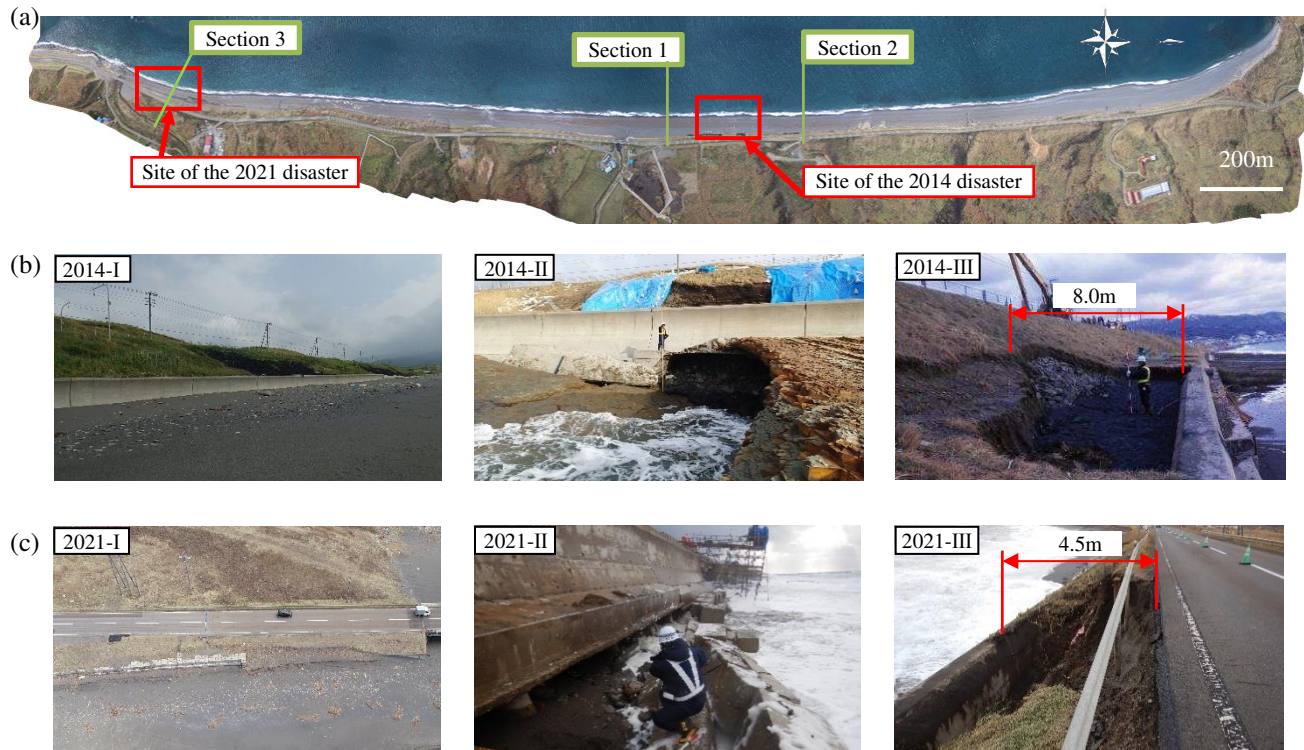
The results of the field surveys that were conducted several days after the 2014 and 2021 events and in 2019 that corresponded to normal times are shown in Fig. 2. The photographs 2014-I and 2021-I show the situations in 2019 where the foreshores were covered with sand and no significant erosion took place. In contrast, the photographs 2014-II and 2021-II show that the foreshore sands were lost, owing to surface erosion that occurred under the action of high waves; subsequently, the base and foundation of the retaining walls were exposed. At the site of the 2014 event, there existed a weak erodible bedrock beneath sands (2014-II). The photographs 2014-III and 2021-III demonstrate that large collapses took place behind the retaining walls. The extent of collapse during the 2014 event was equal to 8.0 m, which was significantly larger than that of 4.5 m during the 2021 event. The field surveys also identified the trace of peeling of vegetation on the road slope surface behind the retaining wall following the 2014 event, whereas it was not confirmed following the 2021 event. This indicates that the severe wave-induced overtopping flows acted behind the retaining wall at the time of the 2014 event. The associated mechanisms will be discussed later in this paper.

Figure 2. Field surveys of the 2014 and 2021 disasters: (a) Locations of foreshore slope surveys, (b) Situations at normal times (2014-I) and following the 2014 disaster (2014-II, 2014-III), and (c) Situations at normal times (2021-I) and following the 2021 disaster (2021-II, 2021-III).

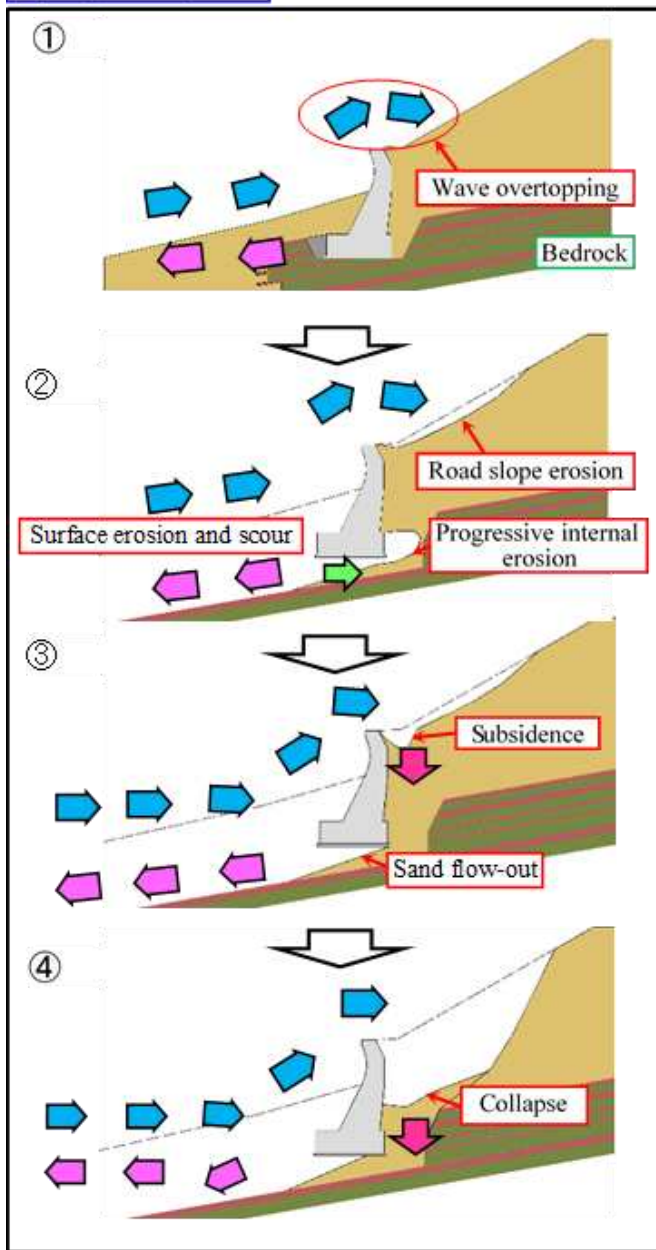
The processes and mechanisms for the 2014 and 2021 disasters based on the field, numerical, and experimental investigations described above can be schematically shown in Fig. 13. For the 2014 disaster, the five-year probability wave produced wave overtopping. The wave-induced runup and return flow, i.e., swash and backwash, acted on the foreshore sands and the weak erodible bedrock. These caused surface erosion and scour in front of the base of the retaining wall. The continued severe wave action then gave rise to the occurrence of progressive internal erosion, accompanied by the formation of cavities beneath and behind the retaining wall. In the meantime, the wave overtopping/overflow led to erosion of the road slope surface behind the top of the wall. Here, the overflow represents infiltration that reduces suction in the ground, which has been shown to destabilize cavities formed by the wave-induced internal erosion (Kudai et al., 2021), and the overflow promotes flow-out of granular materials beneath a foundation of coastal structures (Sassa et al., 2016). Hence, the coupled severe wave action and overflow brought about subsidence and sand flow-out that resulted in a large collapse behind the retaining wall.

In contrast, the 2021 disaster stemmed from the one-year probability wave that did not produce wave overtopping. Nevertheless, the wave-induced runup and return flow, i.e., swash and backwash, were severe enough to cause surface erosion and scour in front of the base of the retaining wall, which gave rise to progressive internal erosion beneath and behind the retaining wall. The continued wave actions involving swash and backwash destabilized the cavities formed, leading to subsidence and sand flow-out. As a consequence, collapse occurred behind the retaining wall. Overall, both the 2014 and 2021 disasters share the same basic mechanisms: namely, the coupled surface erosion, scour, and internal erosion beneath and behind the retaining wall, which led to collapse. The existence of the overtopping flow enlarged the extent of collapse in the 2014 disaster compared to the 2021 disaster.

Figure 13. Sketches based on the field, numerical, and experimental investigations, showing the processes and mechanisms of the 2014 and 2021 disasters.

The above results and discussion indicate that the 2014 and 2021 disasters stemmed from the wave-induced internal erosion beneath and behind the retaining wall. This means that the deterrence of the internal erosion beneath the base of the retaining wall may serve as an effective countermeasure to prevent the occurrence of future collapse behind the retaining wall. This can be achieved by applying an appropriately designed filter, which has been shown to have a sufficient deterrent effect under strong hydraulic forcing at coasts (Kudai et al., 2021). Deterring the wave-induced internal erosion beneath the base of the retaining wall should thus be a viable measure, which could be conducted in conjunction with a protection work to suppress the influence of overtopping on the coastal road slope surface behind the retaining wall.
