## Effect of Dredging and Axial Load on a Berthing Structure

**ABSTRACT:** Piles and a diaphragm wall of a supported berthing structure on marine soils are loaded both axially and laterally. Axial loads are typically generated by the self weight of the structure and external live loads; lateral loads are typically generated by wave current and seismic loads. These loads are generally considered in the design of berthing structures. However, the lateral force generated by lateral soil movements due to dredging may not be considered or accounted in the design of berthing structures. Hence, a full-scale field study was conducted on a berthing structure to estimate the actual axial load distribution during axial loading and the lateral displacement during dredging. After construction of the berth, it was decided to conduct a full scale axial load test on a single pile and monitor the lateral movements of the berth during and after dredging. This paper describes the load transfer data obtained from a bored cast – in – situ pile socketed 1.5 m into hard rock and the lateral displacement of the berth recorded during and after dredging to a -9.5 m dredge depth.

Muthukkumar K., Sundaravad

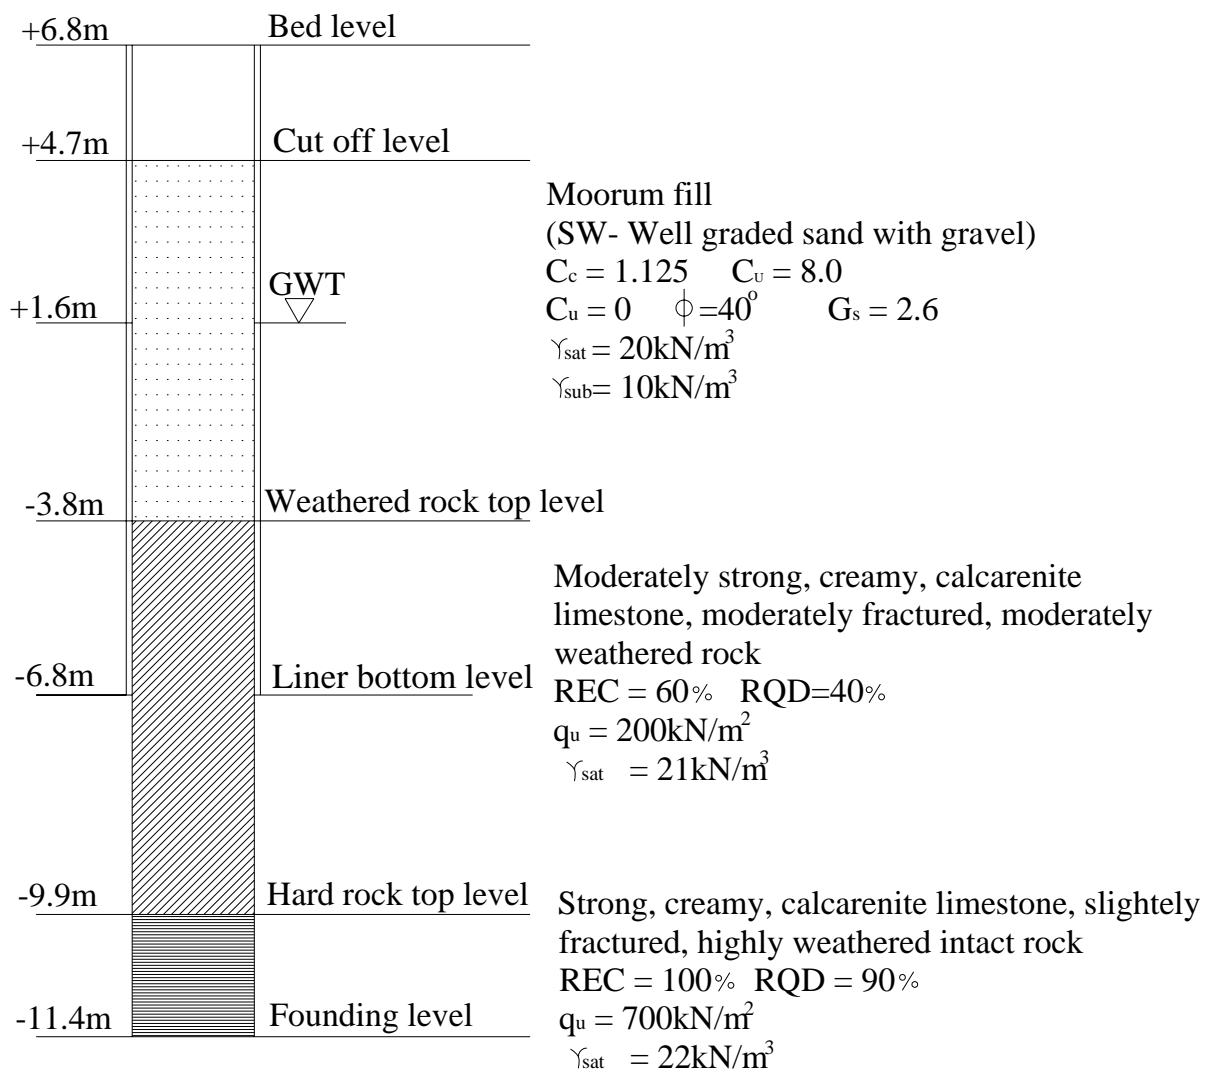
Figure 1. Typical Soil Profile at Pile Load Test Location.

A typical soil profile at the location of pile load test is shown in Fig. 1. The top 10.5 m consist of filled moorum soil, followed by rocky formation. The index and engineering properties of the encountered soils and rock are as follows.

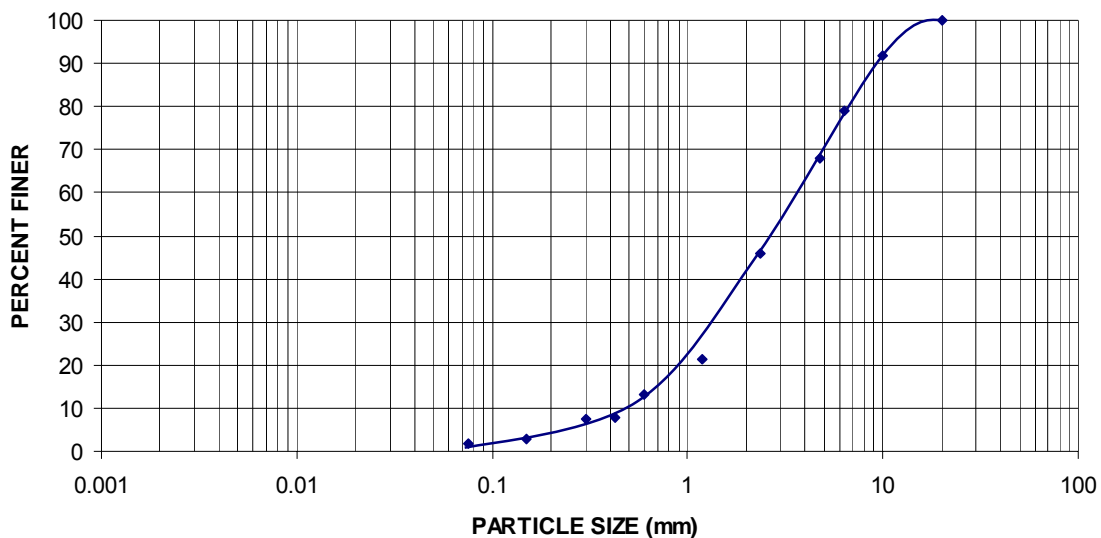
Figure 2. Grain Size Distribution Curve for Moorum Soil.

A typical grain size distribution curve of moorum fill is shown in Fig. 2. The effective particle size ( $D_{10}$ ) is 0.5 mm, average particle size ( $D_{50}$ ) is 2.7 mm, Coefficient of Uniformity ( $C_U$ ) is 8.0, Coefficient of Curvature ( $C_C$ ) is 1.125 and Specific Gravity ( $G_s$ ) is 2.6. As per ASTM D-2487, the moorum fill soil is classified as well graded sand with gravel (SW). To obtain the value of angle of internal friction, direct shear tests were conducted on the moorum soil. The average angle of internal friction of the moorum soil was estimated to be  $40^\circ$ . Typical direct shear test results are presented in Fig. 3.

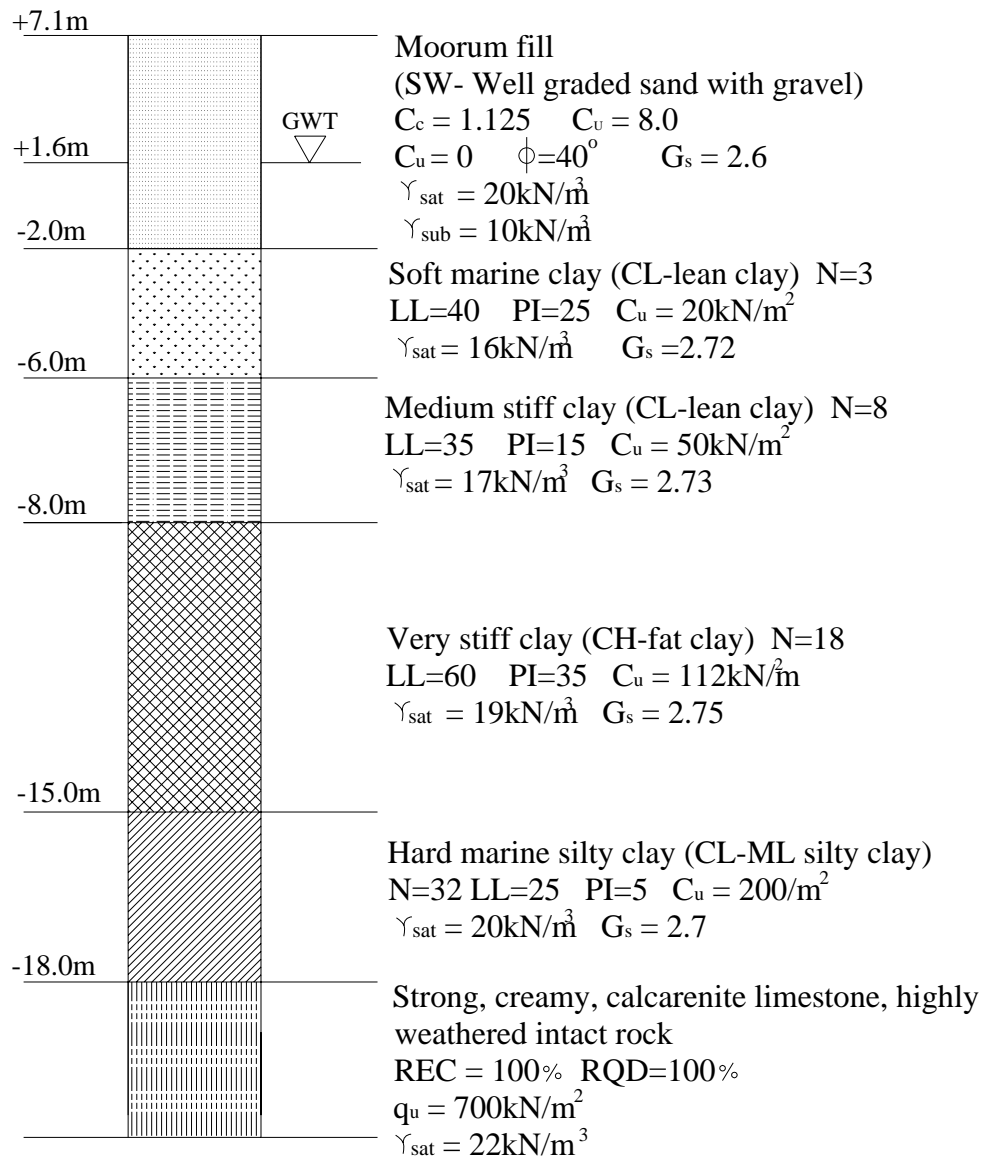
Figure 4. Typical Soil Profile at Inclinator Test Locations.

Fig. 4 shows the typical soil profile at the pile and diaphragm wall panel locations where the inclinometer was installed. The top soil is moorum fill of 9.1 m thickness followed by 4 m soft marine clay with an average SPT (N) value of 3, followed by 2 m thick medium stiff clay with an average SPT (N) value of 8, followed by 7 m thick, very stiff clay with an average SPT (N) value of 18. The clay is underlain by 3 m thick hard marine silty clay with an average SPT (N) value of 32 which in turn is underlain by strong, creamy, calcarenite limestone, highly weathered intact rock with REC value of 100% and RQD value of 100%. Based on the RQD values, the encountered rock formations are classified as excellent rock. The index and engineering properties of the moorum soil are identical to the pile load test location moorum soil, presented previously. The encountered fine-grained soils index and engineering properties are presented below.

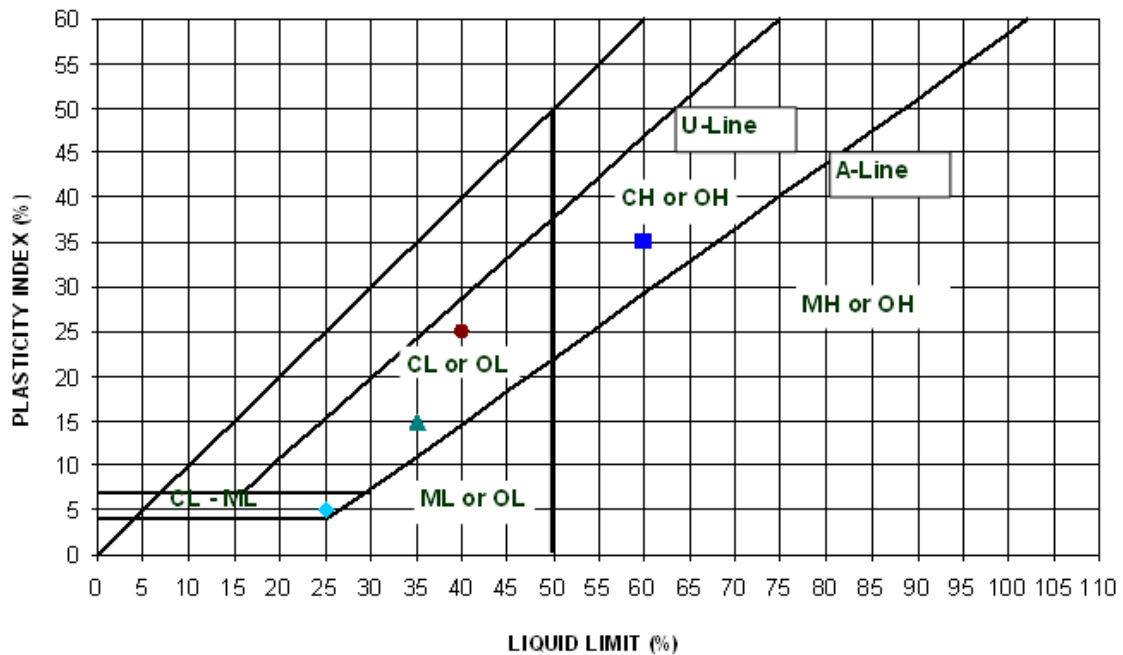
Figure 5. Classification of fine grained soil (ASTM D2487)

To obtain the index and engineering properties of the fine-grained soils, disturbed and undisturbed soil samples were collected at different depths. Liquid limit and plastic limit tests were conducted on the collected soil samples, to classify the soils based on the Unified Soil Classification System (USCS). The classification of the encountered fine grained soils is presented in Fig. 5. The undrained shear strength of the encountered fine grained soils was evaluated by conducting in-situ field vane shear tests in the soft clay soil and unconfined compression tests in the collected undisturbed soil samples. Two vane shear tests were conducted at elevations -2.0 m and -4.0 m. The average undrained shear strength of the layer (elevations between -2.0 m & -4.0 m) was obtained as 20 kN/m<sup>2</sup>. The vane shear computations are presented in the appendix. The unconfined compression tests were conducted on the undisturbed soil samples collected at elevations of -6.0 m, -8.0 m, -11.0 m, -13.0 m, -15.0 m and -17.0 m. The typical unconfined compressive strength variation plot for elevations of -6.0 m, -11.0 m and -15.0 m are shown in Fig. 6a, 6b and 6c respectively. The average undrained shear strength of lean

Elevation (m)	Symbol	LL (%)	PI (%)	Passing # 200 Sieve, (%)	USC Classification
-2.0 to -6.0	●	40	25	70	CL (Lean Clay)
-6.0 to -8.0	▲	35	15	60	CL (Lean Clay)
-8.0 to -15.0	■	60	35	80	CH (Fat Clay)
-15.0 to -18.0	◆	25	5	40	CL-ML (Silty Clay)

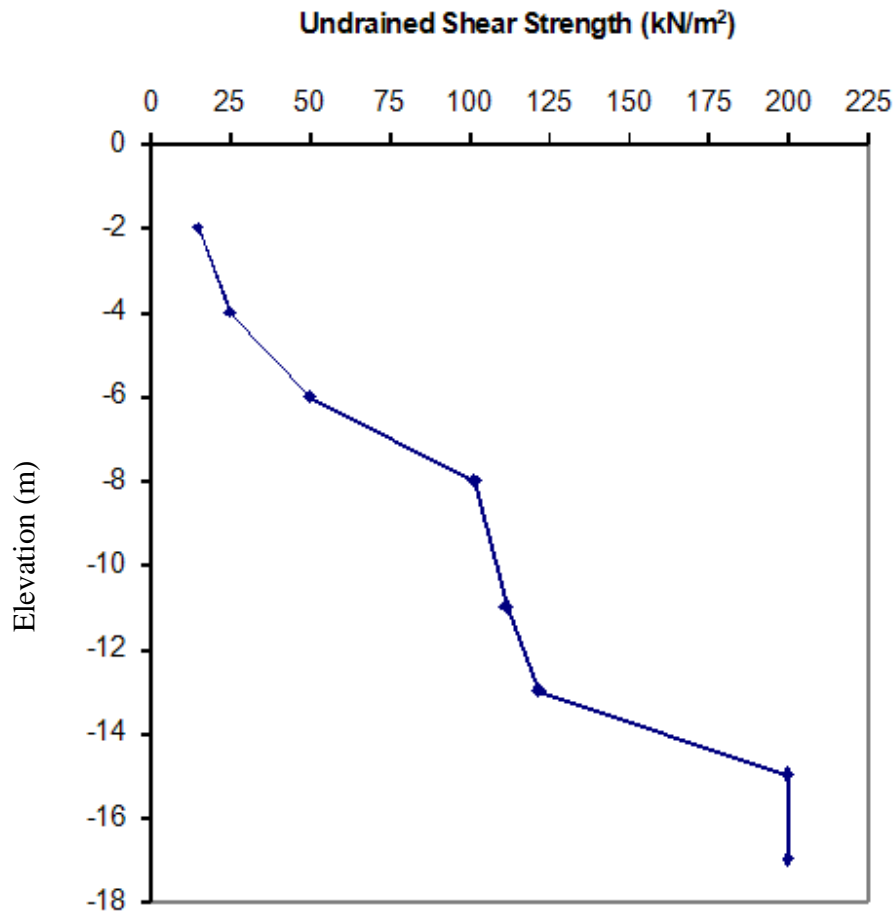
Figure 7. Variation of Undrained Shear Strength with Depth.

clay at elevations between -6.0 m and -8.0 m was estimated as 50 kN/m<sup>2</sup>. The average undrained shear strength value of fat clay at elevations between -8.0 m and -15.0 m was estimated as 112 kN/m<sup>2</sup>. The average undrained shear strength value of silty clay at elevations between -15.0 m and -18.0 m was estimated as 200 kN/m<sup>2</sup>. The undrained shear strength variation with elevation is shown in Fig. 7. The unconfined compressive strength computations are presented in the appendix.

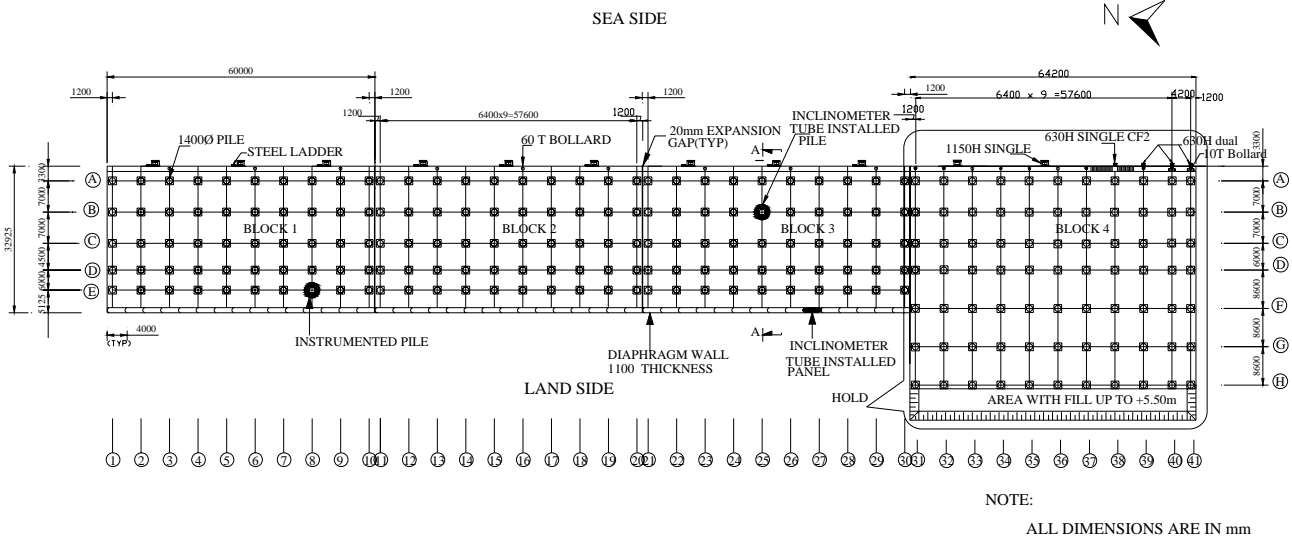
Figure 8. General Layout of Berthing Structure.

The general layout of the berthing structure and a cross section of the berth is shown in Fig. 8 and Fig. 9 respectively. The total length of the berth is 252 m and the width is 33 m. The berth is supported by both piles and the diaphragm wall. The diaphragm wall thickness is 1100 mm and extends to an elevation of -25.7 m. The construction of guide walls for the diaphragm wall is shown in Fig. 10. The diaphragm wall is constructed with the appropriate number of panels and each panel has a length of 5.0 m. Bored cast in-situ concrete piles of 1400 mm diameter are used and the founding elevation is varied between -11.4 m and -22.0 m based on the soil profile. The axial load test pile is terminated at an elevation of -11.4 m and the instrumented with inclinometer pile is terminated at an elevation of -22.0 m. The construction sequence of piles is shown in Fig. 11. The bored cast in-situ concrete piles were constructed using piling gantry. The natural seabed level at the structural location is +0.0 m elevation. To satisfy the berthing facility of the vessel, the ground level is required to be dredged up to an elevation of -9.5 m. The dredging was done in three stages, in each stage 3.0 m thick material is dredged. The inclinometer readings were collected when the water elevation in front of the structure was -3 m (prior to dredging) and -9.5 m (after -9.5 m dredging). Two sets of readings were collected at -9.5 m elevation, one immediately after dredge level reached an elevation of 9.5 m and the other 3 months after the first set of readings to evaluate time effects.

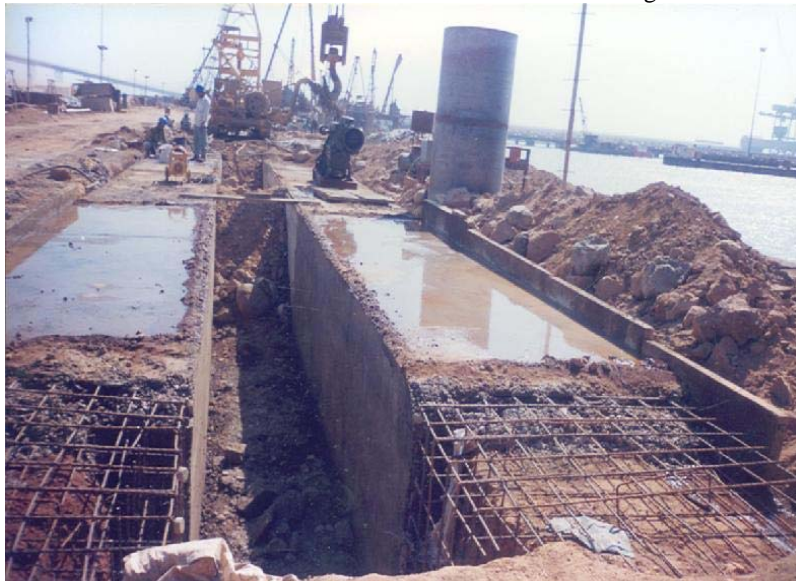
Figure 10. Construction Of Guide Walls For Diaphragm Wall.

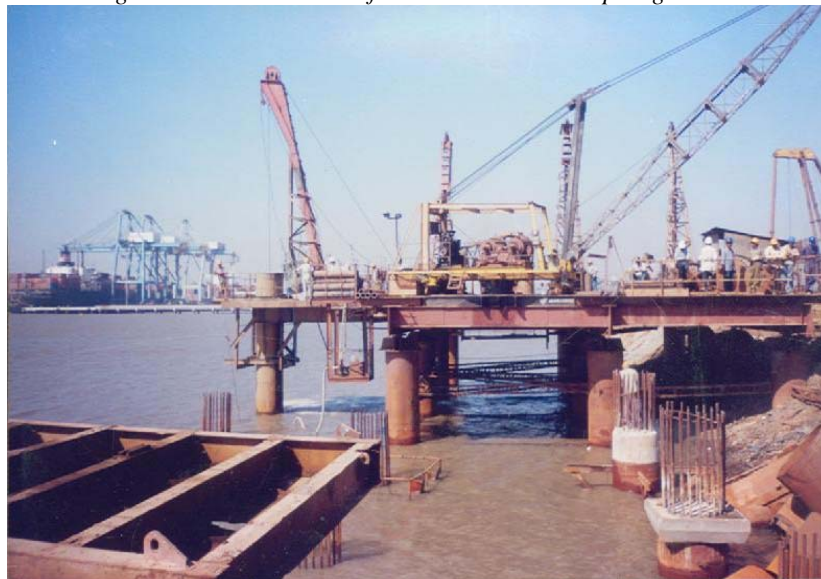
Figure 11. Construction of Piles.

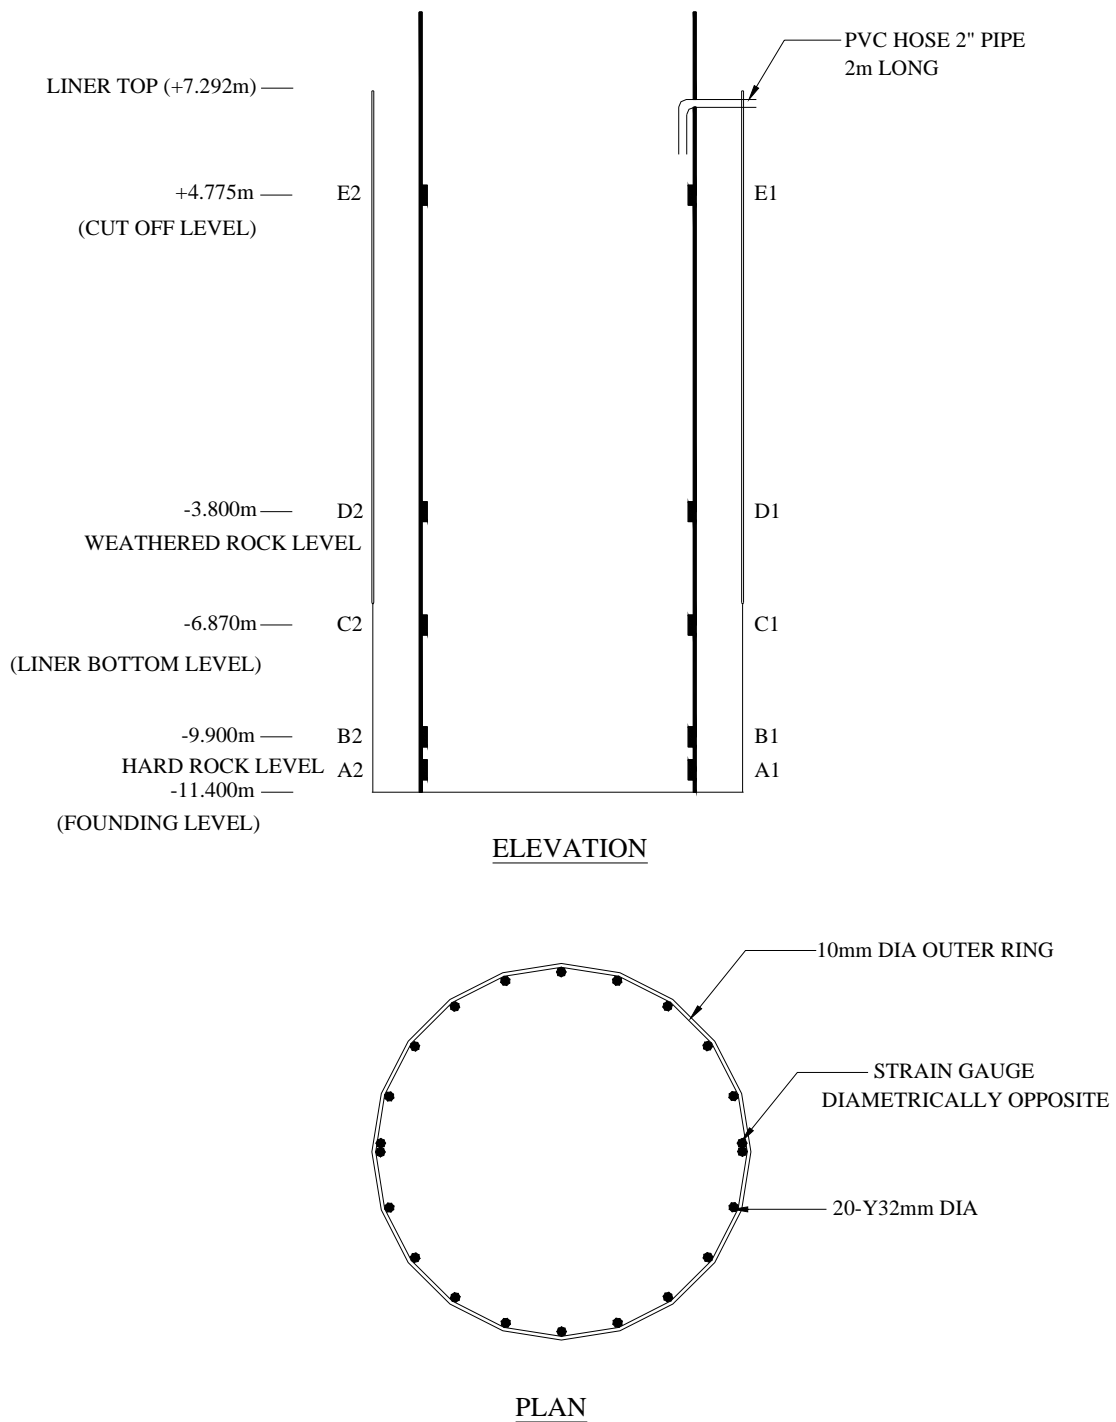
Figure 12. Pile Instrumentation with Strain Gauges.

The test pile is instrumented with electrical resistance type strain gauges. The gauges are attached at five different elevations as shown in Fig. 12. Two diametrically opposite main reinforcement rods are selected to mount the strain gauges. After mounting the gauges, the electric cable from each gauge is safely secured along the reinforcement bar to minimize the possibility of damage by the Tremie pipe during concreting. The cables of the gauges on the same reinforcement rod are bundled together and tied with a plastic wire to the reinforcement rod every 30 cm. The electric cables have a minimum length of 5 m beyond the cut off length to enable connection to the measuring instrument during the load test. All the strain gauges are aligned vertically.

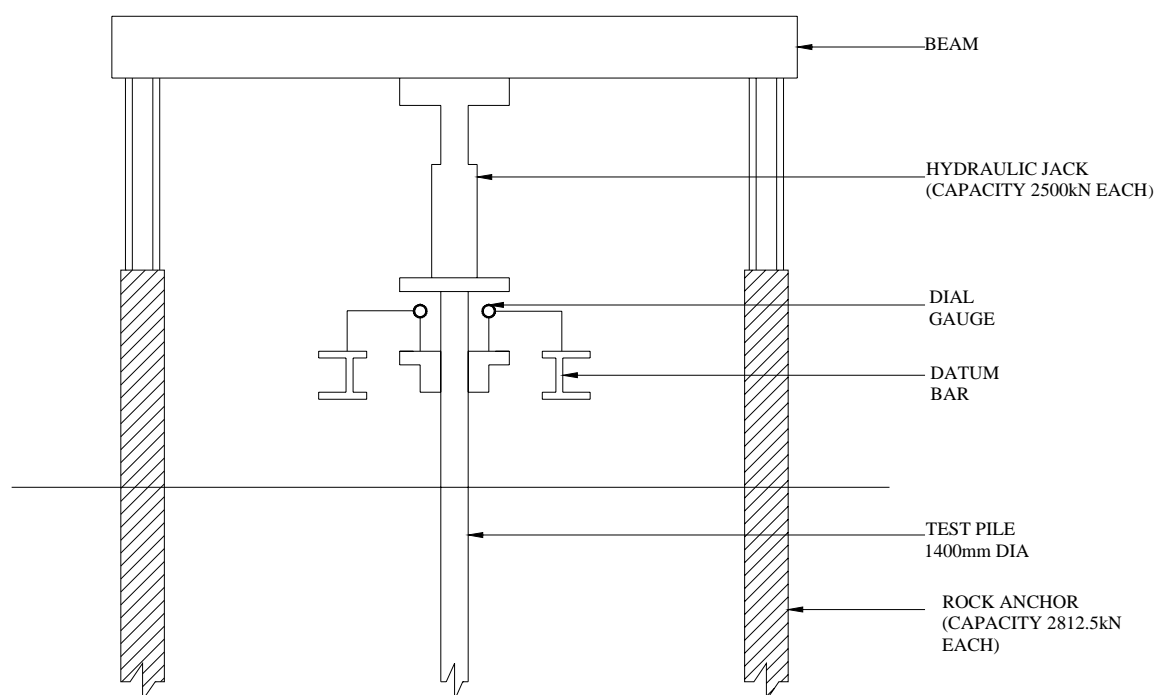
Figure 13. Schematic View of Pile Load Test Arrangement.

For the axial load test, the load applied on the test pile is obtained by the reaction forces from 4 pre-stressed rock anchors. Each anchor has a capacity of 2812.5 kN. The load on the pile is applied via 4 hydraulic jacks each of 2500 kN capacity. The settlement of the pile is recorded by 4 fixed dial gauges located at the same distance from the center of the pile. These dial gauges are installed on two datum bars with immovable support, at a distance of 3.6 m from the edge of the pile. A schematic view of the pile load test arrangement is shown in Fig. 13.

Four hydraulic jacks were placed concentrically on the test pile. The test was conducted according to the recommendations in IS 2911 (Part- 4) – 1985. The test load of 9000 kN is reached in a total of eight stages. Dial gauge readings were taken at regular intervals of 10 minutes until the readings remained constant for 10 minutes. After maintaining the test load for 24 hours, unloading was performed in 5 stages and readings were recorded as specified in IS2911 (Part-4) 1985. During the

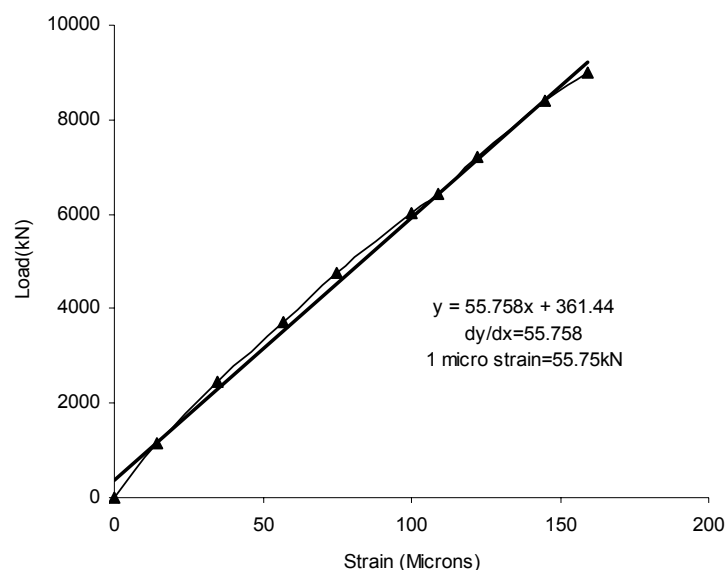
Figure 14. Strain Gauge Calibrations.

load test, the axial strain of the pile at each level was measured by the read out unit for every increment of loading. Strain gauge readings were taken 10 to 15 minutes after the load increment was applied. To estimate the mobilization of axial load along the pile shaft, the measured strain readings were converted to equivalent axial load by using a calibration constant. To obtain the calibration constant, one strain gauge was embedded in a concrete cylinder of 150 mm diameter and 300 mm long. The strain gauge was oriented such that the axis of strain gauge was parallel to the concrete cylinder axis. The cylinder was cured for 28 days and then tested in compression. The strain readings were observed to be almost linear with applied load. Fig. 14 shows the load as a function of strain. From the graph, the calibration constant of 55.75 kN was obtained, 1 micro strain being equal to 55.75 kN load.

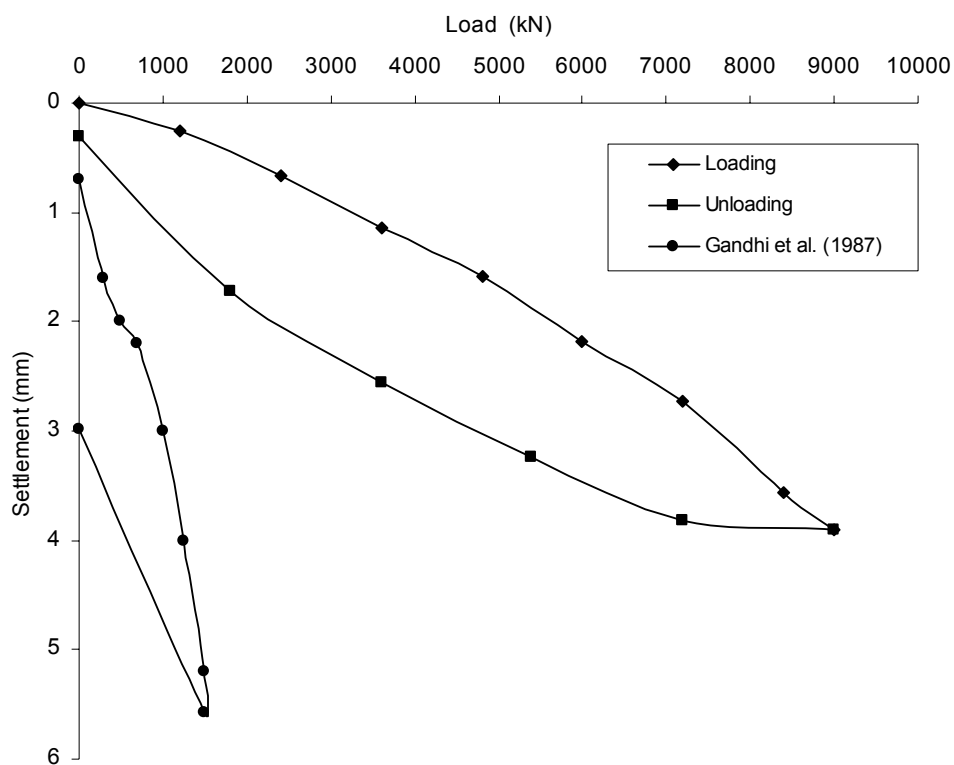
Figure 15. Load Settlement Curve.

The pile was tested up to 1.5 times the design load, i.e., up to 9000 kN. The load settlement curve is shown in Fig. 15. As per IS 2911 (Part-4) 1985, the maximum settlement at working load (1.5 times design load) may not exceed 12 mm. In the present study, the total settlement was 3.9 mm, rebound was 3.6 mm and net settlement was 0.3 mm, indicating that the pile

behaved well and has not reached its capacity. The pile load test results were compared to the Gandhi et al. (1987) pile load test results, which are also shown in Fig. 15. As presented in that paper, the pile load test was conducted on a 6.5 m long and 0.5 m diameter pile. Out of the 6.5 m, 0.5 m are socketed in hard rock strata. The test was conducted at the NALCO project site, Angul in India. The soil profile at this location includes 3.0 m of red soil with an average SPT (N) value 35, followed by yellowish grey weathered rock with SPT (N) values of about 100. Dark grey hard rock is present at 6.0 m below the ground level. The subsurface stratigraphy of the present study area (JNPT, Mumbai) and Gandhi et al. (1987) study area (NALCO project site, Angul) are not the same and thus, the load-settlement response of the test piles is different.

- (1) The total settlement of 3.9 mm was within the settlement limit of 12 mm as per IS 2911 (Part-4) 1985, which indicates that the pile has not reached its capacity.

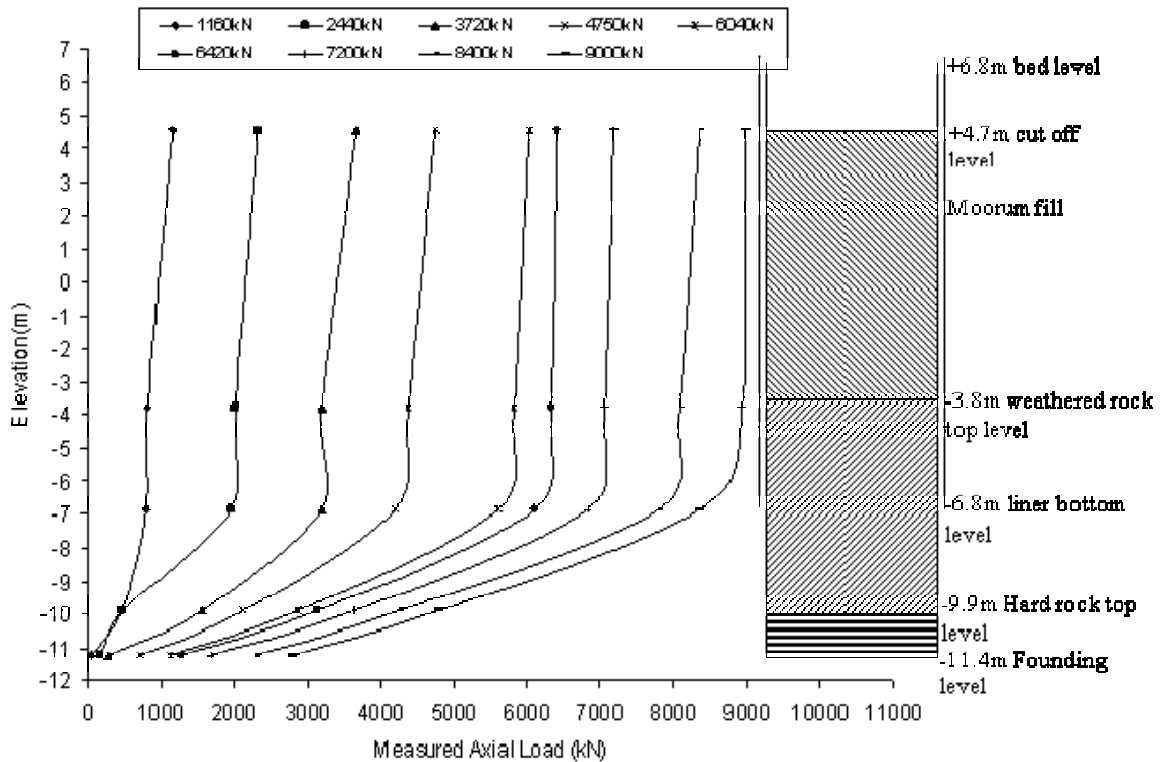
Figure 16. Mobilization of Axial Load.

Fig. 16 shows the load resisted by each soil layer. The maximum load is mobilized from an elevation of -6.87 m to -9.9 m, where the weathered rock is present. The mobilization of frictional resistance is not significant at the top layer of moorum fill. Nearly 4000 kN load is mobilized in the weathered rock, 2000 kN mobilized in hard rock, and 2000 kN mobilized in the moorum fill strata under a total applied load of 9000 kN. Only 1000 kN load is resisted by end bearing by the hard rock.

- (2) The weathered rock at the site offered substantial frictional resistance, i.e. about 20% to 45% of the total resistance.
- (3) A maximum of 75% load is mobilized by frictional resistance and the remaining 25% load is mobilized by the end bearing resistance. At higher loads the contribution of the end bearing resistance increases.
- (4) The use of strain gauges was successful in measuring the axial load distribution in concrete piles.

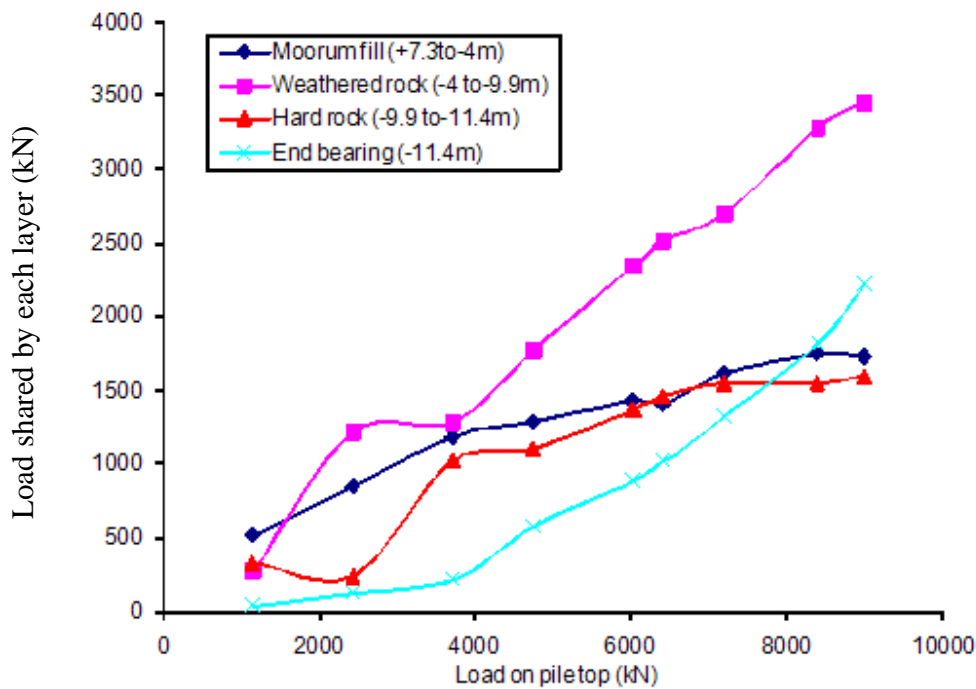
Figure 17. Axial Load Shared by Each Layer.

Fig. 17 shows the load shared by each layer for all applied load increments. For all cases except the load increment of 8400 kN and 9000 kN, the frictional resistance was significantly increased in all soil layers compared to the end bearing resistance. For the test load of 9000 kN, the end bearing resistance was higher than the frictional resistances of the moorum fill and the hard rock. However, the mobilization of end bearing was less than the frictional resistance in weathered rock. Nearly 75% of the load is resisted by friction and 25% of the load is resisted by end bearing. The weathered rock contributed about 20% to 45% of the total pile resistance.

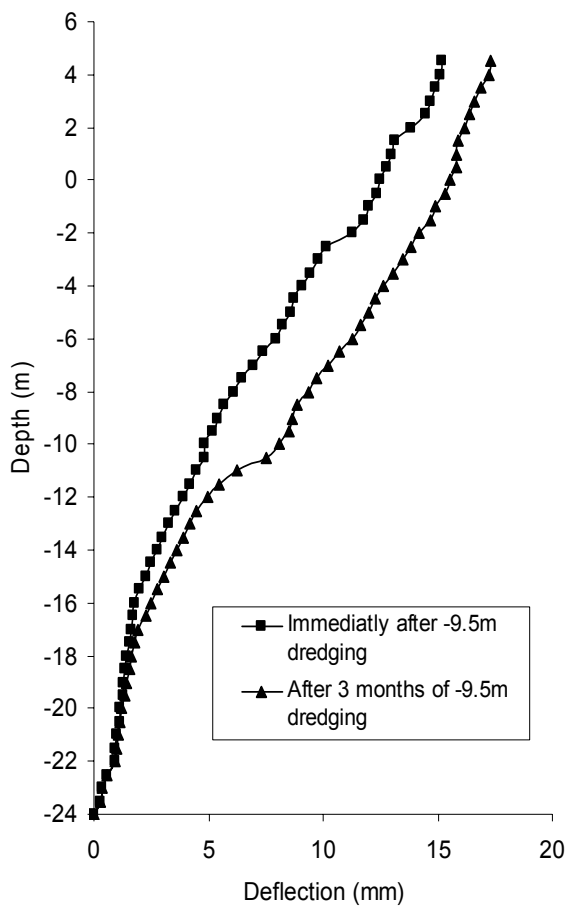
Figure 18. Deflected Shape of Diaphragm Wall.

After construction of the full berth, the inclinometer readings were collected in 3 stages. First set of readings were taken after construction of the berth and prior to dredging. This reading represents the initial position of the diaphragm wall and pile. The second readings were collected immediately after dredging to an elevation of -9.5 m. The difference between the second and first reading is the deflected shape of the diaphragm wall panel and pile. The third readings were collected 3 months after dredging to an elevation of -9.5 m. The difference between the third and second reading is shown in Fig. 18 and 19.

It can be observed that for the diaphragm wall immediately after -9.5 m dredging, the maximum deflection is 15.2 mm at the level of +4 m, while at the same level the maximum deflection increased to 17.3 mm after three months. The increase in deflection is probably due to the consolidation and associated pore pressure dissipation effects of the soft clayey soil. The same behavior was observed for the pile also. For both the pile and the diaphragm wall the deflection from -16 m elevation and lower is small compared to the upper layers due to the lower hard layers of marine silty clay and rock.

- (1) The maximum deflection of 30 mm was measured in the berthing structure after dredging to an elevation of -9.5 m. The permissible lateral movement of the berthing structure was 150 mm and thus the deflections observed were considered small.
- (2) About 87% of the maximum deflection was mobilized at the soft top layers, probably due to the presence of the underlying harder ground materials.
