Leaning Tower of Pisa: Behaviour after Stabilization Operations

ABSTRACT: It is well known that the foundations of the Leaning Tower of Pisa were stabilised using the method of underexcavation to reduce the southward inclination of the Tower by about 10 percent in combination with controlling the seasonally fluctuating water table beneath the north side. Having been closed to the public since early in 1990, the Tower was re-opened in December 2001. The paper summarises the response of the Tower during the period of implementation of the stabilisation works. Monitoring of the movements of the Tower has been continuing and the observations obtained since 2001 are presented. It is shown that over the six years between 2003 and 2008 the induced rate of northward rotation of the Tower has been steadily reducing to less than 0.2 arc seconds per year. Similarly the rate of induced settlement of the centre of the foundation has been steadily reducing and is approaching the background rate of settlement of the Piazza. Piezometer measurements close to the north side of the foundation shows that the drainage system has been successful in stabilising the groundwater levels beneath the north s

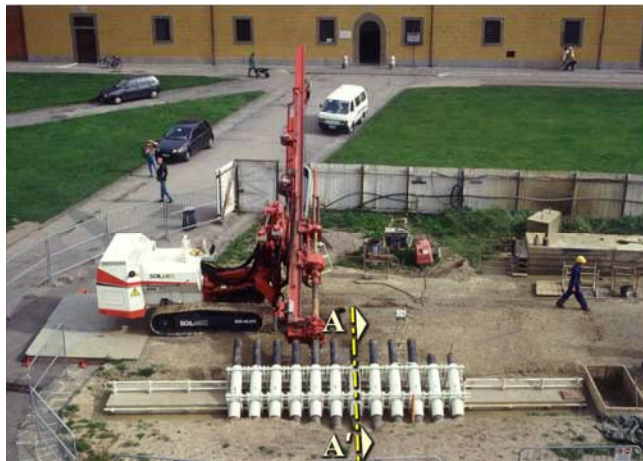
Figure 9. Holes for preliminary underexcavation.

In August 1998 the Committee agreed to carry out limited soil extraction from beneath the Tower with a view to observing its response. This preliminary underexcavation was to be carried out over a limited width of 6m north of the Tower using twelve bore holes lined with 219mm diameter casings (Fig. 9). On 9th February 1999, in an atmosphere of great tension, the first soil extraction took place. The Tower slowly began to rotate northwards. When the northward rotation had reached about 80 arc seconds by early June 1999 the preliminary soil extraction was stopped. Northward rotation continued at a decreasing rate until October 1999.

Preliminary underexcavation Extraction hole - Section A-A'
