## Collapse of Showa Bridge Revisited

**ABSTRACT:** The collapse of the Showa Bridge during the 1964 Niigata earthquake features in many publications as an iconic example of the detrimental effects of liquefaction. It was generally believed that lateral spreading was the cause of failure of the bridge. This hypothesis is based on the reliable eye witness that the bridge failed 1 to 2 minutes after the earthquake started which clearly ruled out the possibility that inertia (during the initial strong shaking) was the contributor to the collapse. Bhattacharya (2003), Bhattacharya and Bolton (2004), Bhattacharya *et al* (2005) reanalyzed the bridge and showed that the lateral spreading hypothesis cannot explain the failure of the bridge. The aim of this short paper is to collate the research carried out on this subject and reach conclusions based on analytical studies and quantitative analysis. It is being recognised that precise quantitative analysis can be difficult due to lack of instrumented data. However, as engineers, we need to carry out order-of-magnitude calculations to discard various failure hypotheses.

International Journal of Geoengineering Case histories, <http://casehi

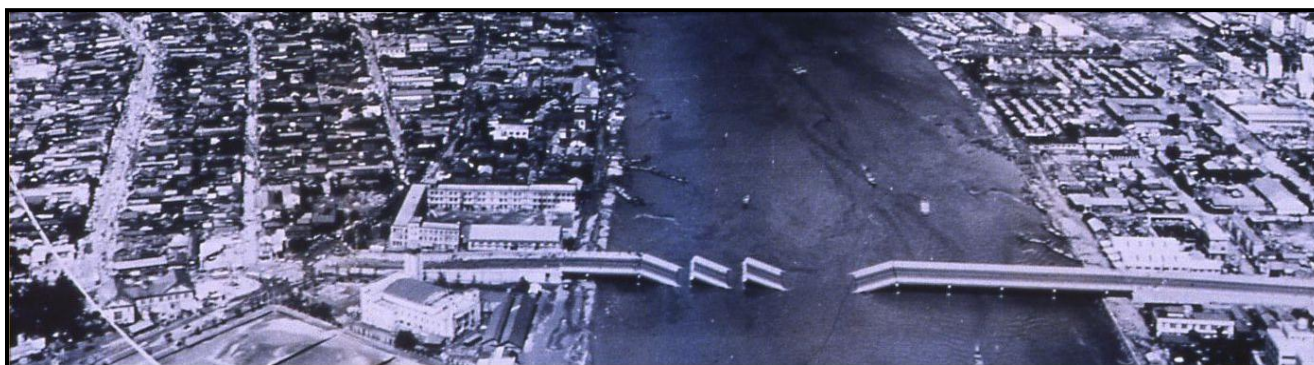
Figure 1. Collapse of Showa Bridge.

It is interesting to observe that the middle of the bridge i.e. the bridge piers collapsed while the abutments (end piers) remained stable. Figure 2 shows the ground profile along the longitudinal direction of the bridge following Hamada and
