# Geotechnical and Structural Challenges over an Active Landslide

ABSTRACT: The construction of the steel arched Tsakona Bridge, designed to overpass an active landslide, required several temporary projects. Auxiliary steel towers were used for the erection and welding of the arch segments. Most of them had to be founded in the body of the sliding mass. An automated instrumentation and monitoring system was installed on site providing early warning to the engineers in charge in case large displacements were measured. The real-time recording data provided valuable information about the landslide movements. These monitoring results defined the geotechnical and structural design criteria for the deep foundation of the temporary towers. Several 2D and 3D geotechnical and structural models were created to evaluate the sliding effect on the foundation components, finalize their dimensioning and calculate the required reinforcement. The procedure followed for the design of the temporary deep foundation is described based on the criteria devised using the monitoring system, emphasizing on the continuous feedback between the geotechnical and structural design teams. Several key structural

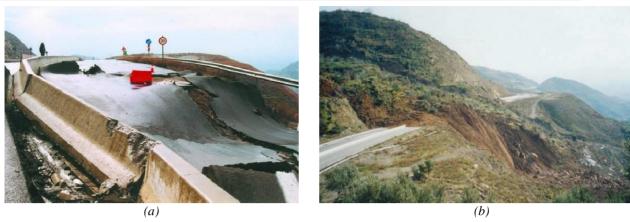
Figure 1. The Tsakona landslide (February 2003) (EMEK S.A (2015)) (a) large settlements on the road pavement (b) massive soil movement (Fikiris et al. (2001)).

The highway to the city of Kalamata in southern Peloponnese crossed through an old landslide, which was reactivated in January 2003 after a period of heavy rainfalls, leading to a major catastrophic slide. The triggered landslide is one of the largest that have occurred in Greece, the consequences of which are shown in Figure 1. Horizontal and vertical displacements of the sliding mass up to 100 m and 40 m, respectively, were measured, causing a soil mass movement of about 6,000,000 m³ of flysch colluvia and manmade deposits, extended in a large area of 400 m upslope and 700 m downslope of the highway (Belokas 2013, Belokas and Dounias 2016). Among several options studied for the rehabilitation of the National Highway, bridging over the landslide was selected as the most cost-efficient and technically feasible solution (Fikiris et al. 2011). The steel arched Tsakona Bridge, sketched in Figure 2, was decided to be constructed over the sliding mass, which moved downslope at an average rate of about 1.5-2.0 mm/month. This rate was increasing significantly during the periods of intense rainfalls, exceeding for short periods of time the value of 30 mm/month (projected rate of movement).

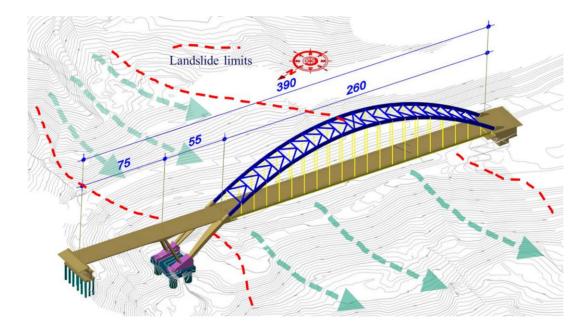
Figure 2. The Tsakona Bridge overpassing the active landslide.

The 390 m long Tsakona Bridge consisted of 130 m long access part of prestressed concrete deck and a steel arch with a completely suspended steel deck of 260 m length. The abutments and the V-shaped pier were made of reinforced concrete, seated outside the limits of the landslide on stable ground (Fikiris et al. 2011). The erection of the bridge arch required fourteen (14) twin steel temporary auxiliary towers, reaching a maximum height of about 60 m. The towers were anchored on piers, and consisted of pile groups (Figure 3). For the left (East) upslope branch of the Highway seven piers named as  $\Pi 1A-\Pi 7A$  were built with pile lengths 5 m and 8 m. For the right (West) downslope branch of the Highway, another seven piers were constructed, named as  $\Pi 1\Delta-\Pi 7\Delta$ , with pile lengths that varied between 8 m for the pier  $\Pi 7\Delta$  and 32 m for  $\Pi 1\Delta$ .

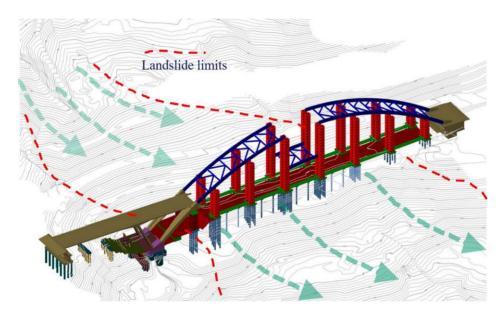
Figure 3. Arch erection of the Tsakona Bridge using temporary steel towers.

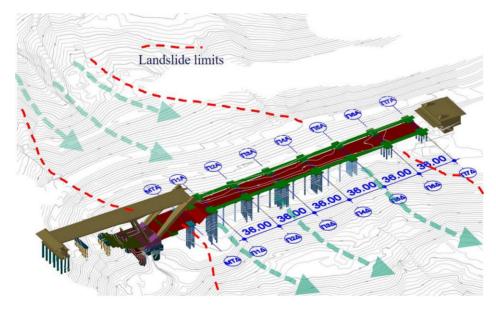
Figure 4. The temporary infrastructure projects. Pier P1 through P7 are shown. P1A is for the eastern P1 and P1∆ is for the western P1. Dimensions in m.

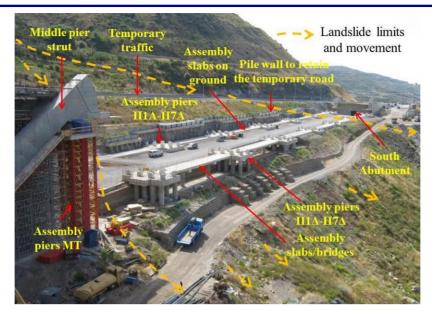
Figure 5. General view of the worksite with the temporary projects.

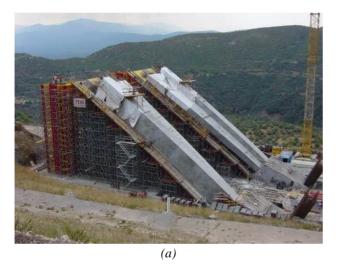
Figure 9. Construction of the (a) curved struts and (b) straight struts of the bridge pier.

The main body of the V-shaped pier consisted of two pairs of supporting struts. The southern struts were curved, following the parabolic geometry of the arch. The northern ones were designed as straight elements on the same inclined plane, converging towards each other. For the construction of the curved struts, scaffolding towers were used, anchored on slabs on the ground. For the straight struts a self-climbing formwork system was mobilized. Temporary horizontal bracings along the transverse direction kept the straight struts in place. At the same time, temporary tendons were utilized to suspend these struts from the completed curved ones, providing the necessary stability to the unfinished V-shaped pier (Figure 9). Before the construction of the curved struts, the two MT towers were installed to support their top ends. They were designed to provide bearing capacity of 12000 kN and 16500 kN each, under static and seismic load combination, respectively. Their foundation consisted of pile-groups penetrating the stable bedrock, connected with pile caps. Ground anchors were also foreseen, as mitigation measure to be activated in case large movements were observed during construction (Figure 10). A special arrangement was provided on the top of the MT towers to compensate any contingency movement within the loose soil above the bedrock as well as the elastic deformations of the auxiliary towers and the deformation due to temperature fluctuations. This arrangement included two (2) elastomeric bearings and four (4) lifting jacks for each tower. Continuous accurate surveying of the level of the bearings and vertical adjustments through the jacks were ensuring the fixed vertical position of the support during construction, until the complete functionality of the arch was achieved.

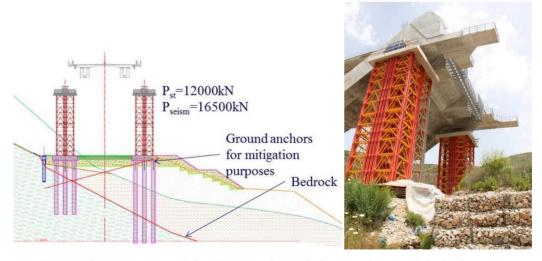
Figure 10. Arrangement of the MT towers beneath the curved struts of the bridge pier.

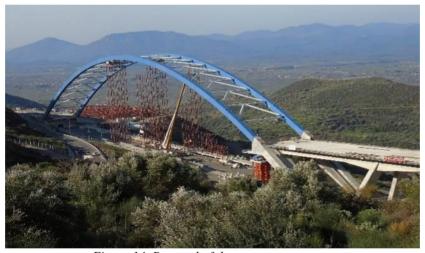
Figure 14. Removal of the temporary towers.

Other crucial issues were related with gradual removal of the arch supporting towers (Figure 14), as well as the total release of the bridge and the removal of the last supporting structure, the MT towers.

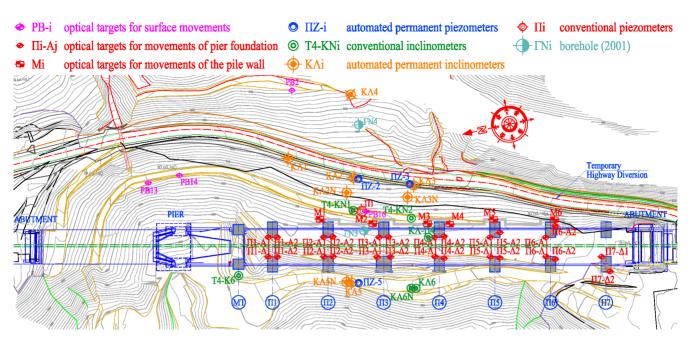
Figure 15. Arrangment of the geotechnical instruments in plan-view.

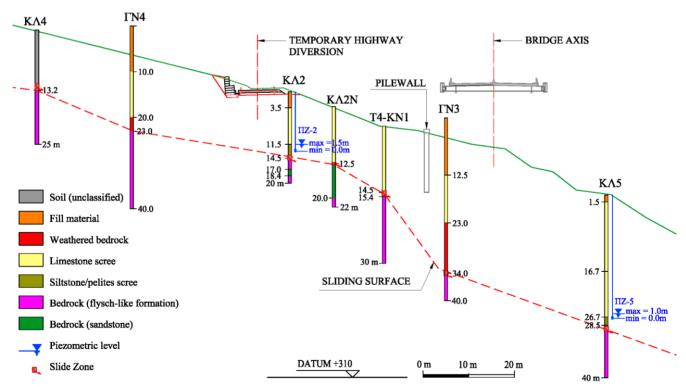
Figure 16. Section in between Piers  $\Pi$ 2 and  $\Pi$ 3 showing the position of the geotechnical instruments with respect to the bedrock surface.

shown in Figures 6 through 8 and 16. The scope of this procedure aimed at defining the geotechnical parameters that would feed the final structural design of each pier. These parameters were the coefficients of the earth pressure produced by landslide slippage and the constants of the equivalent elastic supports that would be applied as springs at the bottom of each pile of the structural models, simulating the soil-structure interaction. The constant of equivalent vertical spring of each pile of the piers was expressed as K=P/vz, where P=1000 kN was a single load applied on the top of the corresponding pile and vz was the calculating settlement. For the piles of the left branch a mean value derived from the analyses of all piers and a spring constant of 140,000 kN/m was adopted, while for the right branch the calculated values varied within a range of 120,000 kN/m – 1,000,000 kN/m. These results were in accordance with the ones derived from loading tests of nonfunctional piles. Regarding the earth pressure evolved at the upslope piles of the right branch piers  $\Pi 2\Delta - \Pi 4\Delta$ , presenting the maximum free height and being founded in the sliding body, the horizontal and vertical stresses were calculated under static loads, resulting in equivalent pressure coefficient equal to  $K_0$ =0.50. The same value was obtained for the imposed movement, since the floating piles moved along with the sliding mass, as also demonstrated by the 3D geotechnical analyses and confirmed by the monitoring data.

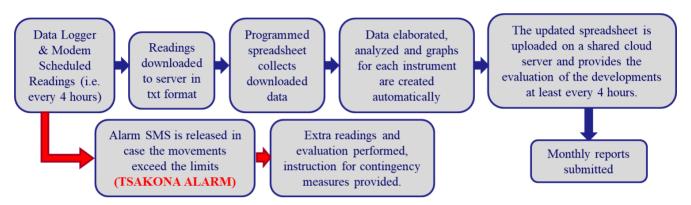
Figure 17. Automated monitoring procedure – Flow chart.

project. This application automatically processed the recorded data to information of engineering interest (displacements, piezometric level and rain level) updating representative tables and graphs for each instrument, continuously providing the evolution of the phenomena for further assessment and evaluation. The results of this procedure were uploaded to a shared cloud server every 4 hours, being accessible to the responsible design and construction teams, who could appraise the potential risk of the landslide any time at any point of the site. Apart from the continuous evaluation and analysis of the recording data, the data logger was setup to send SMS messages to the engineers in charge, in case large movements were recorded exceeding specific alert movement thresholds, initiating thus a series of increasing awareness and contingency actions. Several cases of excessive sliding movements as well as seismic events were noted during the construction period of the bridge and special instructions were issued to the construction team, especially during the winter season after incidents of intense rainfalls. The flow chart of the monitoring procedure is given in Figure 17. Two typical diagrams of the measured incremental and the calculated cumulative displacements in an automated inclinometer are given in Figure 18.

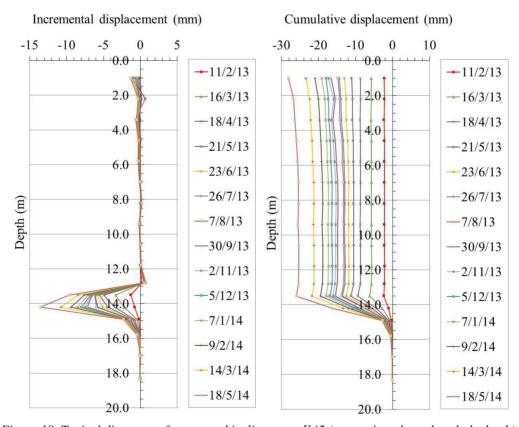
Figure 18. Typical diagrams of automated inclinometer KA2 (measuring along the whole depth).

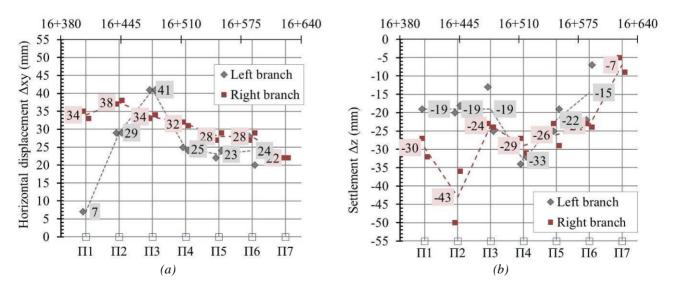
Figure 19. Recorded differential (a) horizontal and (b) vertical displacement between piers (time period 3/13 - 3/14).

- Differential horizontal and vertical displacements were observed between the piers of the two branches of the highway and between the piers of the same branch, as plotted in Figure 19. The maximum differential horizontal displacement was noted between piers Π1A and Π1Δ reaching 2.7 cm, while the maximum vertical displacement was measured between piers Π2A and Π2Δ, being equal to 2.4 cm.

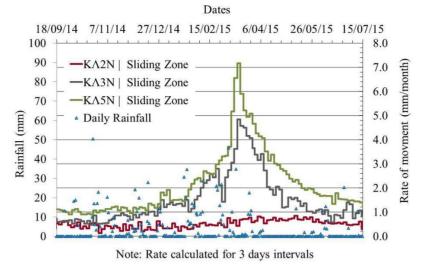
Figure 20. Diagram of slide movement rate with respect to rainfall.

- The rate of the sliding movement varied seasonally depending on rainfall, as shown in Figure 20. The rate picks are concentrated in the months of February and March, reflecting major rainfall incidents as well as the accumulation of rainfall along the whole rainy season (November-March). The influence of heavy rainfalls in the piezometric levels can be seen in Figure 21.

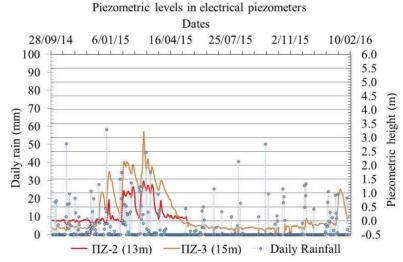
Figure 21. Diagram showing correspondence of piezometric levels to rainfall.

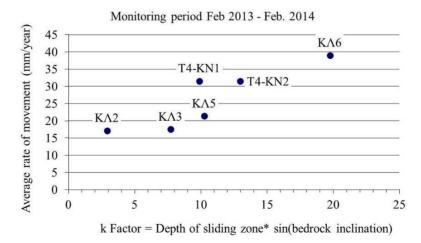
Figure 22. Rate of movement for different locations of the slide zone.

- Differences in the movement rate were noted among the monitoring locations, as concluded from Figure 22 and Table 2. The depth of the sliding zone, as well as the inclination of the bedrock, which differed significantly across the landslide mass, were the basic parameters that influenced the rate of movement. The empirical factor k (=depth\*inclination) was calculated to define the dependence of the slide rate on the depth and the inclination of the sliding surface at various landslide locations. As expected, the graph of Figure 22 illustrates a strong positive correlation between the mentioned geometrical factors on the landslide velocity (the slide rate increases with depth and bedrock inclination).

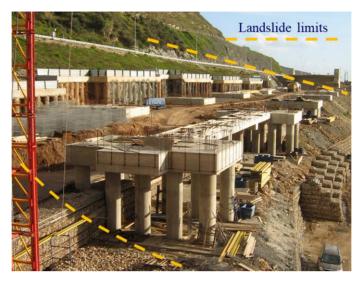
Figure 23. Assembling line of the right branch.

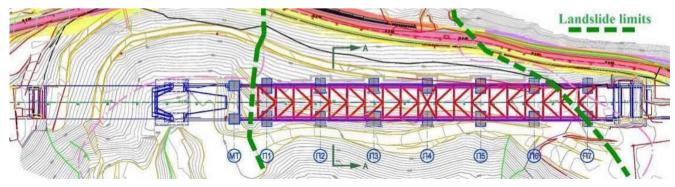
Figure 24. Location in plan view of the characteristic transverse view A-A.

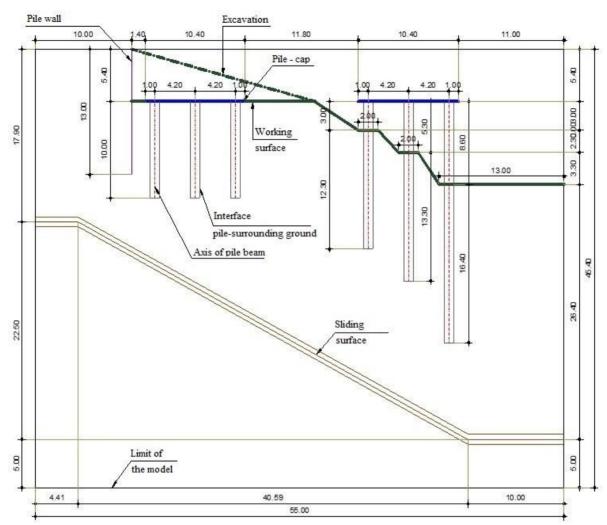
Figure 25. Geometry of the «guide-model» based on the transverse section A-A.

- Subsequently, a geotechnical analysis was performed with the software PLAXIS, using a 2D model having the same geometry of Figure 25. The scope of this analysis was to calibrate the 2D geotechnical model with the «guide-model» by means of the equivalent stiffness of the structural elements, comparing the internal forces and the calculated displacements. 2D geotechnical analyses for each pair of the fourteen (14) piers proceeded, considering in each case the local morphology of the sliding surface and the local profile of the soil mass movement. In this way, the complex and time consuming procedure of modelling and analysing each pair of piers with the aforementioned method of the «guide-model» was not necessary.

- Finally, using the software SOFiSTiK, the internal forces and displacements of a typical 3D structural model with the geometry of the characteristic section of Figure 25 were compared with the corresponding ones of the «guide-model» showing satisfactory agreement. In the final phase of this procedure, 3D structural models were created for each structural element of the foundation (piles and pile cap of each pier) aiming at the optimization of the dimensioning and the calculation of the required reinforcement. For these structural analyses the required data for the geotechnical parameters were based on the 2D geotechnical analyses performed with PLAXIS.

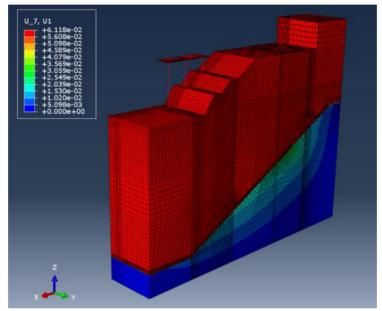
Figure 28. Transverse slope displacement (in m) due to the imposed movement.

Snapshots of the «guide-model» at the characteristic steps of the analysis are provided in Figure 27. The soil displacement due to the imposed horizontal movement at the end of Step 7 is plotted in Figure 28, showing that the slope movement practically led to a uniform displacement of the soil above the sliding surface. The most critical internal forces are calculated for the piles of the right branch due to the morphology of the ground and their significant free height. According to the analysis results, the uniform displacement of the soil mass, caused only a small increase of the internal forces of the piles at the end of Step 7 arising at 3.4% for the axial forces, 4.2% for the shear forces and 37.5% for the bending moments at the connection of the piles with the pile caps, while smaller differences are noted for the buried parts of the piles. The horizontal displacements of the piles of the right branch pier are plotted in Figure 29, showing that at the end of Step 7 the displacements are almost the same along the piles. This leads to the conclusion that no significant differential displacements were introduced to the structure due to the landslide, which was in accordance with the measurements of the geotechnical instruments.

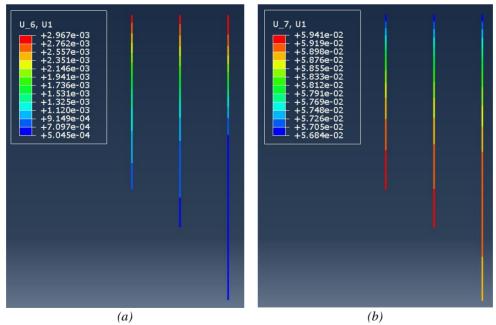
Figure 29. Horizontal displacement (in m) in the transverse direction of the bridge of the right branch piles: (a) Step 6, (b) Step 7.

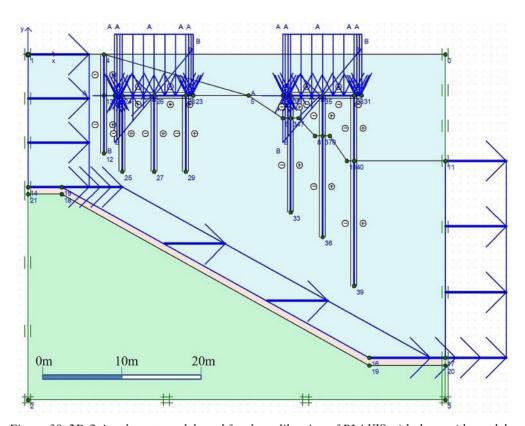
Figure 30. 2D finite element model used for the calibration of PLAXIS with the «guide model».

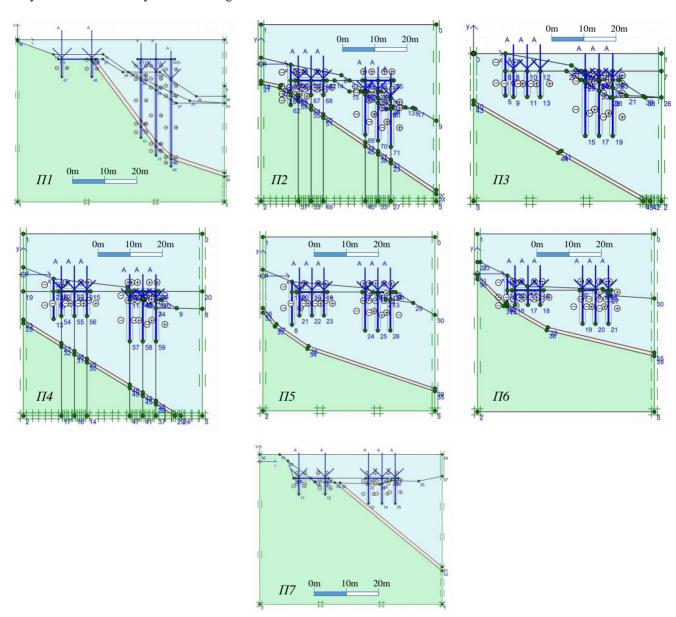
Figure 31. Models of each pair of piers for the 2D geotechnical analyses.

Thereupon, seven models were created for each pair of piers, illustrated in Figure 31, representing not only the geometrical characteristics of each pier, by means of the pile lengths and pile-cap dimensions, but also the different morphology of the surrounding ground and the geometry of the bedrock surface. The geometry of these models is derived by the sections

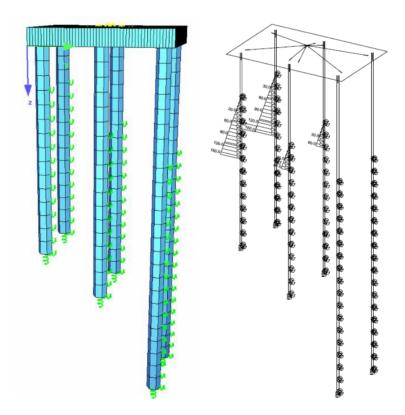
Figure 32. 3D finite element model for the calibration of SOFiSTiK.

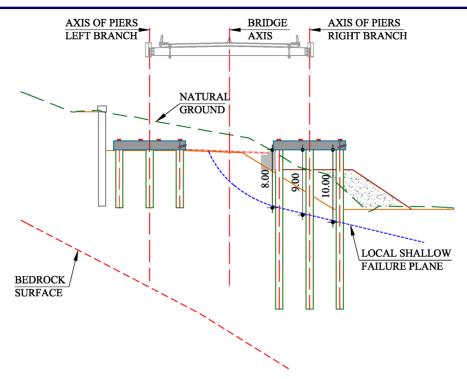
Figure 33. Contingency local shallow failure planes.

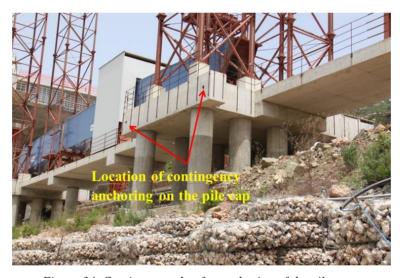
Figure 34. Contingency plan for anchoring of the pile caps.
