Flooding Vulnerability Lessons Learned in Assessing the Effects of Flooding Caused by the Canterbury Earthquake Sequence

Reference: Taylor, M., Fisher, T., Ng, K.K.S. and Pennington, M. (2018). *Flooding Vulnerability Lessons Learned in Assessing the Effects of Flooding Caused by the Canterbury Earthquake Sequence*. International Journal of Geoengineering Case Histories, Vol.4, Issue 4, p.242-253. doi: 10.4417/IJGCH-04-04-02

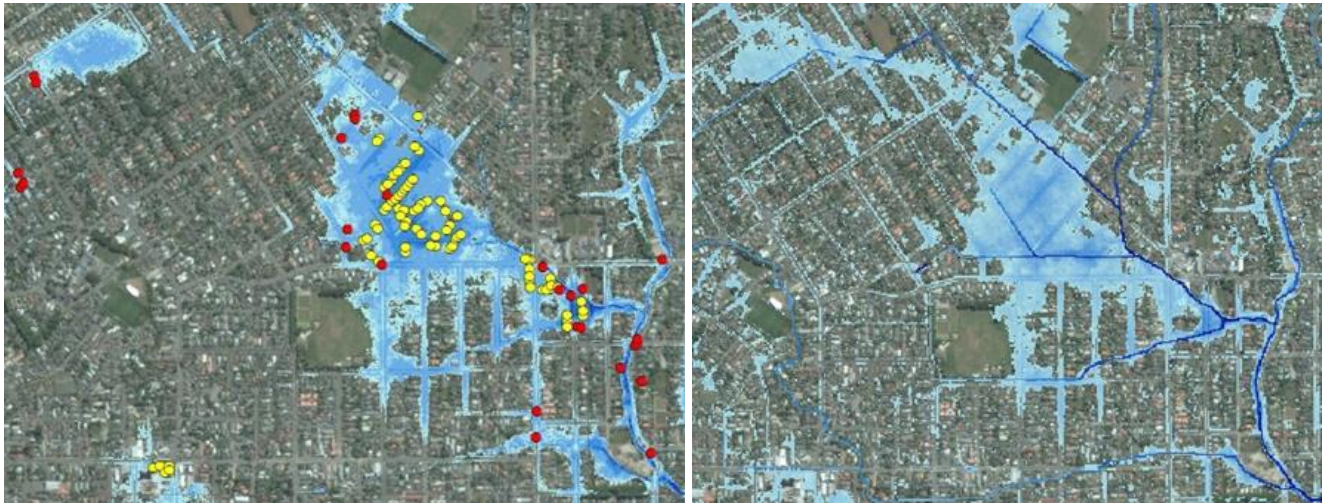
Figure 7. Calibration run of maximum depths (right) compared to a combined T&T, CCC and NIWA observed flooding map (left) for the 4 and 5 March 2014 event – Flockton Basin.

The usefulness of the increase processing speed became apparent following the 4 and 5 March 2014 flood event. At the time of the flood event occurring (which T+T hindcast as between a 20 and 50 year Average Recurrence Interval (ARI) river flood event as measured in the Avon at the Gloucester Street gauge), the IFV model was in the final stages of completion. However, the model had not (because there was no data available) been verified or calibrated to actual flooding. The event provided an opportunity to undertake this. Again, the value of rapid mapping proved extremely useful. Teams involving T+T, EQC, NIWA and CCC independently mapped flood extents. CCC also collated flood reports from residents. This mapping together with river and rain gauge data was used to calibrate the model. We consider (and the International Peer Review Panel agreed) that the resulting Overland flow model was appropriate for the use of IFV. A comparison of the calibrated model and the observed mapping for the Avon catchment is shown in Figure 6. A similar comparison is shown for a badly affected area known as the Flockton Basin in Figure 7.
