Electrical Resistivity at Internal Erosion Locations in Levees

Reference: Tucker-Kulesza, S., Rutherford, C. and Bernhardt-Barry, M. (2019). Electrical Resistivity at Internal Erosion Locations in Levees. International Journal of Geoengineering Case Histories, Vol.5, Issue 2, p. 55 - 69. doi: 10.4417/IJGCH-05-02-01

Hager Slough Levee

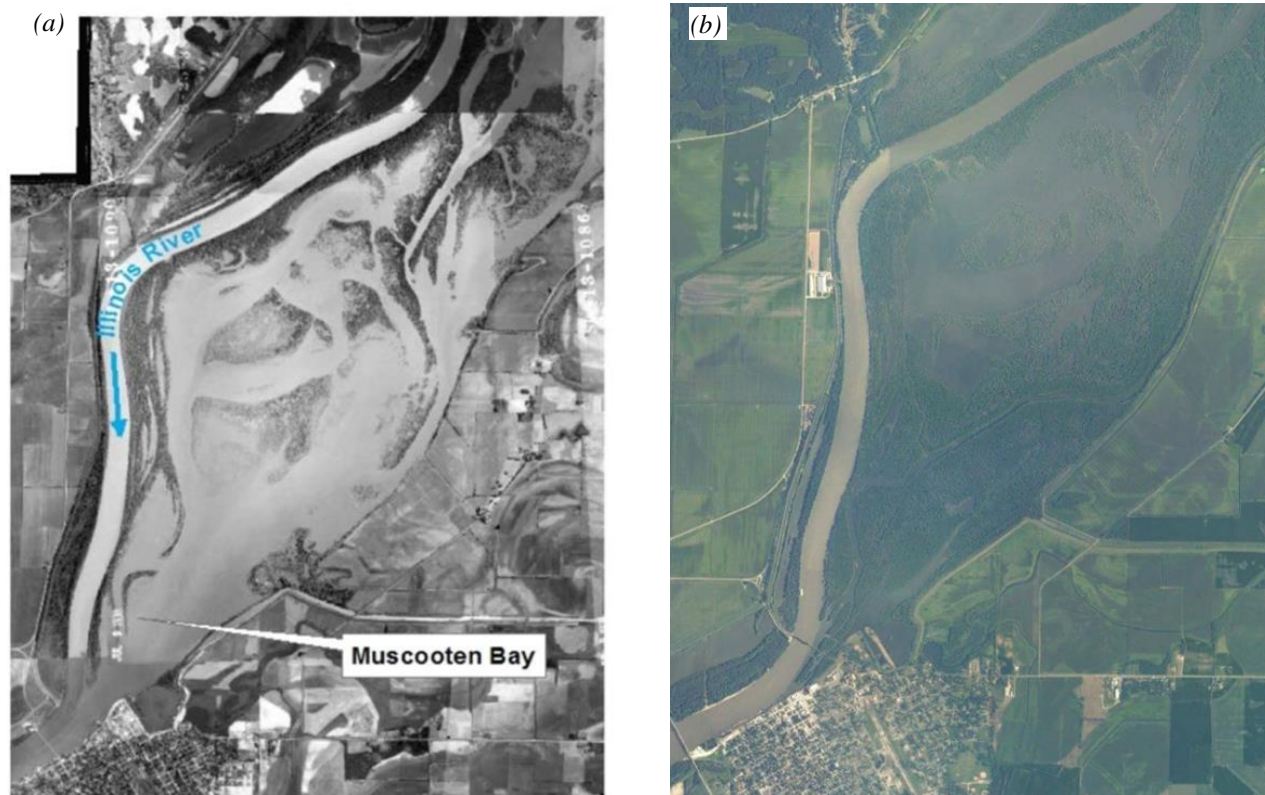
Figure 2. Sangamon River history: (a) Muscooten Bay pre-diversion (~1939); (b) Muscooten Bay post-diversion (~2011) (Bishop et al. 2015).

The historic channel of the Sangamon River was originally 101 km long with a slope of 0.09 m/km. The river was channelized, and levees were built by local farmers to create drainage for the agricultural lands surrounding the river between 1905 and 1909. In 1949, the U.S. Army Corps of Engineers (USACE) diverted the lower 9.7 km of the river south through Muscooten Bay (Figure 2). In the 1980s, the river was straightened by the USACE to help with the silting of the Beardstown marina. Currently, the river channel is only 57.9 km long with an average channel slope of 0.19 m/km (Bishop et al. 2015). As a result of the straightening of the channel and diversion, the sediment load carried by the Sangamon River has been deposited in Muscooten Bay and its adjacent areas (Lee 1982). This caused silt and sandbars to form along the riverfront of Beardstown, causing issues with boating access in the marina (Jangea 2003) and the formation of log jams along the Sangamon River (Blanchette 2016). The USACE studied the problem by modeling the watershed and sediment transport, leading to a recommended sediment management plan (Bishop et al. 2015).

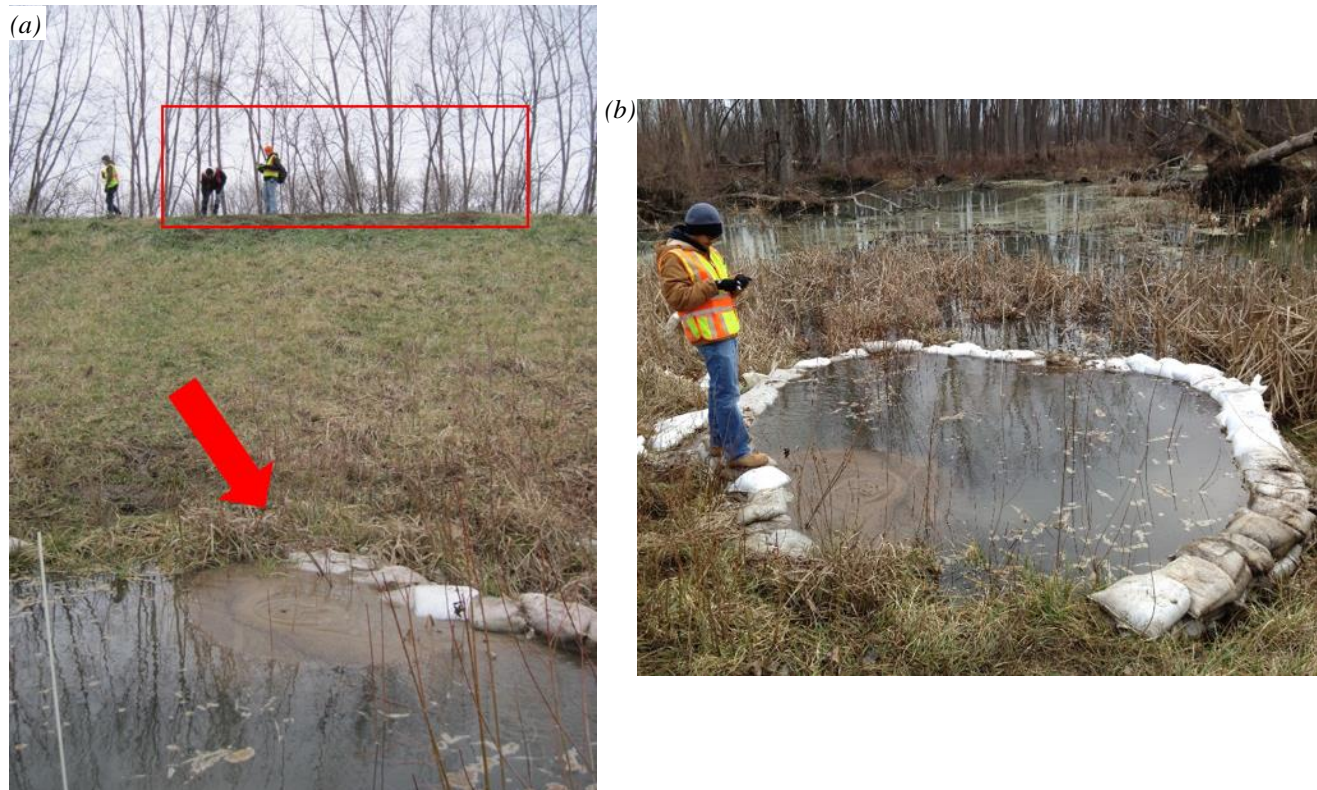
Figure 5. December 2015 flood reconnaissance: (a) settlement of crown with active sand boil at toe of levee, (b) active sand boil with sand bag ring (Rutherford et al. 2016).

Settlement of the levee crown occurred in several locations during the 2015 flooding which required repair (repair images not available). Subsidence of the levee crown in these locations was observed to be adjacent to sand bag rings (Figure 5), suggesting that the subsidence was due to material loss. The objective of the geophysical investigation described in this study was to evaluate if ERT can be used as an imaging technique to detect zones of material loss within the levee. Such a system would enable improvement of remediation methodologies following flood events where sand boils occur. ERT may also be used to evaluate if a levee is damaged internally despite the lack of external physical evidence (e.g., sand boils). Following this introduction are a brief background on ERT and the research methodology. The ability of ERT to identify material removal has been investigated by performing a series of ERT surveys and supported with soil borings and a laboratory electrical resistivity measurement of the material in the sand boils. A discussion of the field and laboratory results is presented, including limitations of this case history, followed by conclusions and recommendations.
