Scour at the Seawall in Surfside, Texas, During Hurricane Harvey (2017)

ABSTRACT: Hurricane Harvey was a Category 4 hurricane on the Saffir-Simpson hurricane wind scale. National Oceanic and Atmospheric Administration (NOAA) water level gages documented 1.1 m of water level elevation over predicted tide in Freeport, Texas, on 25 – 26 August 2017. The NOAA wave buoy 42019 offshore off Freeport documented wave heights > 7 m. A reconnaissance team of the Geotechnical Extreme Events Reconnaissance (GEER) Association visited Surfside, Texas, on 3 September 2017. While no significant damage to infrastructure was observed, the GEER team identified a significant scour runnel parallel to the Surfside seawall. The purpose of this article is to present the detailed observations of the scour runnel parallel to the Surfside seawall during Hurricane Harvey (2017). The sloped seawall is separating a shore-parallel street from the beach and is composed of angular boulders of approximately 30-50 cm in diameter. The observed runnel represented a depression of up to ~ 0.3 m in depth and ~ 4 m in width. It maintained mostly a distance of 0-5 m from the visible toe of the seawall. Boulders seemed part

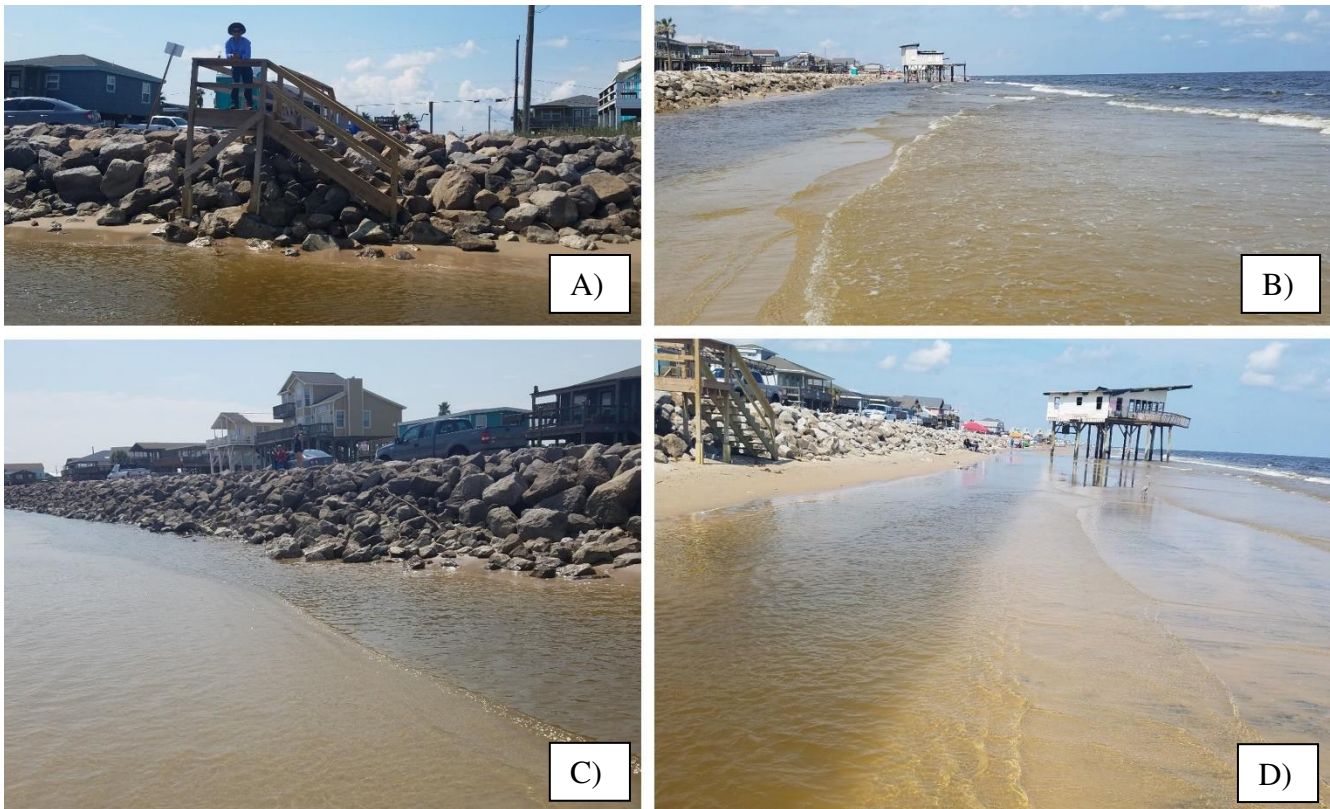
Members of the GEER team visited Surfside Beach on yearday 246 at approximately 20:00 UTC (Stark et al. 2017). At the time of the visit, the beach was again utilized by tourists and local residents. Minor observable damage to the seawall or infrastructure was documented by the GEER team, which is in line with assessments and opinions of local residents. However, a well-formed runnel of about 20-40 cm depth had formed approximately seawall-parallel (Figs. 6 and 7). Local residents confirmed that this runnel had formed during Hurricane Harvey. The runnel was fringed by rather sharp edges with the offshore directed edge being overall less steep than the onshore directed edge. The runnel width varied from about 1.5-4 m. The narrower sections were typically closer to the seawall toe (Fig. 6 lower left). In some sections, the onshore edge of the runnel was located at a distance about 2-3 m from the toe of the seawall. In these cases, the beach between the runnel and the seawall toe appeared fairly steep (Fig. 6 lower right). Dislocated boulders from the seawall were found, and seemed to be predominantly co-located with sections where the runnel approached the seawall toe (Fig. 6 left). Offshore of the runnel, a rather flat ridge of about 15-25 m width was observed (Fig. 6 right). The slope of this ridge was clearly flatter than the slope of the beach between the runnel and the seawall (if present).

Figure 6. Seawall-beach-runnel-ridge system observed on yearday 246 at approximately 20:00 UTC (15:00 local time) at Surfside Beach, Texas. The following coordinates represent the position of the photographer for each image: A) and B) 28.9433°N 95.2920°W, C) 28.9434°N 95.2918°W, D) 28.9461°N 95.2890°W.

At the offshore runnel edge, a significant amount of sediment transport was observed, and recorded in an underwater video. Sand was mobilized from the edge and carried into the runnel, likely actively infilling the runnel, and decreasing the height of the ridge. This observation was also expressed in a sediment cloud and murkiness of water at the offshore runnel edge in Figure 6 (lower right).

Small waves approached the beach at the time of the visit (Fig. 7 right). Offshore significant wave heights on that day were less than 0.5 m (Fig. 4). These small waves were visibly breaking at the offshore side of the flat ridge (Fig. 6 right) with a

swash bore running over the ridge and into the runnel (Fig. 6 right, Fig. 7). Wave reflection within the runnel seemed apparent, and little to no swash was observed at the onshore runnel edge (Figs. 6 and 7).

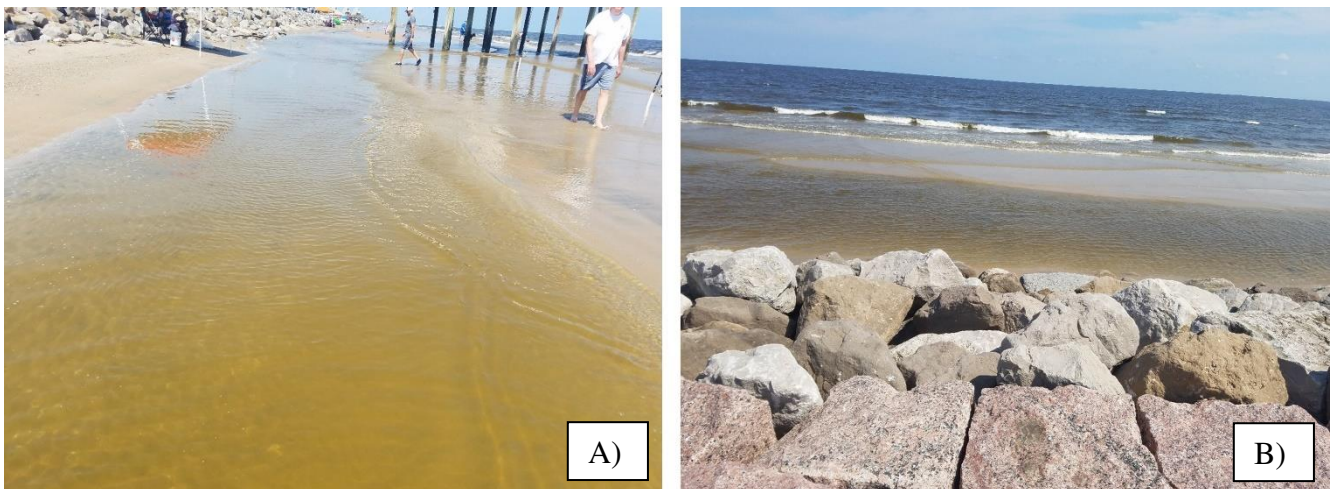
Figure 7. Seawall-beach-runnel-ridge system observed on yearday 246 at approximately 20:00 UTC (15:00 local time) at Surfside Beach, Texas. The following coordinates represent the position of the photographer for each image: A) 28.9460°N 95.2890°W, B) 28.9451°N 95.2903°W.
