Geotechnical Effects and a 6-Year Outlook of the 2012 Hurricane Sandy in the Eastern United States

ABSTRACT: Hurricane Sandy was the deadliest and most destructive event of the 2012 Atlantic hurricane season. It originated as a storm off the coast of West Africa that turned into a tropical wave in the southwestern Caribbean Sea, and then into a hurricane that moved slowly north along the United States East Coast. Numerous regional coastal communities and urban centers in New Jersey (NJ) and the New York City (NYC) metropolitan area experienced widespread flooding, extreme winds, and heavy damage that disrupted daily life and business in Lower Manhattan, the world's financial capital. Consequences with great geotechnical engineering interest include: (i) modification of the regional coastal geomorphology due to storm surge, with the birth of new inlets, erosion, scour of soil at the shorelines; (ii) damage in coastal communities that revealed the vulnerability of residential building foundations not designed according to modern flood protection standards; and (iii) interruption of service of buried structures and below ground infrastructure due to flood damage to non-structural com

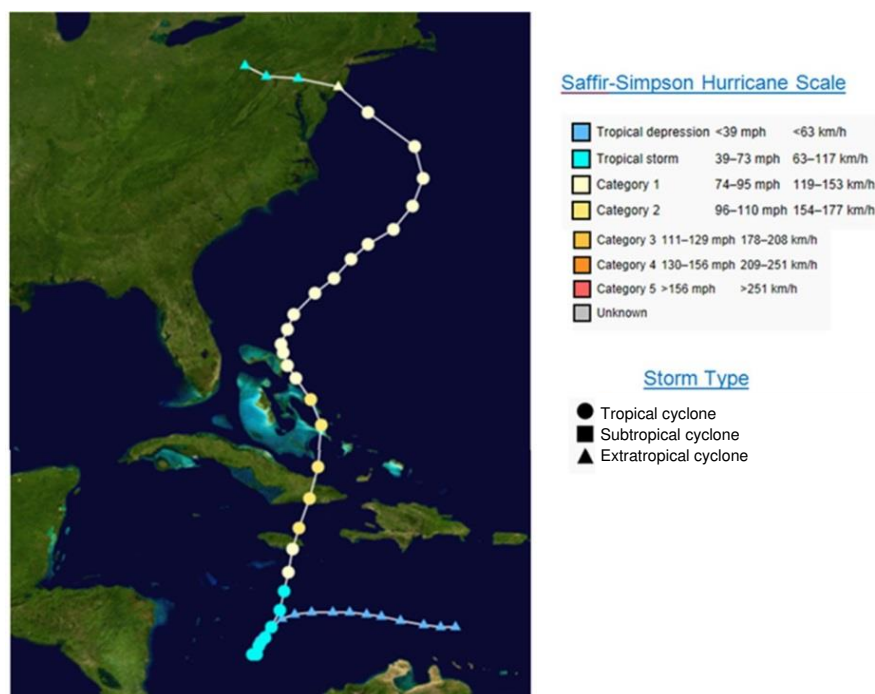
Figure 1. Map of Hurricane Sandy at six-hour intervals. Peak sustained wind speeds are colored per the Saffir-Simpson scale. The shape of points reflects the nature of the storm (based on Cyclonebiskit map with NOAA data and NASA background).

Sandy was a late-season cyclone or hurricane that started as a tropical disturbance off the coast of West Africa and later became a hurricane in the southwestern Caribbean Sea. It moved northeasterly along the U.S. East Coast and turned abruptly, becoming a superstorm as it made landfall near Brigantine, NJ, on October 29, 2012. As the storm approached, the counterclockwise rotation directed high velocity winds to be from the east, driving devastating storm surges into coastal areas of NJ, western LI, and the boroughs of Queens, Brooklyn, and Staten Island (SI). The maximum recorded storm surge (NOAA, 2013), defined as the observed water level (storm tide) minus the predicted astronomical tide levels, reached 3.855 meters or 12.65 feet (ft). Manhattan experienced an inundation of 1.7 m (5.5 ft) above ground from a surge of 3.5 m (11.4 ft). Blake et. al (2013) provide a detailed description of the storm and its path, which is shown in Fig. 1.

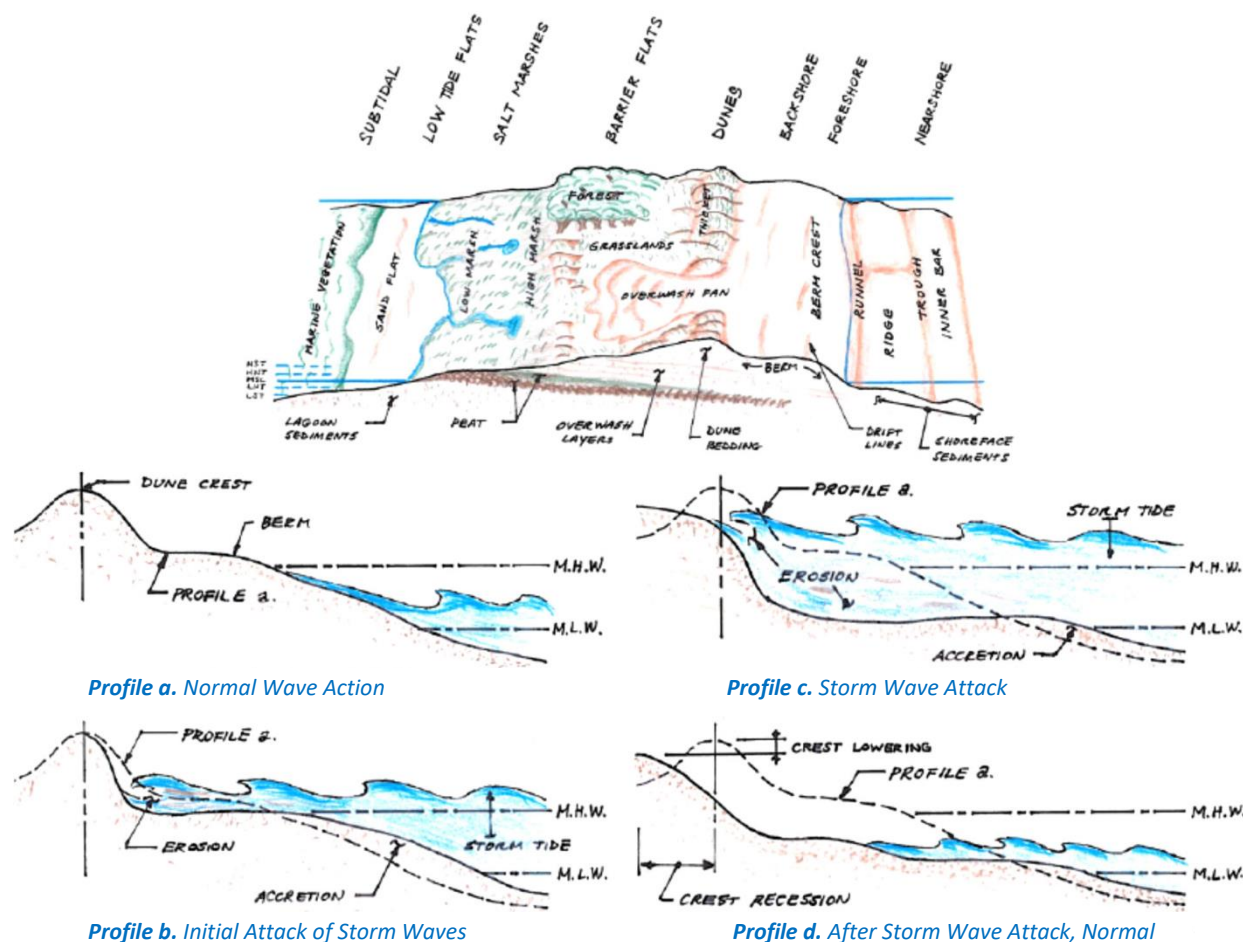
Figure 4. Barrier environments (top) and beach profile changes (bottom) in response to a coastal storm (Refs: A. Dyer from Leatherman, S.P., 1979; Godfrey, 1976; and U.S. Army Corps of Engineers, 1974).

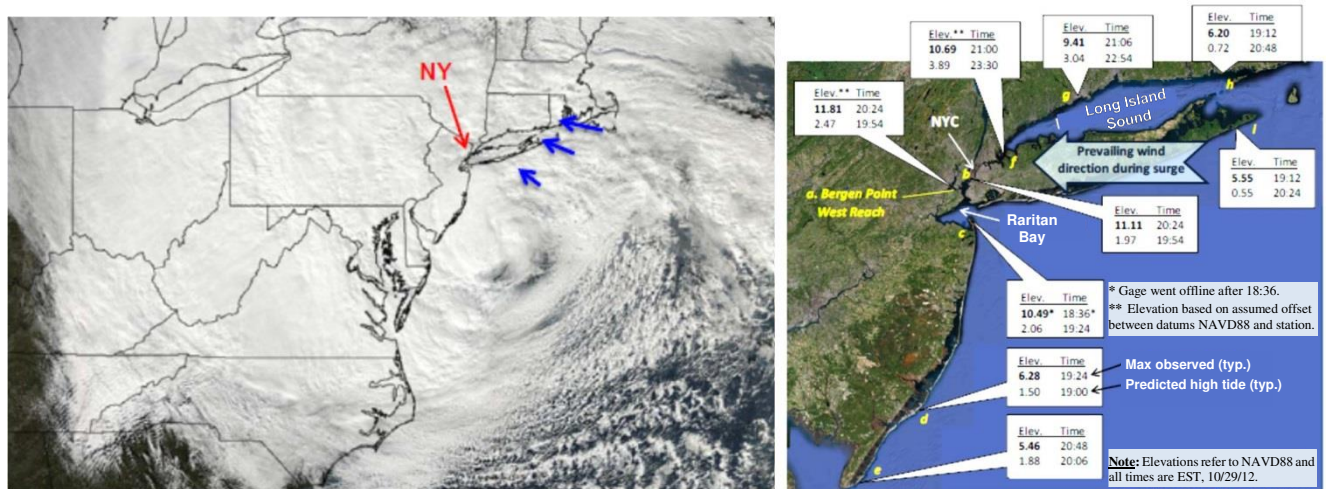
Figure 6. Hurricane Sandy's circulation on 10/29/12 at 2:20 pm EDT; blue arrows show wind direction close to landfall in southern NJ (left; nasa.gov/hurricanes/h2012/Sandy). Observed and predicted tide from NOAA stations (right).

Figure 6 depicts the wind direction, fetch, coastline shape, and normal tidal cycle. The counterclockwise wind currents caused an eastern high velocity wind direction over LI and NYC. This pattern was verified by the GEER team's observation that many of the thousands of fallen trees in LI fell to the west. The following factors contributed to an increase of the surge:

- The westward direction of the winds created a long fetch distance from the east towards Raritan Bay and LI Sound.
- The “constricted” shape of both the Raritan Bay and LI Sound narrowing to the west caused the surge height to increase as it moved into those areas due to a “funneling” effect.
- The slow storm movement resulted in the maximum surge being superimposed above the astronomical high tide.

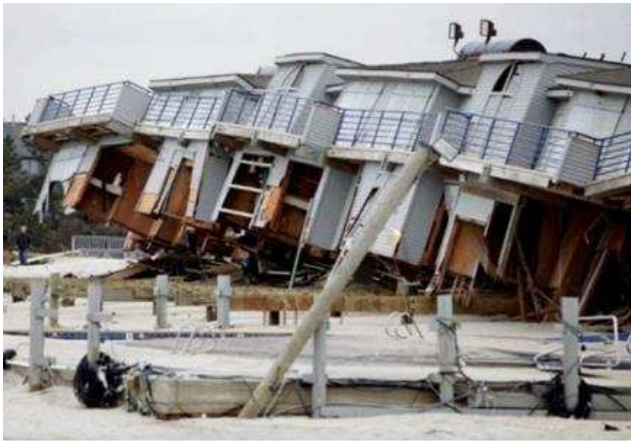
Figure 19. Sea Bright, NJ, beach cabana (40.350086°N, 73.972954°W) pulled off its base (Photo by AP/Wenig; 11/19/12).

A common damage pattern among wood frame houses was the pulling off their foundation due to inadequate anchorage (e.g., Sea Bright, NJ, Fig. 19). These house were subject to flotation, which not only causes distress, but removes dead load from foundations, making them more susceptible to breakage. Particularly, Concrete Masonry Unit (CMU) wall foundations and piers performed poorly, and were found buckled, broken, or completely removed, causing tilt, dislocation, or collapse of the superstructure (Fig. 19). In Sea Gate, Brooklyn, a concrete beachfront retaining wall foundation was undermined by erosion and subsequently broke, while the soil behind the wall was washed out (Fig. 20). In Breezy Point and Roxbury, Queens, two-story wood-frame homes, on CMU block wall and pier foundations, sustained major structural damage, including being pulled off their partially or completely destroyed foundations (Fig. 20). On the other hand, foundations of high-rise residential buildings (typically piles) generally performed well.

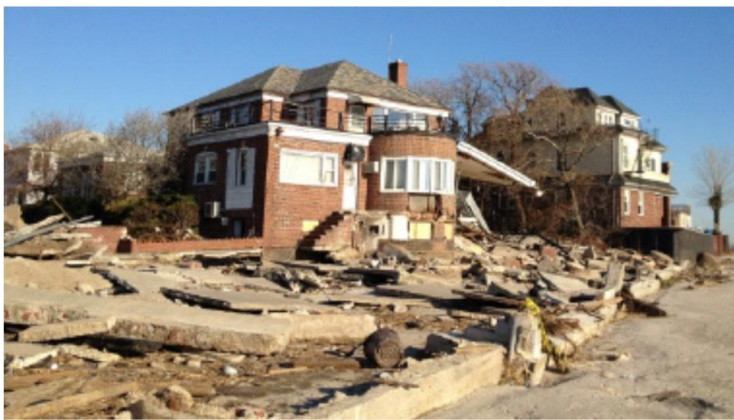
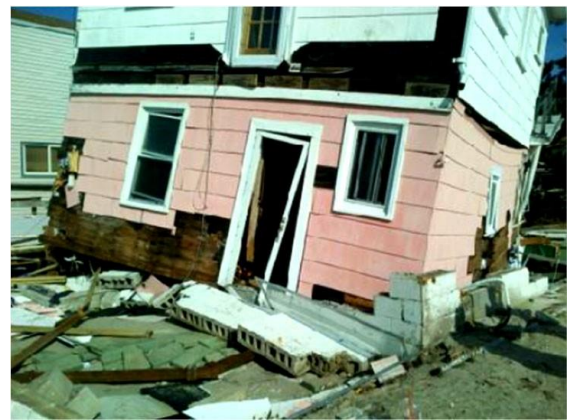
Figure 20. Undermining of beachfront retaining wall and loss of retained soil, Sea Gate, Brooklyn (left, 11/9/12); Destroyed CMU wall foundation, Breezy Point, Queens (right, 11/12/12). Photos by NYCDob (GEER, 2014).
