Asynchronous Mobilization of Shear Resistance in Slope Failures

ABSTRACT: This paper focuses on the case study of the 2014 embankment failure at the Mount Polley TSF in Canada to study deformation-controlled mechanisms of instability leading to the asynchronous mobilization of shear strength and causing progressive failure. Three such mechanisms were identified in this failure: strain-weakening, the delayed mobilization of shear strength in the shell owing to stiffness incompatibility, and a reduction of mobilized shear resistance in the extending regions of the slide due to loss of confinement. Changes associated with these mechanisms were identified in the numerical analysis to help diagnose the impending collapse. These are: the emergence in the strain-weakening unit of a substantive area on the brink of strain-weakening, the depletion of reserve strengths in the foundation materials, and the extension of the unit above the strain-weakening zone owing to differential shear displacements within and outside the failure zone. Safety factor calculations do not adequately capture the stability of the Mount Polley embankment in the year preceding its collapse, and limit equilibrium m

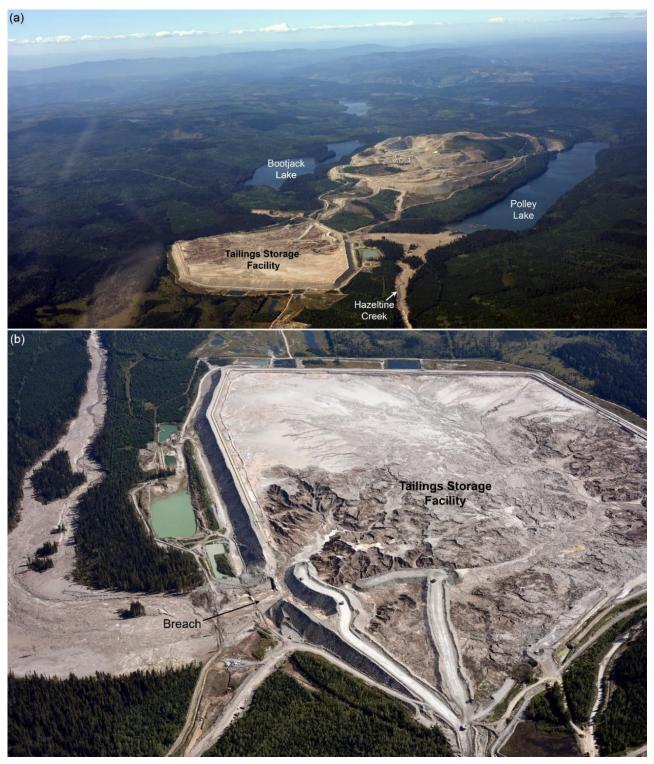
Figure 1. (a) Aerial diagonal view of the Polley Mine looking NNW; (b) Aerial diagonal view of the Mount Polley TSF, looking SSW. Photography courtesy of Jamie Heath, therrasaurus.ca, taken 09/05/2014, reproduced with permission, altered to add labels and enhance contrast/tone.

Mount Polley mine is a gold and copper mining operation managed by the MPMC. It is located in the Cariboo Region of British Columbia, Canada at the approximate coordinates 52°33'N 121°38'W. The mine is situated on glaciated terrain and is surrounded by pristine boreal forest along with a system of glacial lakes and creeks (Zabolotnii 2020, p. 75; Fig. 1).

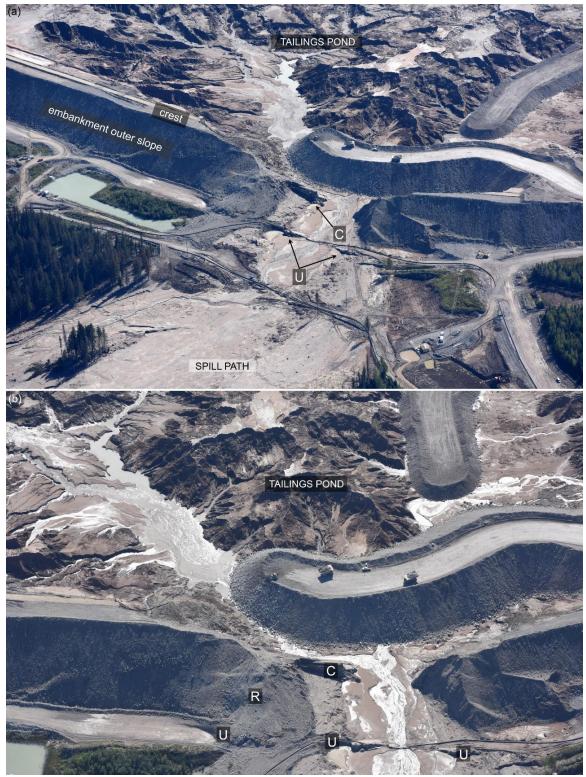
Figure 4. (a) Aerial diagonal view of the breach and spill path areas; (b) Aerial diagonal close-up of the breach location. Labels: C – core remnant, R – rockfill at the east boundary of the slide, U – uplift at the toe of the slide. Photography courtesy of Jamie Heath of terrasaurus.ca, taken 09/05/2014, reproduced with permission, altered to add labels.

Above the slide base, the geometry of the slip was irregular. Extensive ground cracking, shear zones (IRP 2015, Fig. 5.1.7), and sheared remnants of core (Fig. 4, feature C) delineated the extent of the slide in the upstream region roughly along the dam centerline and just few meters upstream of the Upper GLU's upstream edge. The failure zone was restricted to a width \sim 100m at ground level, widening to \leq 150m at crest level. The broad (200-250m) slip surface in the Upper GLU did not clearly propagate into the embankment; however, the rockfill in the shell zone flanking the breach is seen to have undergone significant deformation (Fig. 4, feature R). This material's lower deformation modulus and resulting stress-strain incompatibility with the rest of the structure was inferred both from the large deformations at failure but also from a documented history of poor compaction and low confinement stresses.
