# Practical Design, Numerical Analysis, and Site Monitoring for Huge Arching Effect during Massive Excavation of Undercut Slope in Open-Pit Mine

**ABSTRACT:** *This paper reviews a successful case history where applications of numerical predictions for a massive excavation were undertaken for both Class A and Class B predictions. Forming a stable arch across the pit of an open-pit mine is beneficial to the design of an undercut slope. However, predicting the maximum stable undercut width under which the slope does not collapse is a challenging problem in geotechnical engineering. Slope undercutting techniques originally developed for 1g physical and centrifuge models were realized in practice for a full-scale design at the Mae Moh mine, one of the large coal open-pit mines in Southeast Asia, during the period of 2011 - 2017. Numerical analyses, along with in-situ measurements for data assimilation, were applied to test the novel design concept before and during the surface excavation. At the initial stage of excavating the undercut slope, the mine was studied in terms of forming an arch, by conducting a field experiment of a partial undercutting in Area 4.1, which was of monumenta

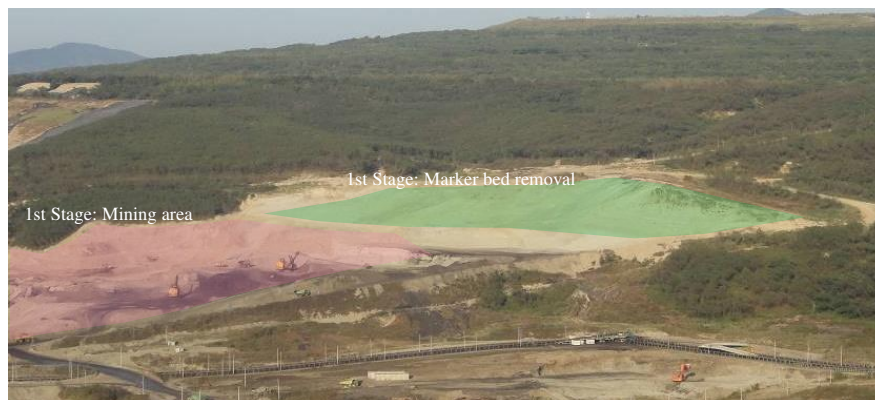
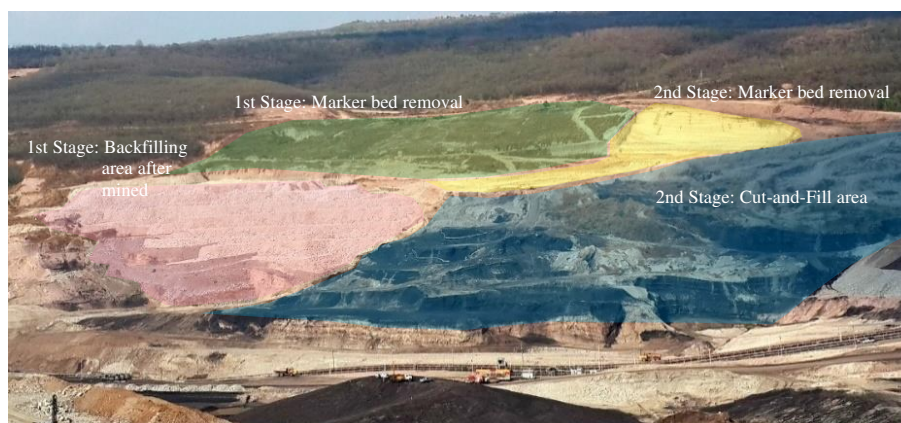
*Figure 12. Photographs of the 1<sup>st</sup> Stage in Area 4.1.*

The undercutting in Area 4.1 was periodically photographed for archival purposes; some of the photographs are presented in Figure 12. The mine equipment was moved to Area 4.1 and the site preparation began in April 2011. Three months later, in July 2011, the Marker bed was ready to be excavated; by August 2011, it had been totally removed. The undercutting of the northern part of Area 4.1 began in August and reached an elevation of 170 msl by January 2012. The undercut span was approximately 80 m. The undercutting continued and reached an elevation of 137 msl by April 2012. The undercut width was approximately 90 m. Between May and June 2012, the backfill, comprising 30,000 cubic meters, was placed from an elevation of 115-192 msl. The undercut width was then shortened to 30 m. The undercutting was restarted and continued in the southern direction in August 2012. The 1<sup>st</sup> Stage was completed in May 2014. Finally, the undercut width had been extended to approximately 100 m by the end of the 1<sup>st</sup> Stage.

(a) Access road and Marker bed removal in 1<sup>st</sup> Stage (as of August 2011)

(b) Mining elev 170 m in 1<sup>st</sup> Stage (as of January 2012)

(c) Marker bed removal and 2<sup>nd</sup> Stage preparation in 1<sup>st</sup> Stage (as of April 2014)
