Segmental Retaining Wall Reinforced with Geogrids, in New Hospital Works (Salamanca, Spain)

Reference: Rodríguez, M.T. and Amo, P. (2022). Segmental retaining wall reinforced with geogrids, in new hospital works (Salamanca, Spain). International Journal of Geoengineering Case Histories, Volume 7, Issue 2, pp. 62-71, doi: 10.4417/IJGCH-07-02-05

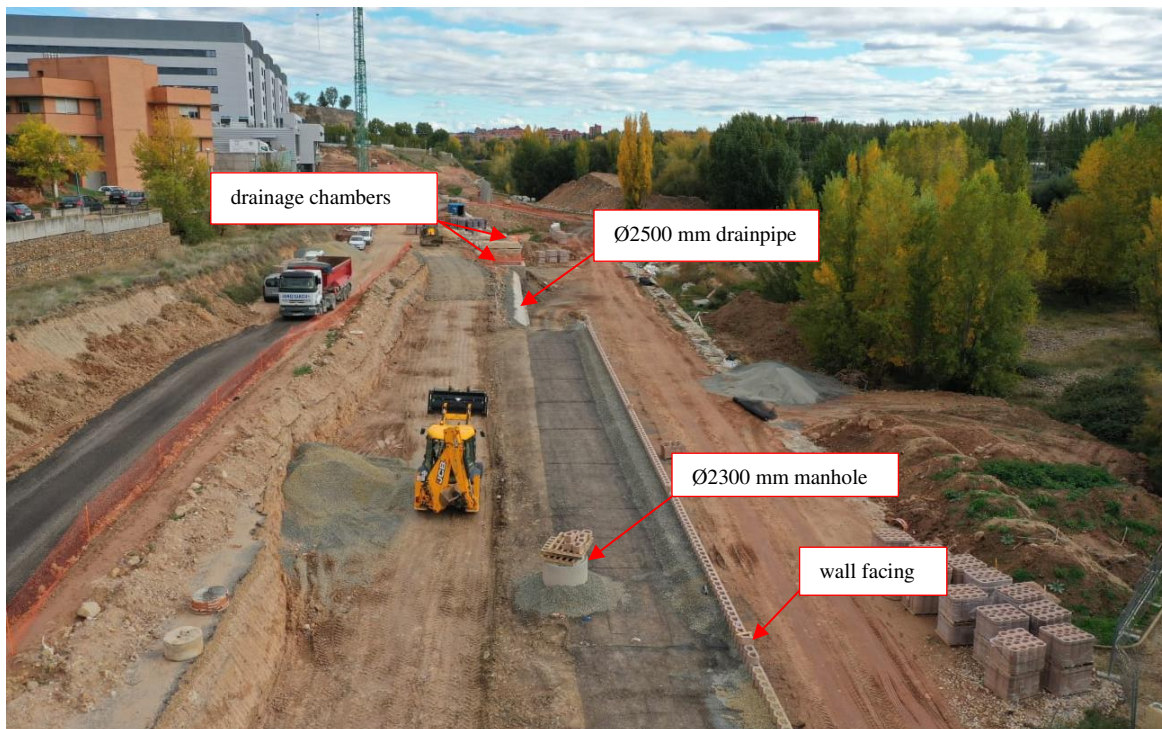
Figure 3. Wall 1 under construction (Orbe Técnicas y Medioambiente).

The last of the challenges was the geometric encounter with the existing prefabricated vertical wall. It was solved thanks to the professionalism and skill on the installers' part, bearing in mind that a face angle of the exposed face is required to make a smooth transition from 80° to 90° with steps at both at the foundation base and at the top of the blocks by varying the horizontal set back of each course. The installation company's engineers carried out a geometric fit using CAD, which was later redefined on site and each course was checked with precision.
