Segmental Retaining Wall Reinforced with Geogrids, in New Hospital Works (Salamanca, Spain)

ABSTRACT: *The construction of a new hospital, located by the river Tormes in the Spanish city of Salamanca, involved the expansion of roads and the construction of a new way of access to the complex, as well as a large retaining wall to bridge the gap between them and the river level. The project original solution was in situ foundations and precast concrete walls. However, at both ends of the alignment of Transición Española Avenue, there were several construction constraints (such as the existence of rainwater chambers for discharging into the river, a large-diameter drainage pipe at the back of the walls, communications, and gas services). The need to maintain steady access to the old hospital in service during the COVID-19 pandemic was furthermore required. The wall was founded on fills with low bearing capacity in other sections. Finally, a reinforced segmental retaining wall (SRW) was adopted as the optimum choice. It consists of concrete block (segmental) facing with a high-quality fill reinforced backfill, reinforced with polyester (PET) geogrids. The facing required a variable inc

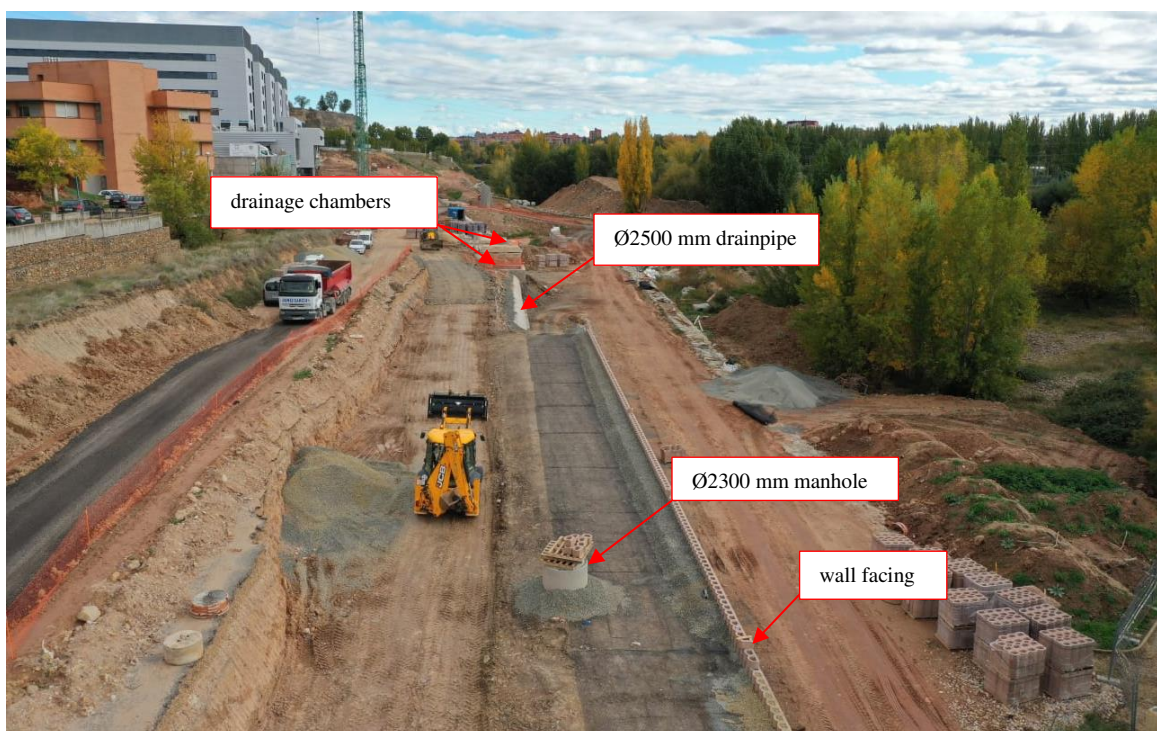
Figure 3. Wall 1 under construction (Orbe Técnicas y Medioambiente).

The last of the challenges was the geometric encounter with the existing prefabricated vertical wall. It was solved thanks to the professionalism and skill on the installers' part, bearing in mind that a face angle of the exposed face is required to make a smooth transition from 80° to 90° with steps at both at the foundation base and at the top of the blocks by varying the horizontal set back of each course. The installation company's engineers carried out a geometric fit using CAD, which was later redefined on site and each course was checked with precision.

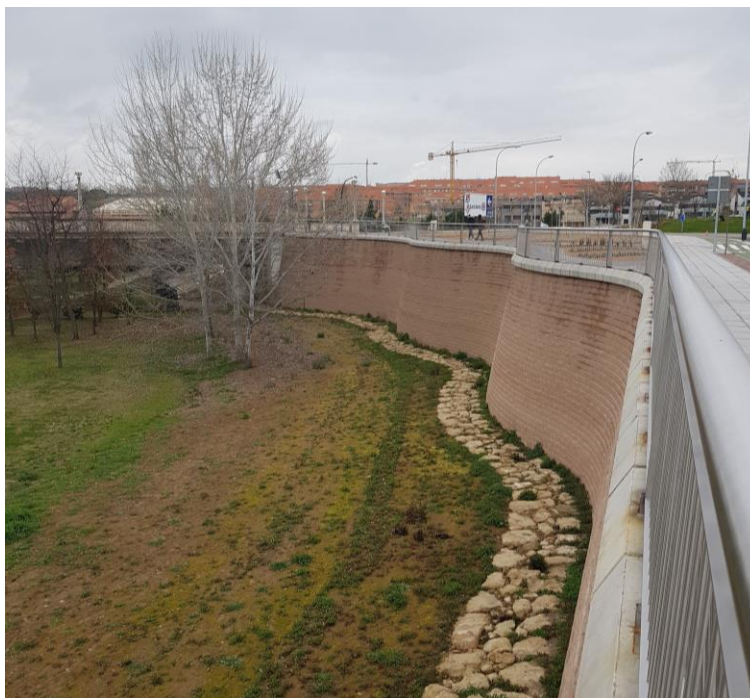
Figure 7. Wall 1 at the present time (Huesker geosintéticos).

owner representative engineer. In addition, a professional team of installers with more than 20 years of experience in the installation of block walls was on site, and the good results are evident (see Figure 7).
