Practical Design, Numerical Analysis, and Site Monitoring for Huge Arching Effect during Massive Excavation of Undercut Slope in Open-Pit Mine

KEYWORDS: Slope Stability, Undercutting, Arching, Open-Pit Mines

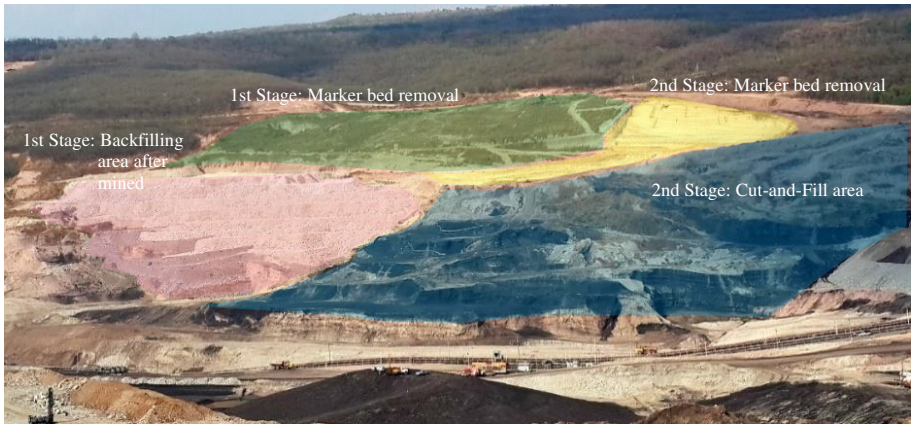
Figure 12. Photographs of the 1st Stage in Area 4.1.

The undercutting in Area 4.1 was periodically photographed for archival purposes; some of the photographs are presented in Figure 12. The mine equipment was moved to Area 4.1 and the site preparation began in April 2011. Three months later, in July 2011, the Marker bed was ready to be excavated; by August 2011, it had been totally removed. The undercutting of the northern part of Area 4.1 began in August and reached an elevation of 170 msl by January 2012. The undercut span was approximately 80 m. The undercutting continued and reached an elevation of 137 msl by April 2012. The undercut width was approximately 90 m. Between May and June 2012, the backfill, comprising 30,000 cubic meters, was placed from an elevation of 115-192 msl. The undercut width was then shortened to 30 m. The undercutting was restarted and continued in the southern direction in August 2012. The 1st Stage was completed in May 2014. Finally, the undercut width had been extended to approximately 100 m by the end of the 1st Stage.

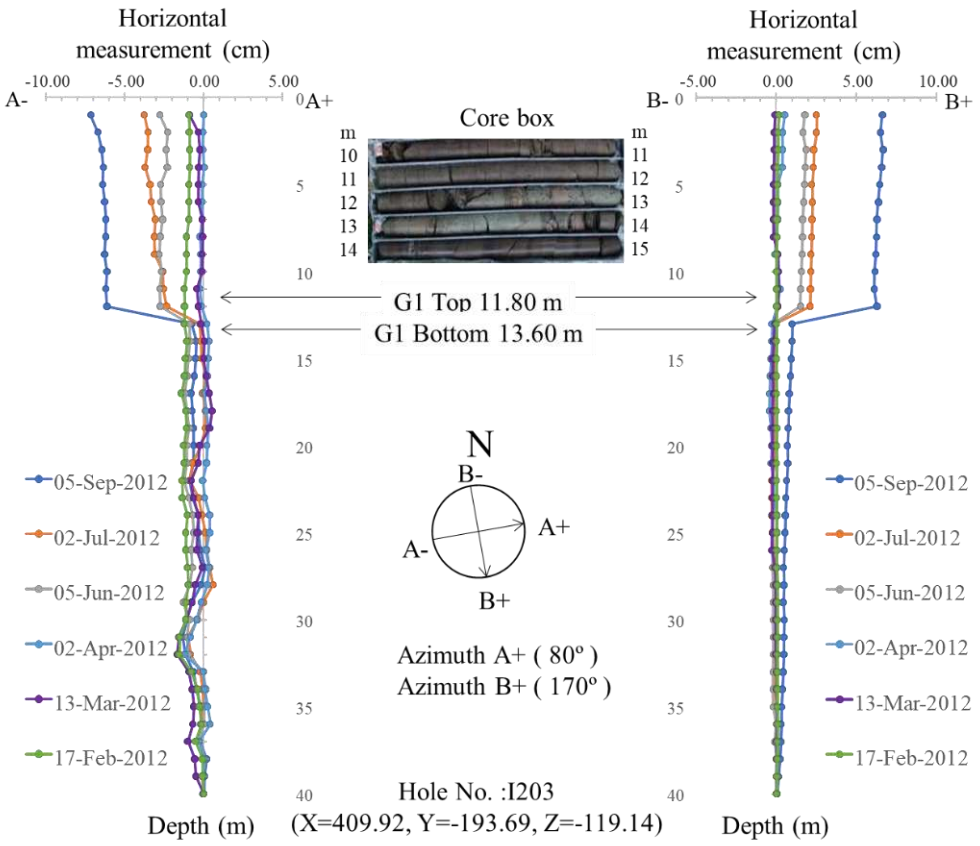
Figure 15. Surface and subsurface displacements measured by I203.

recorded from the ground surface to a depth of 12 m. The depth of 12 m was indicated as the depth of the G1 interface. Along with the progress of the mining activity and the rainy season, the slope was slowly displaced and borehole I203 was gradually bent and totally sheared off by September 2012. The maximum surface and subsurface displacements at the G1 interface were 0.097 m and 0.088 m, respectively. The displacements measured by I203 were likely to be in the G1 interface dip direction. The data obtained by I203 revealed that the ground surface of the potential sliding block above the G1 interface was slightly more displaced than the subsurface.

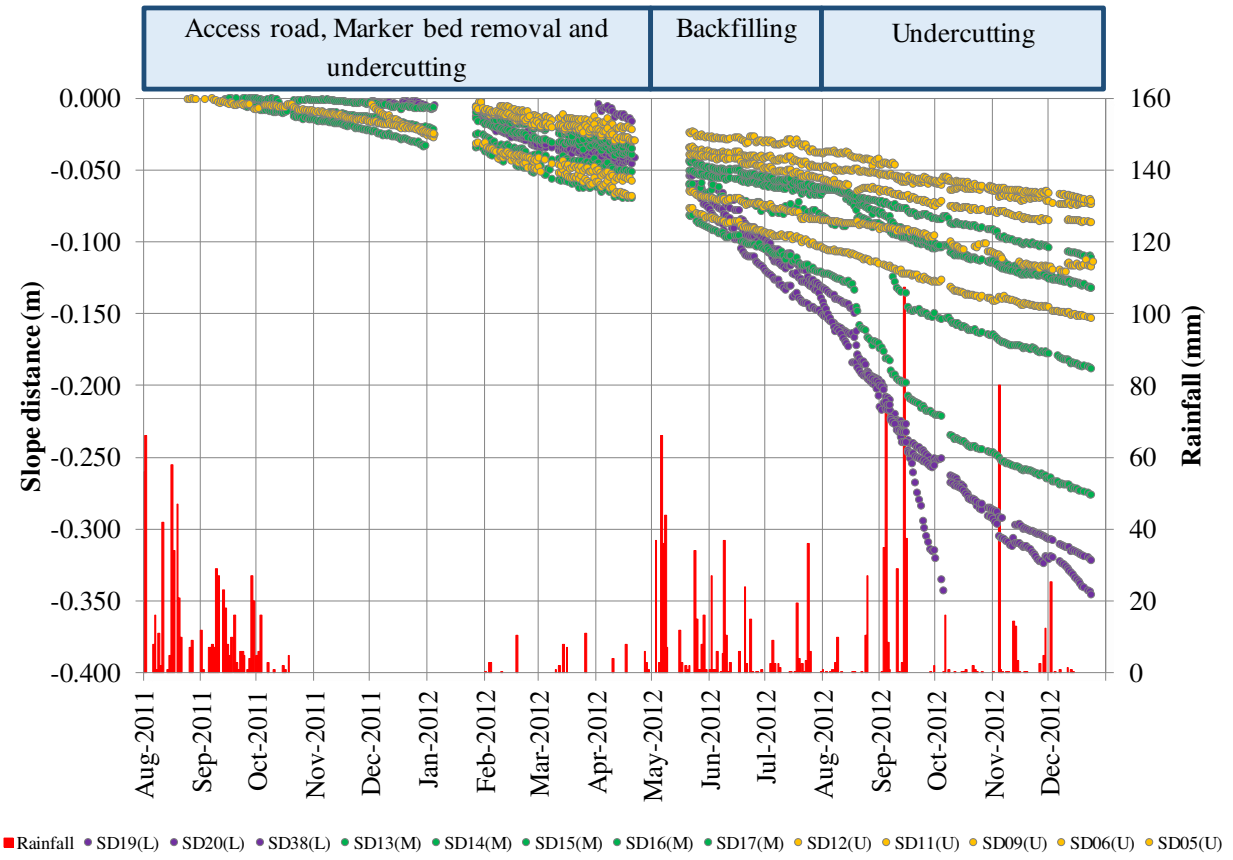
Figure 16. Surface displacements measured by prisms and amounts of precipitation.

The monitoring data for the ground surface displacements during the undercutting of Area 4.1 from 13 prisms are presented in Figure 16 along with the amounts of precipitation. The scheduled preventive maintenance program and an accidental system failure caused the monitoring to be discontinued. However, the monitoring data that were collected were still valuable. In Figure 16, the monitoring data are colorized according to the installation locations of the prisms. The ground surface displacement monitoring data on the Upper Floor, Mid Floor, and Lower floor have been colorized in yellow, green, and purple, respectively.

The surface displacements of the Upper, Mid, and Lower Floors – presented as the changes in the measured distance between the total station and the monitored prisms – were approximately -0.10 m, -0.25 m and -0.35 m, respectively, in early January 2013. The negative values indicate that the prisms displaced toward the total station. It is clear from the figure that the Lower Floor had the largest displacement because of its vicinity to the undercut face, while the Upper Floor had the smallest displacement. It should be noted that the surface displacement, measured by the Robotic Total Station with prisms (Figure 16), is a result of the interface shearing as captured by inclinometer I203 (Figure 15) and the deformation of the potential sliding block.

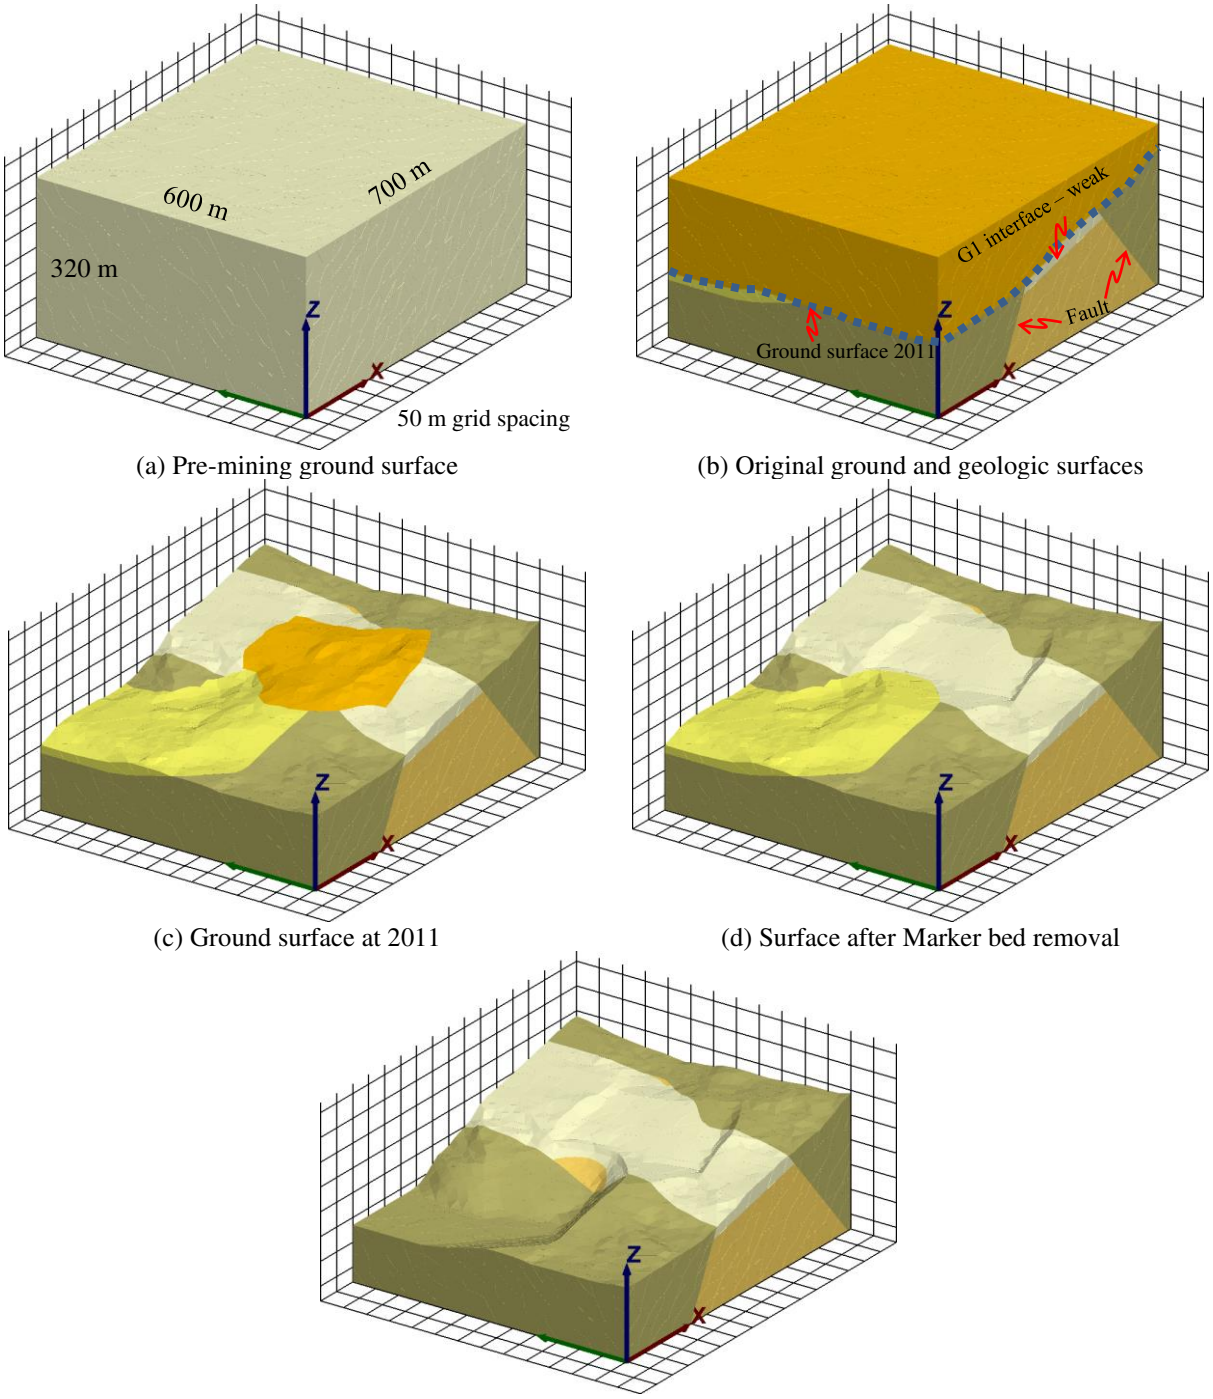
Figure 17. Pre-mining ground surface, topographic, and major geologic structure surfaces in model.

The model started with a big rectangular block, as presented in Figure 17. The dimensions of the pre-mining ground surface were 700(W) × 600(L) × 320(H) m^3 (Leelasukseree and Mavong 2012). The flat top surface of the block represented the original ground topography surface or pre-mining ground surface. The block was divided into mining and geologic structure surfaces. The mining surfaces consisted of the pre-undercut, the mine development (after the Marker bed was removed), and the end of the 1st Stage surfaces. The mining surfaces were used for simulating the sequential excavation. The geologic structure surfaces consisted of two faults and a weak plane (G1 interface). The sub-blocks in the model were able to slide along the geologic structure surfaces, which were the faults and the G1 interface. The 1st Stage model consisted of 579,461 elements and 460,827 nodes.

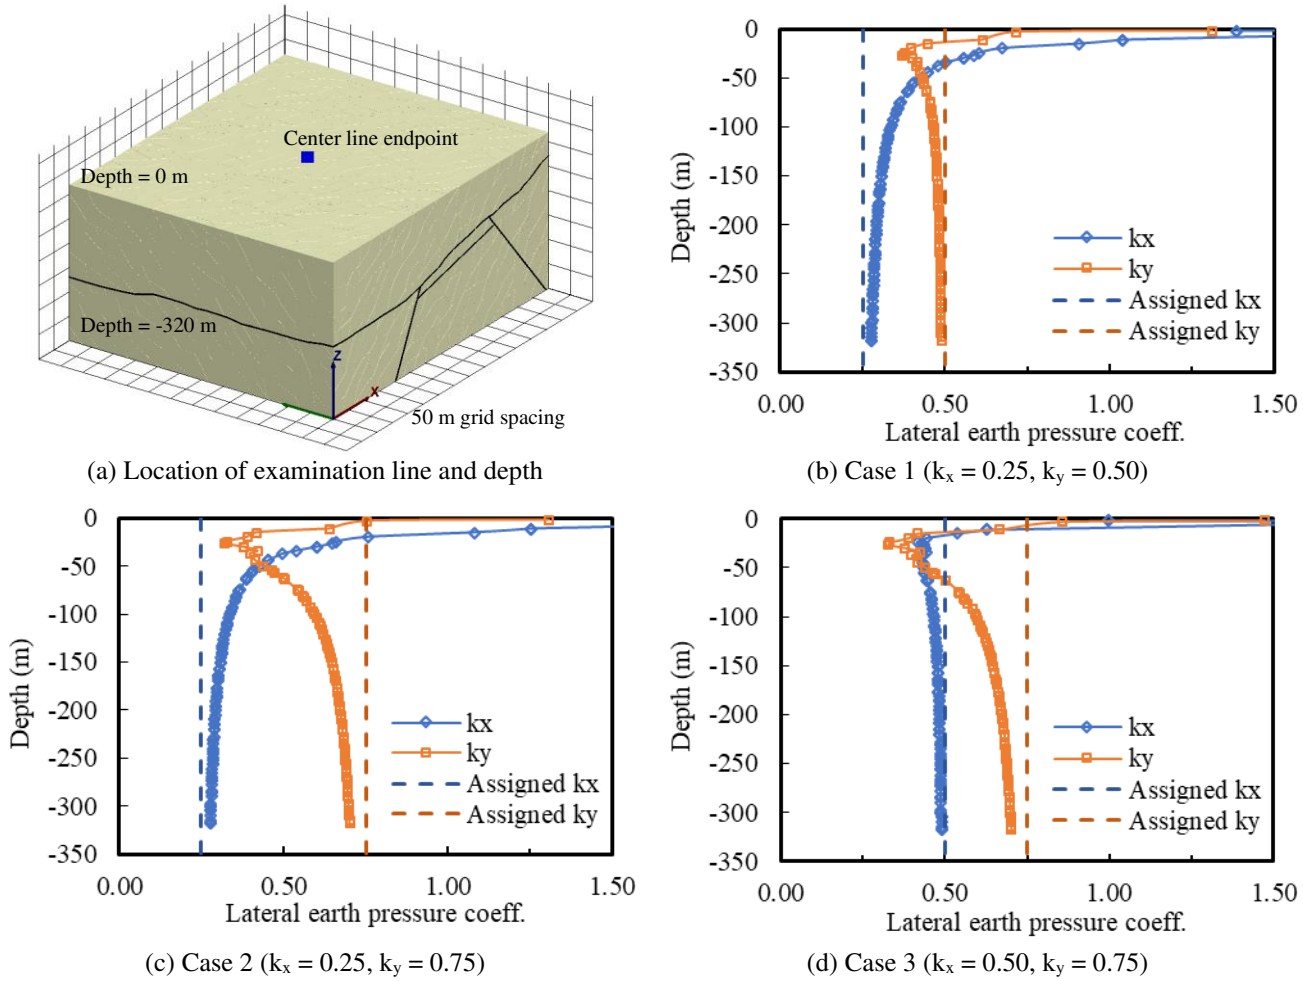
Figure 18. Lateral earth pressure coefficients and depth at original ground surface.

Figure 18 presents k_x and k_y with the depth along the vertical center line of the model. The depth of the model was measured from the top of the big block (blue dot). Near the free face, the values for both k_x and k_y of the zones were much greater than those assigned. They continuously converged to the initially assigned horizontal stresses with depth.

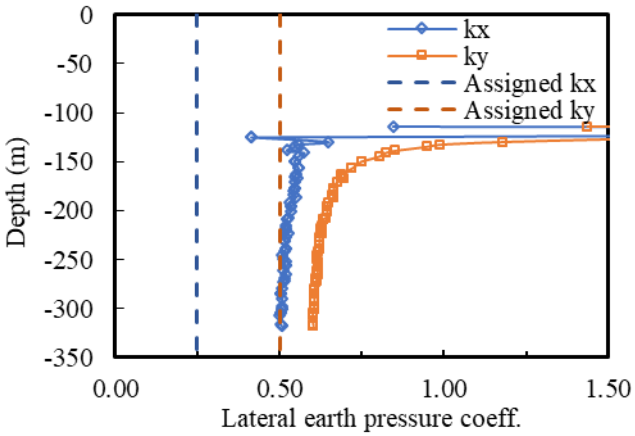
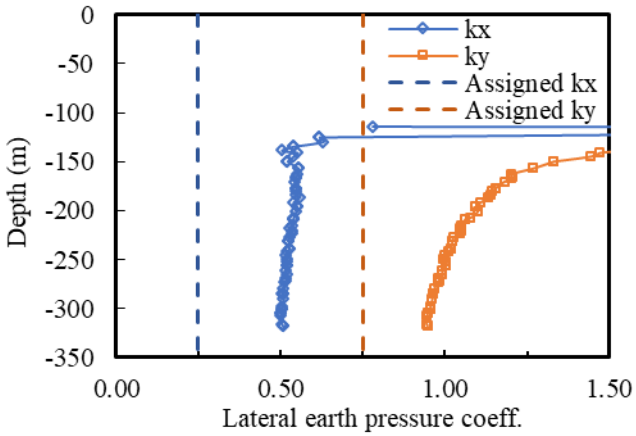
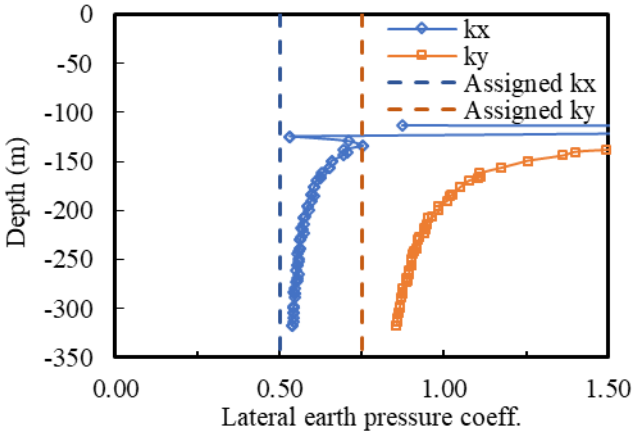
Figure 19. Increase in lateral earth pressure coefficients and depth at ground surface 2011.

Figure 19 also presents the coefficients with depth after the original ground surface was excavated to ground surface 2011. Initial coefficients k_x and k_y are both seen to have increased by quite a fair amount. The lateral earth pressure coefficient in the x direction (k_x) increased from 0.25 to 0.50 in Cases 1 and 2 and rose slightly in Case 3. The values for k_y also increased approximately 0.125 from their initial values in all cases.

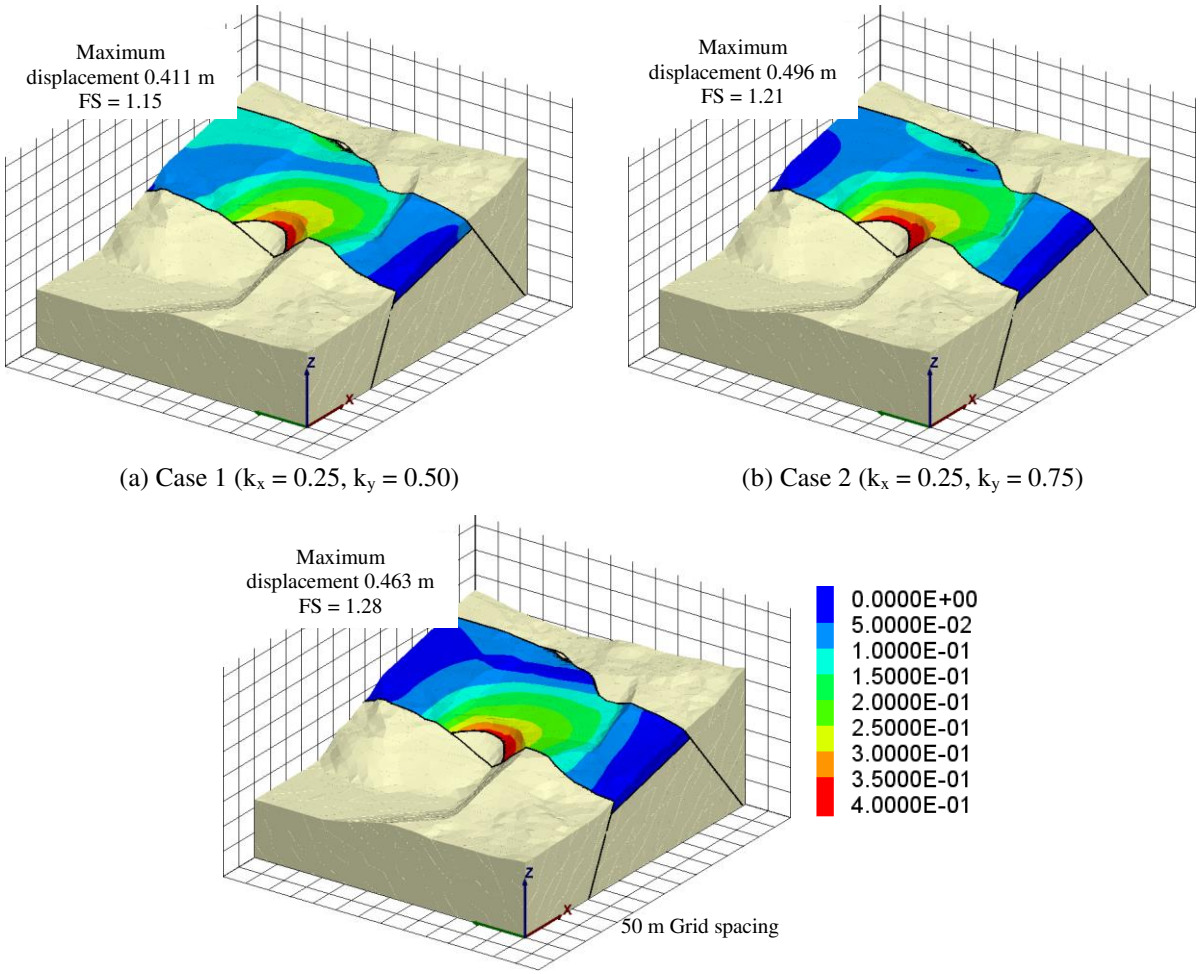
Figure 20. Maximum total displacements of undercut models.

The sequential excavation was continued after the big block model was excavated to ground surface 2011 by the removal of the Marker bed and the undercutting. After the undercutting, the maximum total displacements were in the same location at the potential sliding block's slope face, near the G1 interface (Figure 20). The displacements decreased with the distance

As presented in Figure 20(a), the maximum displacement was 0.411 m and it was located at the potential sliding block's slope face, near the G1 interface. In Figure 22, the displacement contours were overlaid with displacement vectors. The vectors showed an unusual upward displacement component. However, the upward displacement near the undercut face went undetected by the Robotic Total Station in the field. It is very likely that the upward displacement vectors were caused by the massive excavation involving the Marker bed removal and the undercutting steps or model unloadings.

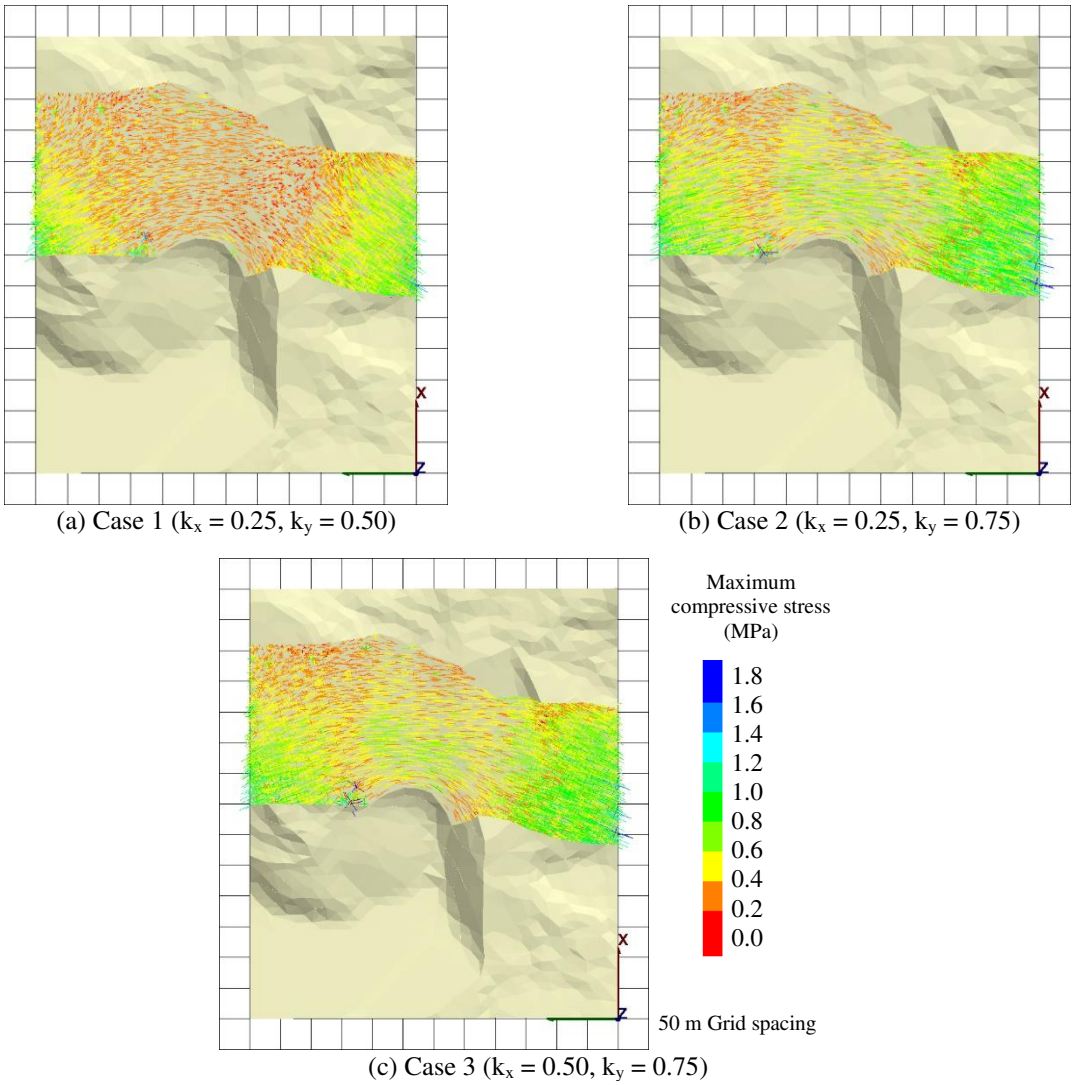
Figure 21. Principal stress trajectories in potential sliding block of undercut models.

The principal stress trajectories of the models are plotted in Figure 21. The positive stress indicates the compressive stress. The direction of the maximum compressive stress is obviously aligned in the tangential direction to the excavation in all cases. The magnitude of the maximum compressive stress in Case 1 was the least. The magnitudes of the maximum compressive stress were apparently similar in Cases 2 and 3. The total displacement contours and principal stresses of all the cases clearly showed arching in the potential sliding block, similar to the simple model. As the total displacements for all cases were slightly different, Case 1 was selected as the case for more undercut slope behavior investigations of Area 4.1.

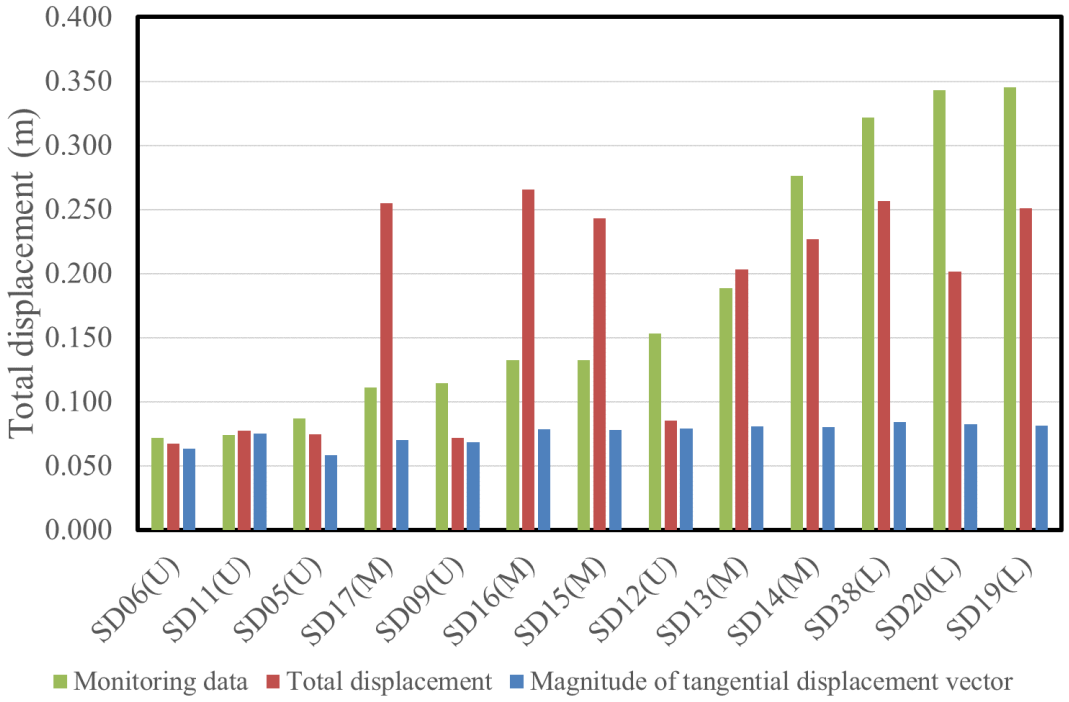
Figure 24. Comparison of surface displacements.

Figure 24 presents the surface displacement plot using the monitoring data, total displacements, and magnitudes of tangential displacement vectors at the G1 interface plane from the numerical model. The total displacements from the numerical model were fairly comparable to those of the monitoring data. The total displacements from the numerical model at SD15, SD16, and SD17 were quite a bit larger than those of the monitoring data. The locations of SD15, SD16, and SD17 were at the Mid Floor and thus not far away from the undercut face.

The total displacements from the numerical model and the magnitudes of tangential displacement were slightly different in the Upper Floor. However, they were incomparable in the Mid and Lower Floors. These floors were located near the excavation, and the nodes around them tended to have the upward displacement component in the numerical model.

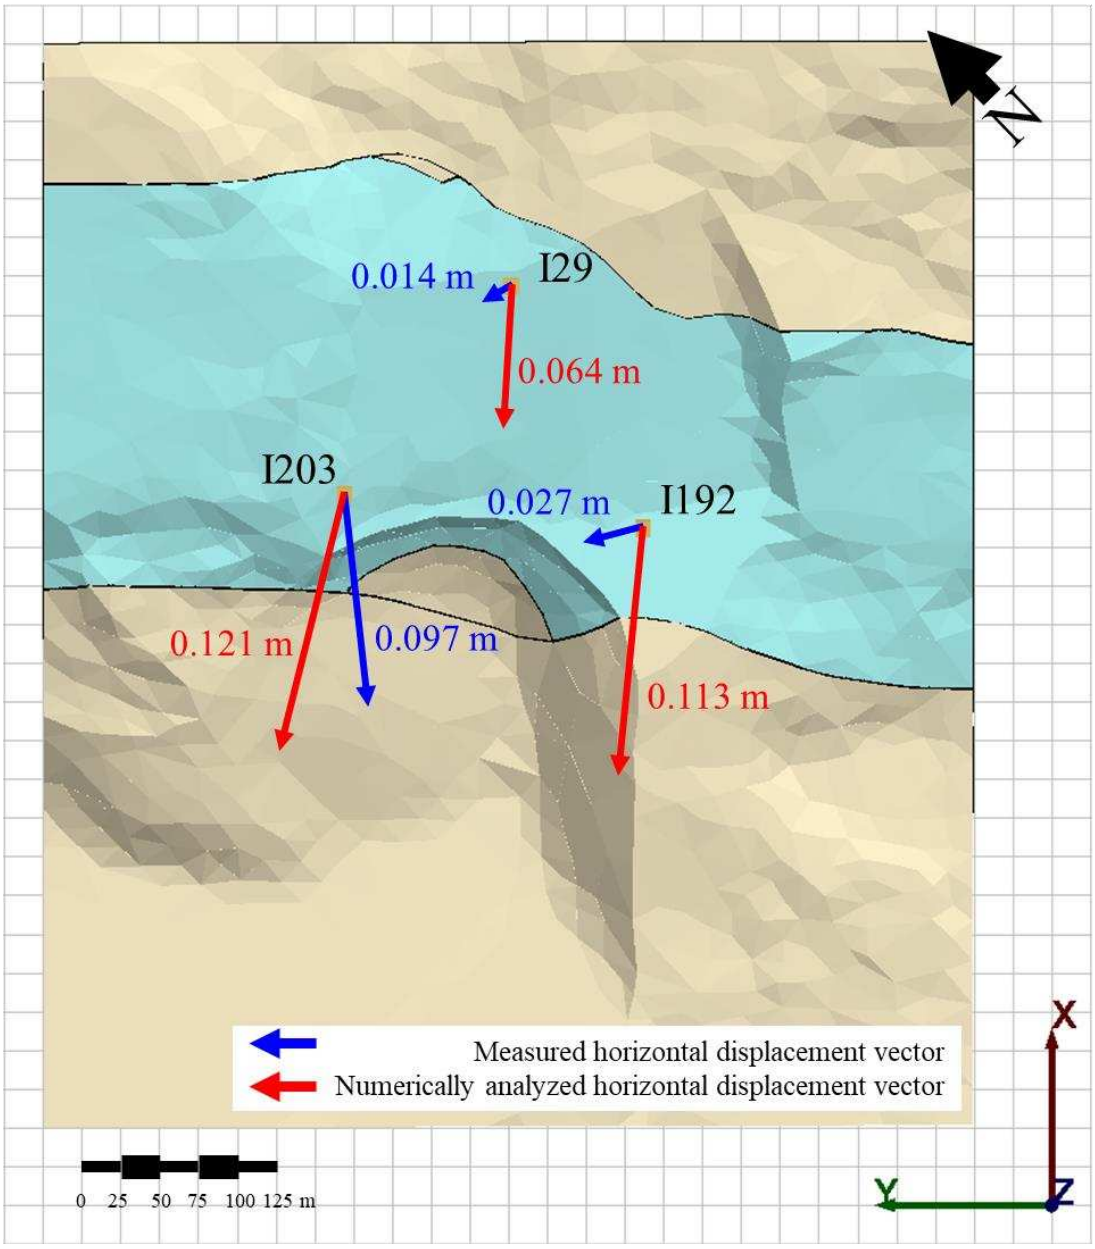
Figure 25. Horizontal displacements of inclinometer collars.

Another comparison of the surface displacements was done for the surface displacements measured by the inclinometers. The surface displacements measured by the inclinometers did not include any vertical displacements. The surface displacements were the horizontal displacements of the borehole collar. The measured borehole collar displacements are tabulated in Table 3. The displacement vectors of the nodes near the inclinometers from the model are also listed in Table 4. To compare the horizontal displacements between the model and the measurements, the horizontal vectors of the nodes near the inclinometers and the borehole collar displacements were drawn together. The horizontal displacements of I203, between the measurements and the numerical model, were comparable both in magnitude and direction. The horizontal displacements from the numerical analysis and the measurements were much different at I192 and I29.

According to Figure 15, although the potential sliding block above the daylighted G1 interface obviously moved along the G1 interface, a slight shear deformation was observed in the underlying rock mass and the potential sliding block. Therefore, the magnitude of the movements observed in Figure 25 is always larger than that of Figure 26 and their difference represents the shear deformation of the potential sliding block.

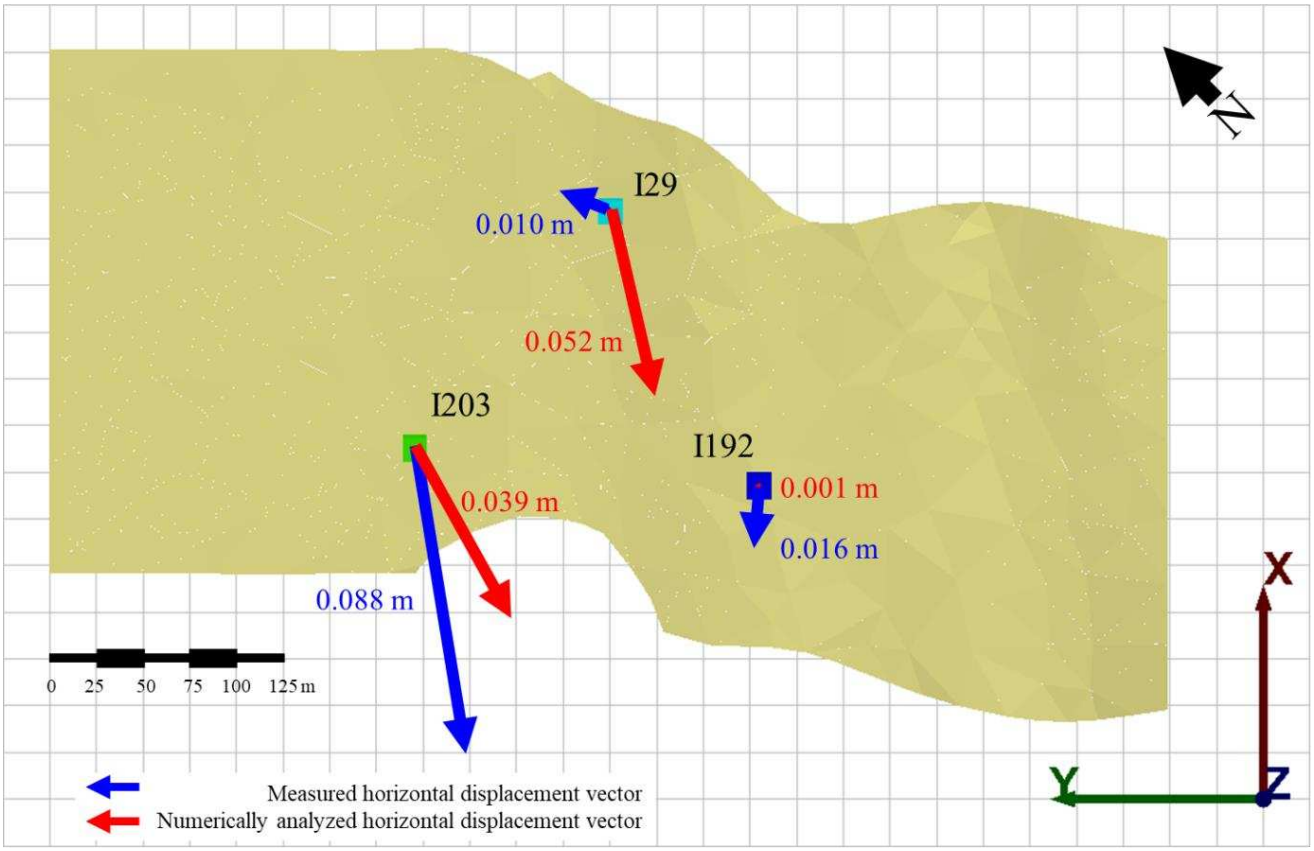
Figure 26. Subsurface displacements of inclinometer at G1 interface.

The subsurface displacements from the numerical analysis on the nodes near the inclinometers fell in the range of 0.001 m to 0.052 m. The subsurface displacement vectors by the inclinometers and the numerical analysis are graphically shown in Figure 26. The subsurface displacements are comparable to the measured ones only for I203. The subsurface displacements near the undercut face, between the inclinometer data and the numerical model, in terms of direction and magnitude, were comparable. For the area farther away from the undercut face, the subsurface displacement directions and magnitudes were unmatched. It is concluded that the complexities of a site's geology could be one of the major challenges of numerical modelings.

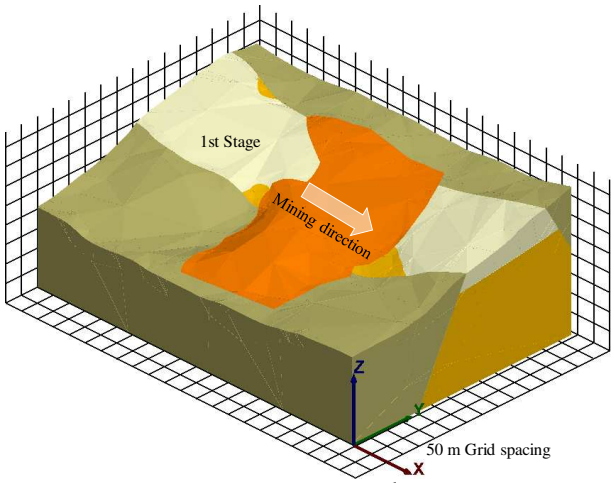
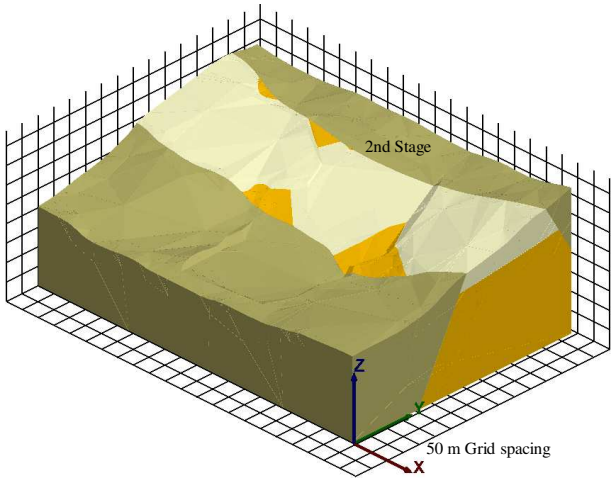
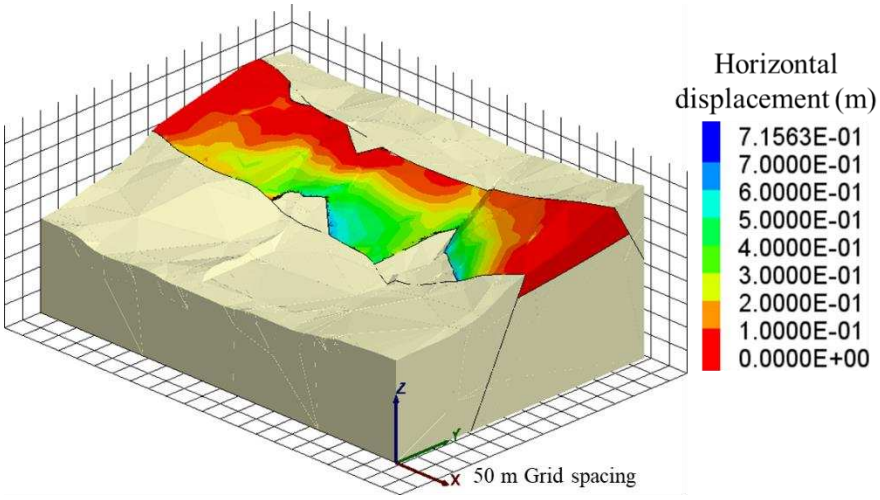
Figure 27. 2nd Stage numerical model and its horizontal displacements of undercut.

The displacement and stress trajectory plots for the numerical model clearly show the existence of arching in the potential sliding block, as presented in Figures 27(c) and 28. The maximum displacement was 0.715 m and it was located near the G1 interface. The numerical model was applied additionally to calculate the safety factor at the end of the 2nd Stage using the popular Shear Strength Reduction technique. The safety factor of the model was reportedly 1.07.

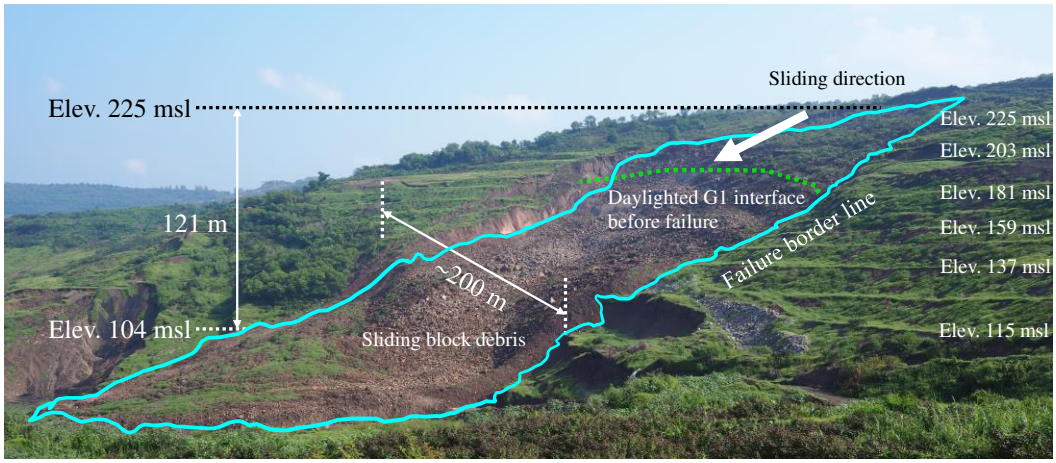
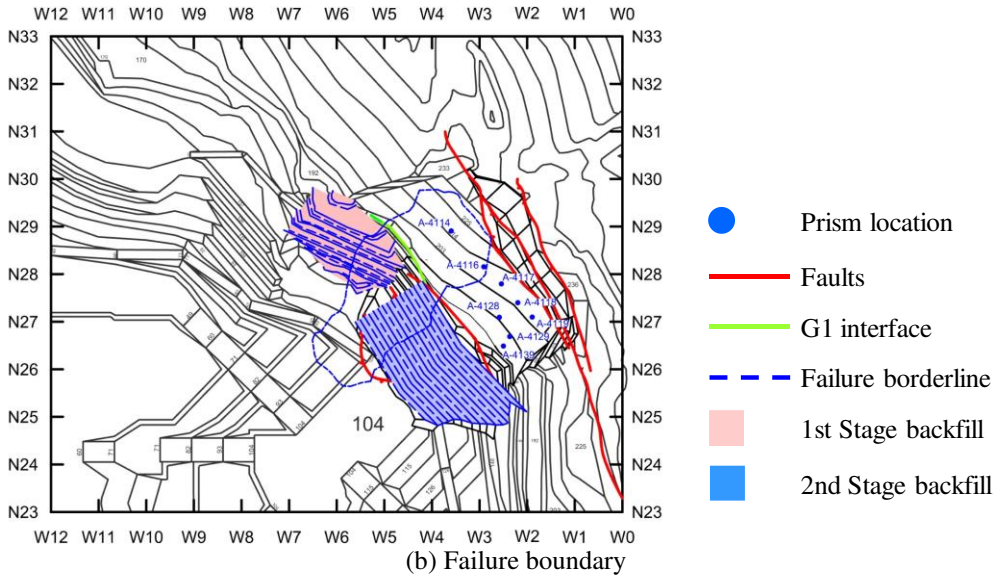
Figure 29. Area 4.1's debris after failure in October 2018.

The slope failure in the field (Figure 29) is shown as a vertical shear plane and is evidence of the rock mass failure on the side of the sliding block (side resistance), also called flank. However, the failure of the rock mass of the block was hardly captured by the numerical model in this study because of the complexity of the geologic structures in Area 4.1. In fact, the results of one case of failure would not be sufficient to confirm other unknown multiple variables. Later, Area 4.1 was treated as an abandoned mining site; therefore, there was no further investigation of this failure.

(a) Photo of Area 4.1 failure

(b) Failure boundary

To confirm the strength parameters used in the numerical analysis, further investigations of the failure would be an excellent back analysis case study. The authors plan to conduct Class C predictions (analyses taken after the construction) for the subsequent papers as water pressure in the G1 interface, which has a significant impact on the stability of undercut slopes.

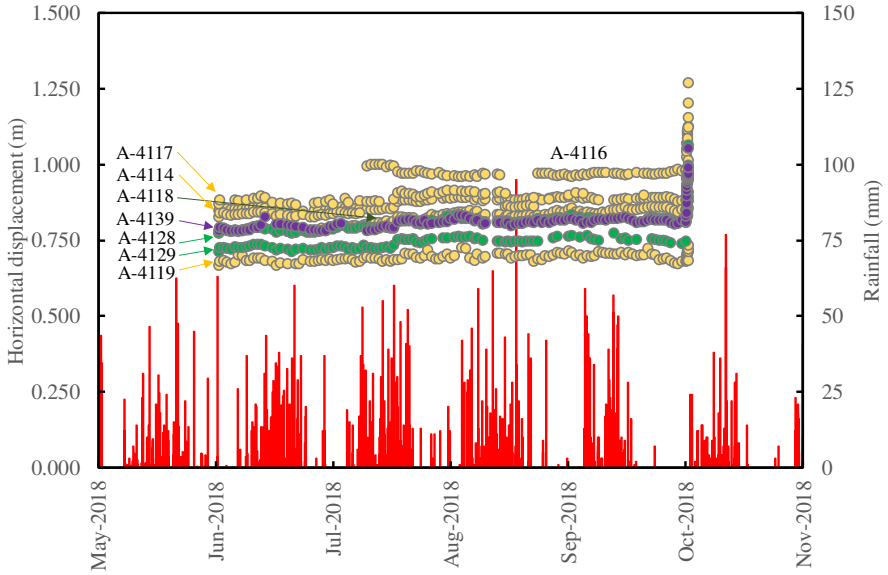
As stated earlier, the monitoring data gathered during the undercutting of the 2nd Stage was unfortunately damaged, but partially recovered. Thus, comparative data between the numerical analyses and the field measurements will be presented. The recovered monitoring data of the 2nd Stage, which were the surface displacements from eight prisms, are presented in this section. Figure 30 shows the surface displacement data between March 2015 and February 2016, and between June 2018 and October 2018.

(a) Surface displacement between March 2015 and October 2018

(b) Surface displacement before failure

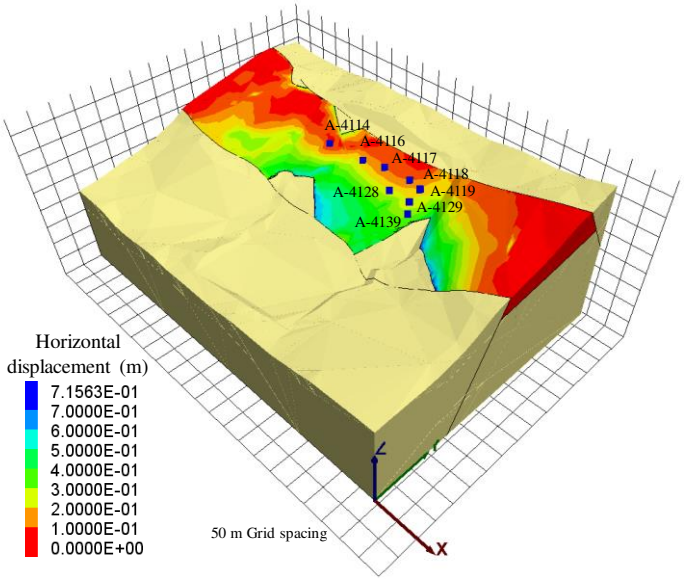
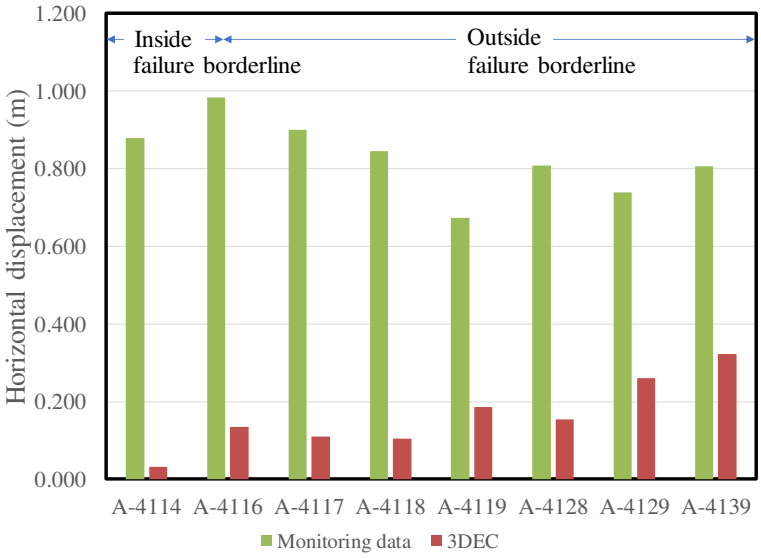
After the undercutting and before the failure, all the available surface displacement data showed that the potential sliding block had the accumulative surface displacement of approximately 1 m and rapidly displaced on the day of failure. The surface displacements from the monitoring data, one day before the failure, are plotted with the surface displacement of the numerical model of the 2nd Stage in Figure 31. The surface displacements of the numerical model were incomparable. The displacement magnitudes of the monitoring data were much larger than those of the numerical model.
