A geocomposite barrier for hydrocarbon containment in the Arctic

Bathurst, R. J., Rowe, R. K., Zeeb, B., Reimer, K. (2006), *A geocomposite barrier for hydrocarbon containment in the Arctic,* International Journal of Geoengineering Case histories, http://casehistories.geoengineer.org , Vol.1, Issue 1, p.18-34.

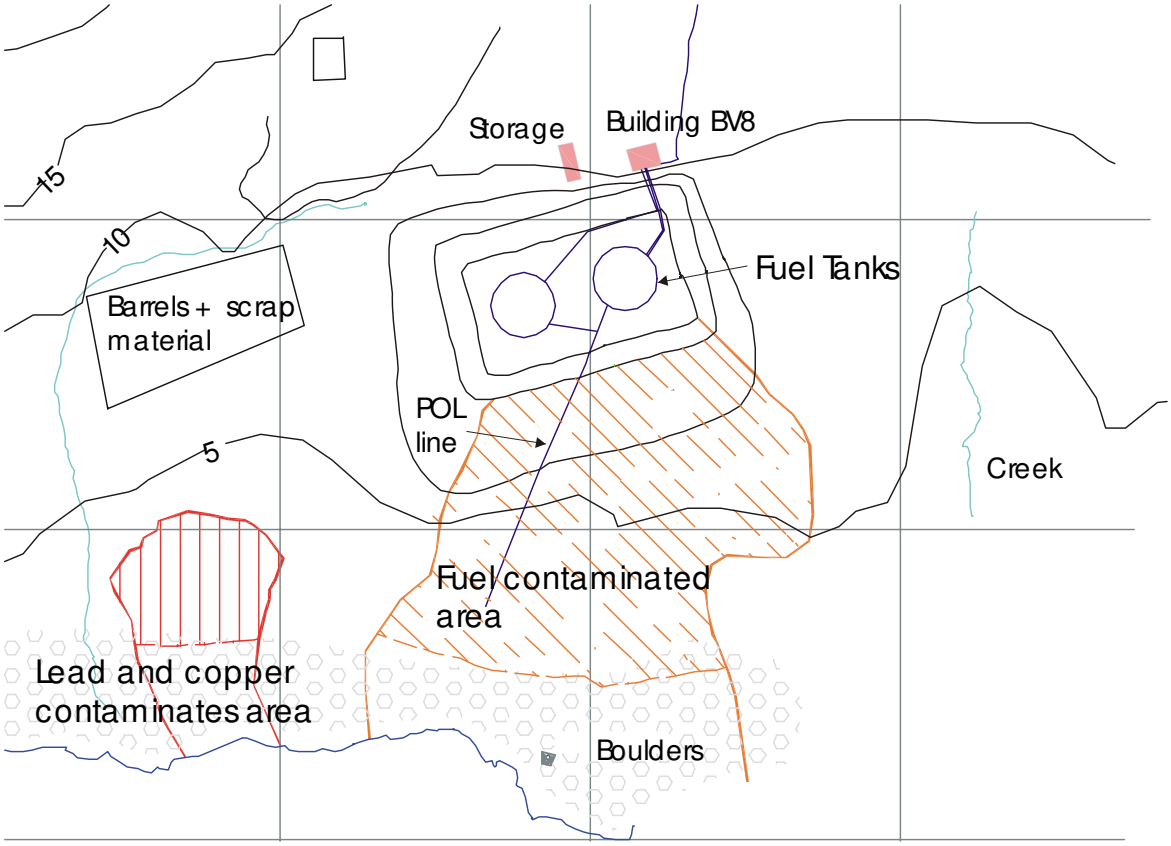
Figure 3. Plan view of fuel contaminated area.

In 2000, additional sampling was undertaken to fully delineate the area contaminated with TPH between the existing POL tanks and the ocean (Environmental Sciences Group, 2001). The goal was to collect sufficient samples to determine the lateral and vertical extent of hydrocarbon (HC) contamination, and to determine whether jet fuel was migrating towards the ocean. This necessitated collection of samples (in a grid pattern) south of the tanks, north of the ocean, and west and east to find the 'clean' line. The extent of the grid was estimated according to the results of the 1998 program, and the topography of the area, which included a boulder field immediately adjacent to the ocean. Taking into account the approximate surface area (>2500 m^2), a 12 m x 12 m grid was considered to be appropriate and given sufficient coverage to the entire area.

Complications were imposed by the predominance of large boulders; hence an opportunistic sampling strategy was adopted whereby samples were collected wherever conditions allowed given the available equipment. A small backhoe was used to dig test pits to a maximum depth of 1.8 m (depth dependent upon reaching permafrost or bedrock). Ultimately, a total of 21 test pits (providing 74 samples) were excavated, with coverage extending to within ~20 m of the ocean (i.e. to the beginning of the boulder field). Laboratory analysis indicated that although many surface soil samples were uncontaminated, most of those collected at depth had TPH levels exceeding acceptable criteria. It became apparent that fuel spilled or leaked at the tank source had migrated down-slope towards the ocean. Whether contamination had reached the bay was questionable, as the difficulty of sampling beneath the boulder field immediately adjacent to the water was impossible to overcome. The area extent of the HC-contaminated zone below and down-slope of the existing POL tank farm is illustrated in Figure 3.

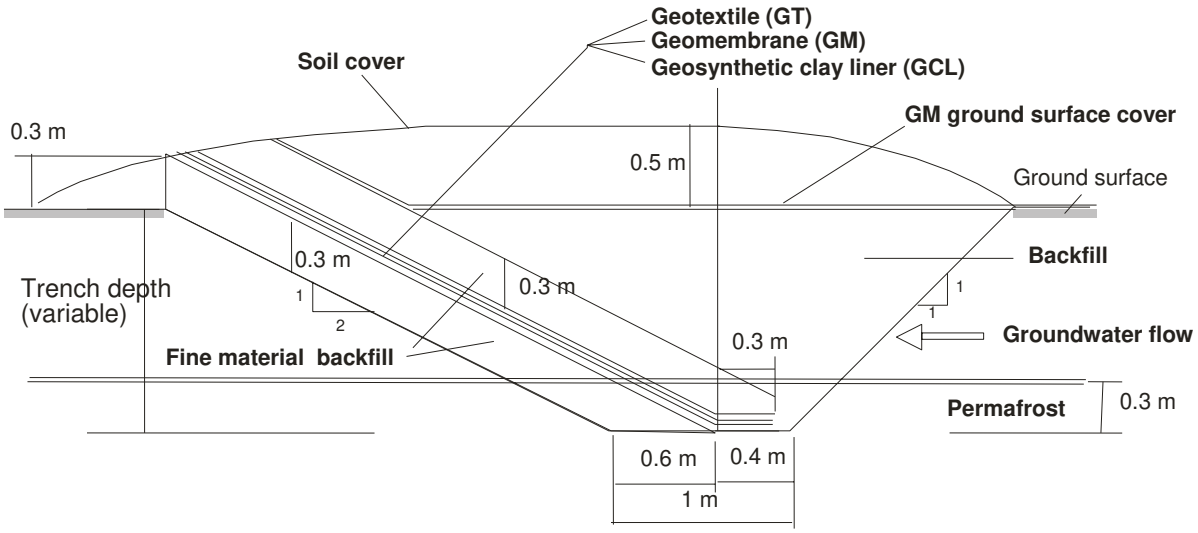
Figure 6. Installation of geosynthetic barrier system anchored in permafrost (Case 1).

Figure 6 shows the geosynthetic barrier system for the case where the bottom of the barrier is anchored in permafrost soil (Case 1) to a depth of 0.3 m. The primary barrier is an HDPE geomembrane sheet with fluorination pre-treatment supplied by Fluoro-Seal Inc. (Sangam et al. 2001; Sangam and Rowe 2005).

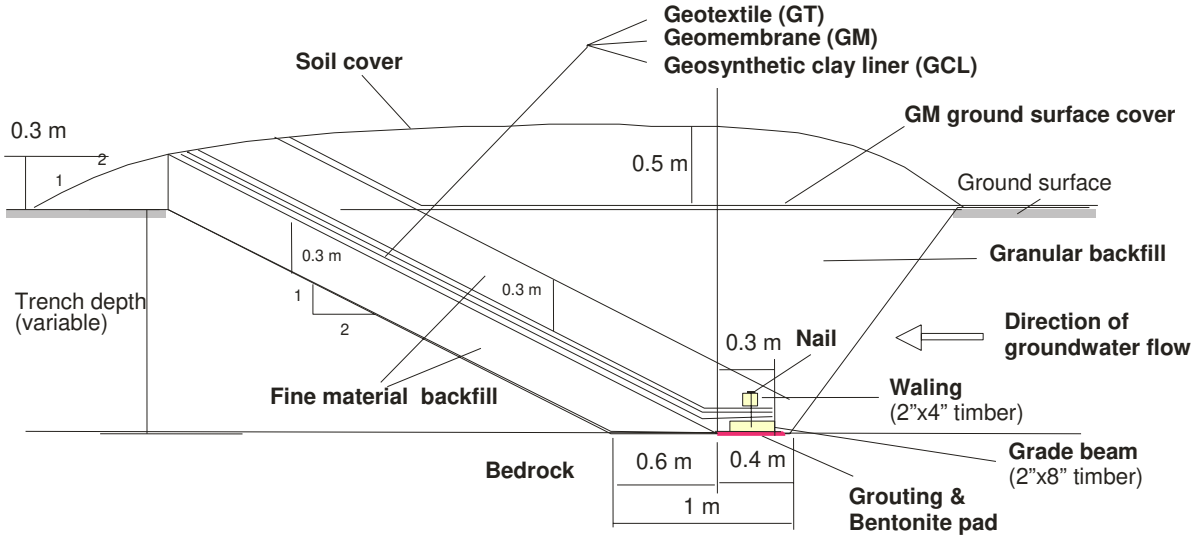
Figure 7. Installation of geosynthetic barrier system anchored to bedrock (Case 2).

The composite system was extended below the permafrost table where practicable. At locations where the excavation trench is located on bedrock, the installation scheme identified as Case 2 was used (Figure 7). The bedrock was cleaned by power washing before using bentonite powder and grout (Sika Arctic Grout) to fill rock surface voids or cracks and to seat a timber grade beam at the bedrock surface. The installation of the geocomposite liner was similar to that shown in Figure 6. Once the two liners were in place, the construction method called for a timber waling to be placed over the geocomposite liner and nailed through to the timber grade beam to secure the bottom end of the barrier. Once buried, water

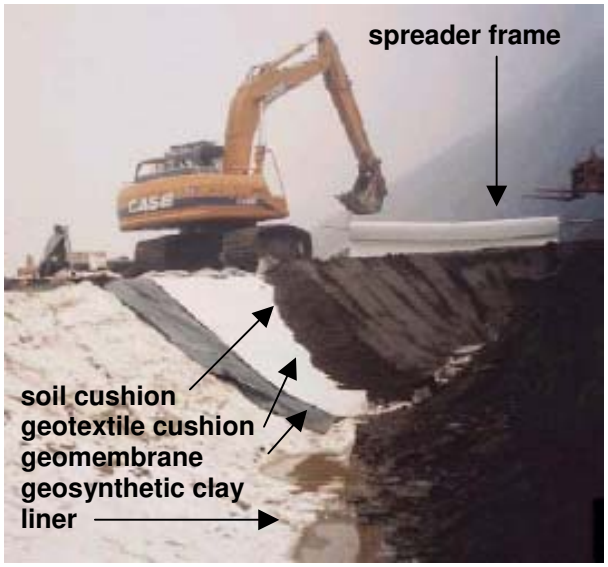
Figure 8. Photograph showing installation and arrangement of liner system components.

The upstream side of the HDPE is protected from the granular backfill by a needle-punched nonwoven geotextile (550 g/m^2) cushion. The down-stream side of the barrier is a needle-punched nonwoven geosynthetic clay liner (GCL). The GCL product (Bentofix Thermal Lock "NWL") has a bentonite mass of 3.66 kg/m^2, hydraulic conductivity of 5x10^{-11} m/sec, and internal shear strength of 24 kPa (typical peak value for specimen hydrated for 24 hours and sheared under 10 kPa normal stress in accordance with ASTM D6243). The swell index of bentonite is 24 ml/2g minimum following ASTM D5890. Loose granular bentonite was placed between panels at a rate of about 400 g per linear m of seam and overlapped by 150 mm. The HDPE and GCL panels were placed using a spreader frame (Figure 8).

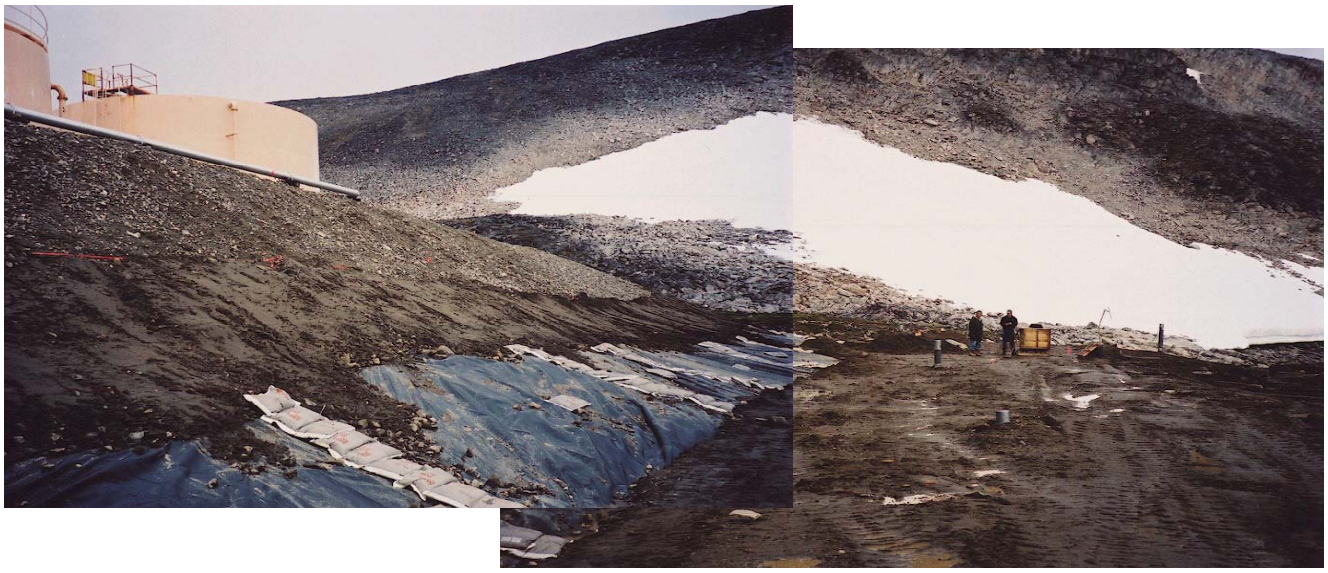
Figure 9. Photograph showing geomembrane cover sheet placed over and upstream of the geocomposite barrier.

After the geosynthetic barrier was in place, the liner system was then covered with a 0.3 m-thick layer of minus 50 mm gravel. This construction stage is illustrated in the photograph in Figure 8. Next, the trench was backfilled using the excavated materials and the ground surface graded and covered by a low weight pre-seamed scrim-reinforced polyethylene geomembrane (Layfield RPE 25) with a thickness of 0.51 mm and a tensile strength of 1,510 N. The boundaries of the cover sheet were anchored into a 1 to 1.5 m-deep trench and ballasted using on-site backfill and sand bags to prevent wind uplift (Figure 9). The cover sheet extended to the downstream side beyond the excavation and below the backfill mound covering the barrier installation. The cover sheet was intended to minimize infiltration from rainfall and snowmelt into the contaminated zone upgradient of the barrier system.

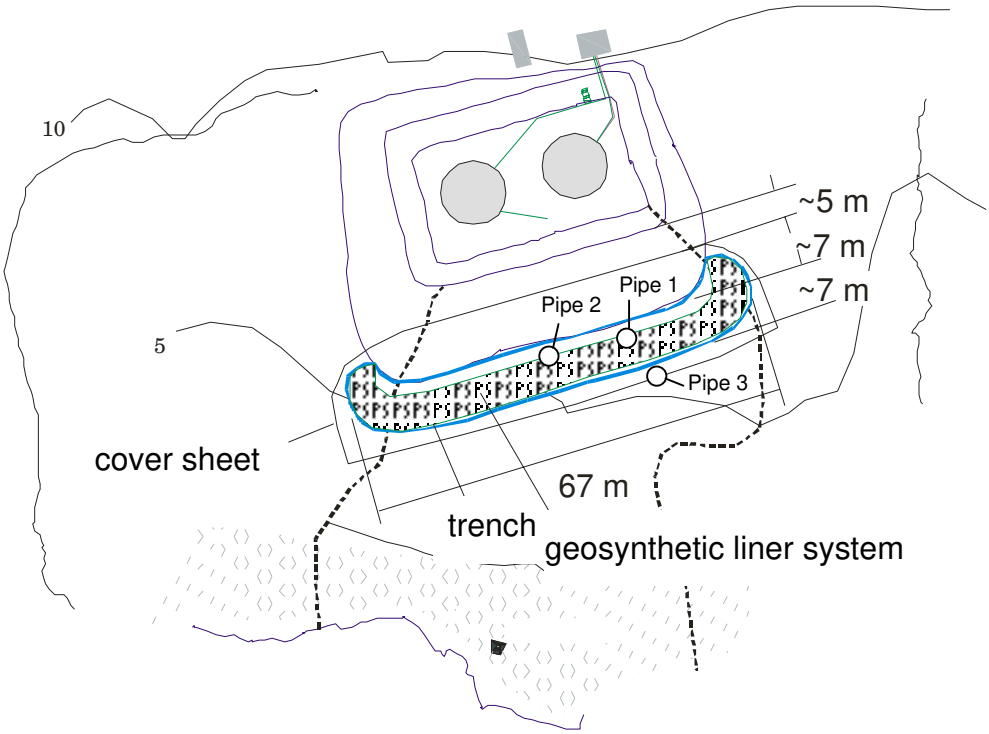
Figure 10. Plan view of containment barrier system location and instrumentation pipe locations.

The final trench was excavated in a single straight length about 67 m long with shorter curved sections at each end to bring the barrier trench into contact with the tank farm berms. The location of the trench was dictated by ground conditions that prevented the barrier system from being placed in the boulder field identified in Figure 3. The final alignment is shown in Figure 10. The consequences of the lack of geotechnical data available at the design stage of this project became apparent at the beginning of construction. The depth to permafrost was discovered to be up to 2.6 m deep, significantly greater than the average 1.5 m assumed at the time of the design. The increased depth is believed to be due to the proximity of the trench to the ocean and the large depth of fill that had been placed at the site during site leveling to accommodate the new tank farm. The deeper excavation led to a 73% increase in the amount of the geosynthetic materials required. The demand for minus 50 mm gravel (cushion) was also greatly increased. Shortening of the original trench length and careful management of the quantity of construction materials was required to ensure that there were sufficient geosynthetic materials to build the barrier system.

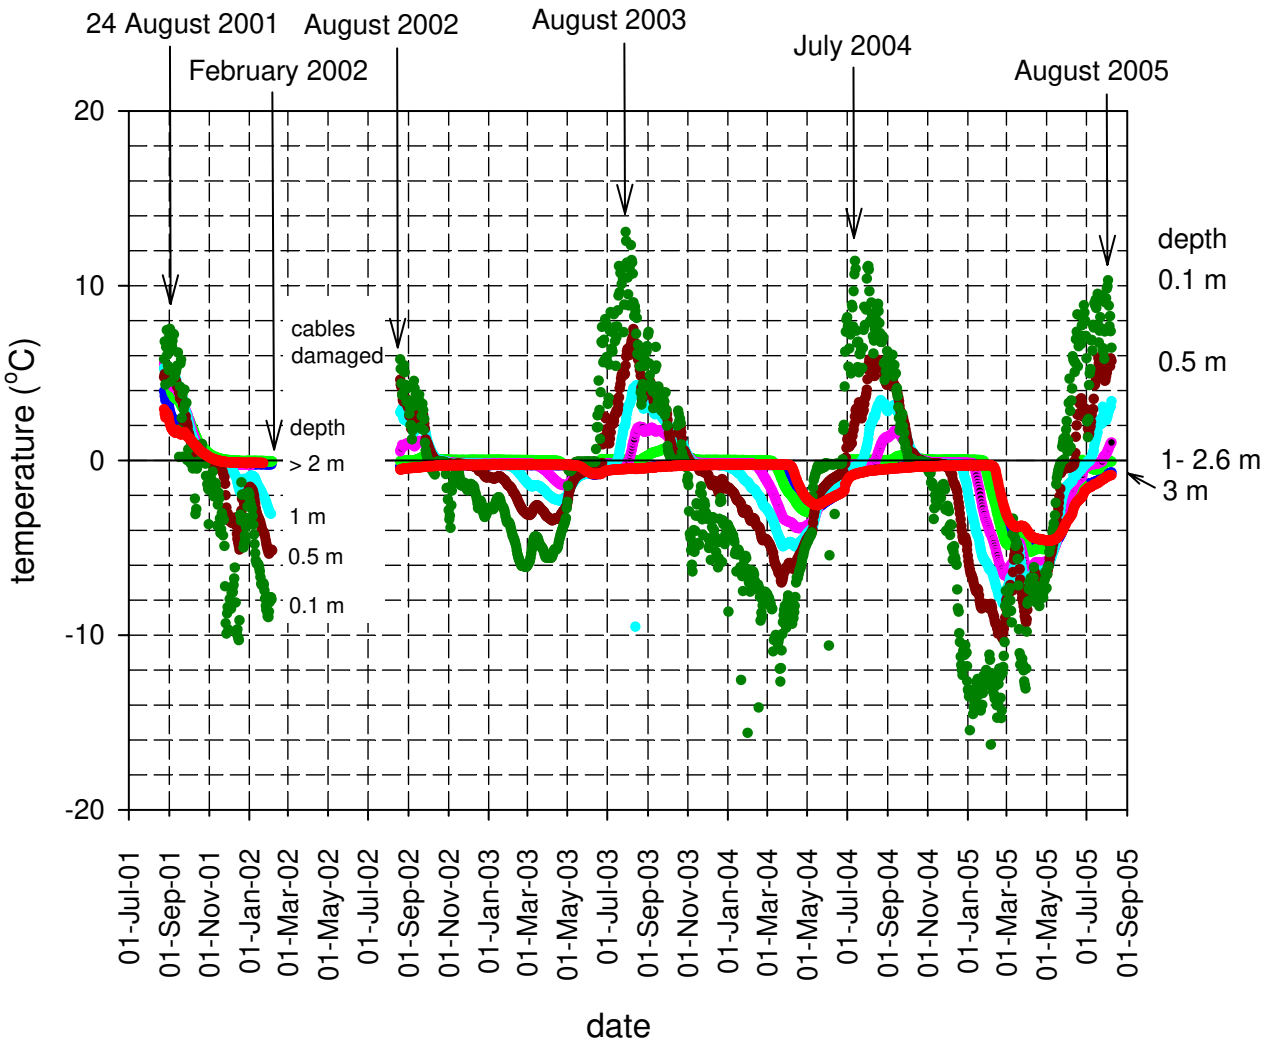
Temperature-time records from thermocouples placed in one of the instrumentation pipes immediately upstream of the barrier are shown in Figure 12. The gap in the records is due to severing of the cables by wildlife at the site in early 2002. The cables were repaired the following summer. Based on the data available, the ground temperatures at a given depth are lower in the winter of 2004-05 than the preceding winters. For monitoring points below a 2 m depth, temperatures are persistently below freezing based on the data available. This point is explored further by plotting temperature profiles from the same installation corresponding to the time of barrier installation and at selected times during the summers of 2003, 2004, and 2005 (Figure 13). The data show that freeze-back has occurred to an elevation well above the base of the original trench. The piezometers located close to the base of the barrier were frozen and hence measurement of the groundwater table behind the barrier was not recorded.

Figure 12. Example temperature-time histories from thermocouples located in Pipe 1 (upstream of barrier).

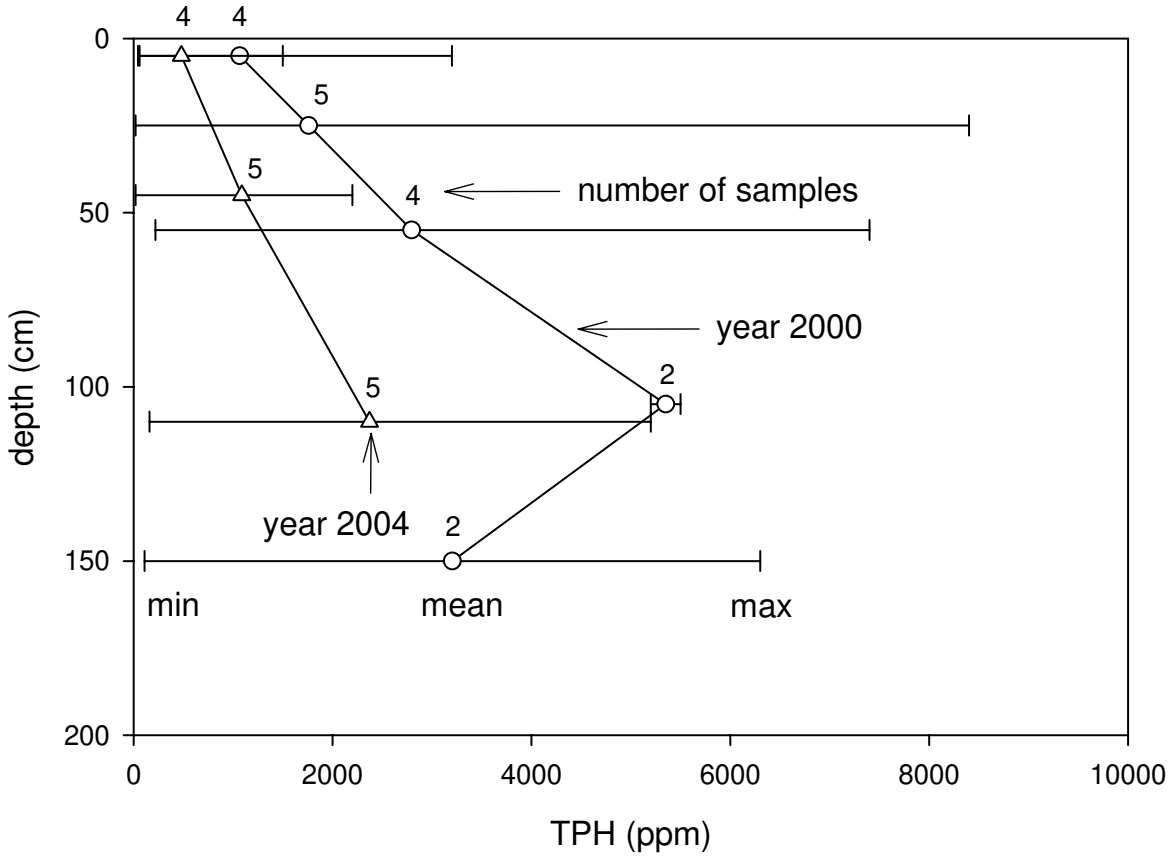
Data from the year 2000 TPH sampling program described earlier in the paper are plotted in Figure 14 together with data gathered in the summer of 2004. The data points are for samples recovered downstream of the barrier system only. As in the initial program, the test pits used to retrieve soil samples in the summer of 2004 were put down at opportunistic locations dictated by the distribution of large boulders at and below the ground surface. The data, although subject to the expected variability, shows that the highest TPH concentrations are at a depth that likely corresponds to the location of the undisturbed permafrost level. This supports the notion that subsurface hydrocarbon migration was bounded by the permafrost table at the site. It appears that the general trend of increasing mean TPH levels with depth is preserved for both data sets. However, statistical analysis of the mean TPH concentrations indicates that the levels in 2004 are about 50% of the values determined prior to the installation of the barrier system. This decrease is probably due to a combination of volatilization, natural attenuation, and dispersal; it does, however, indicate that at least in the short term, the source has been effectively isolated.

Figure 14. TPH measurements taken downstream of the barrier system before and after installation

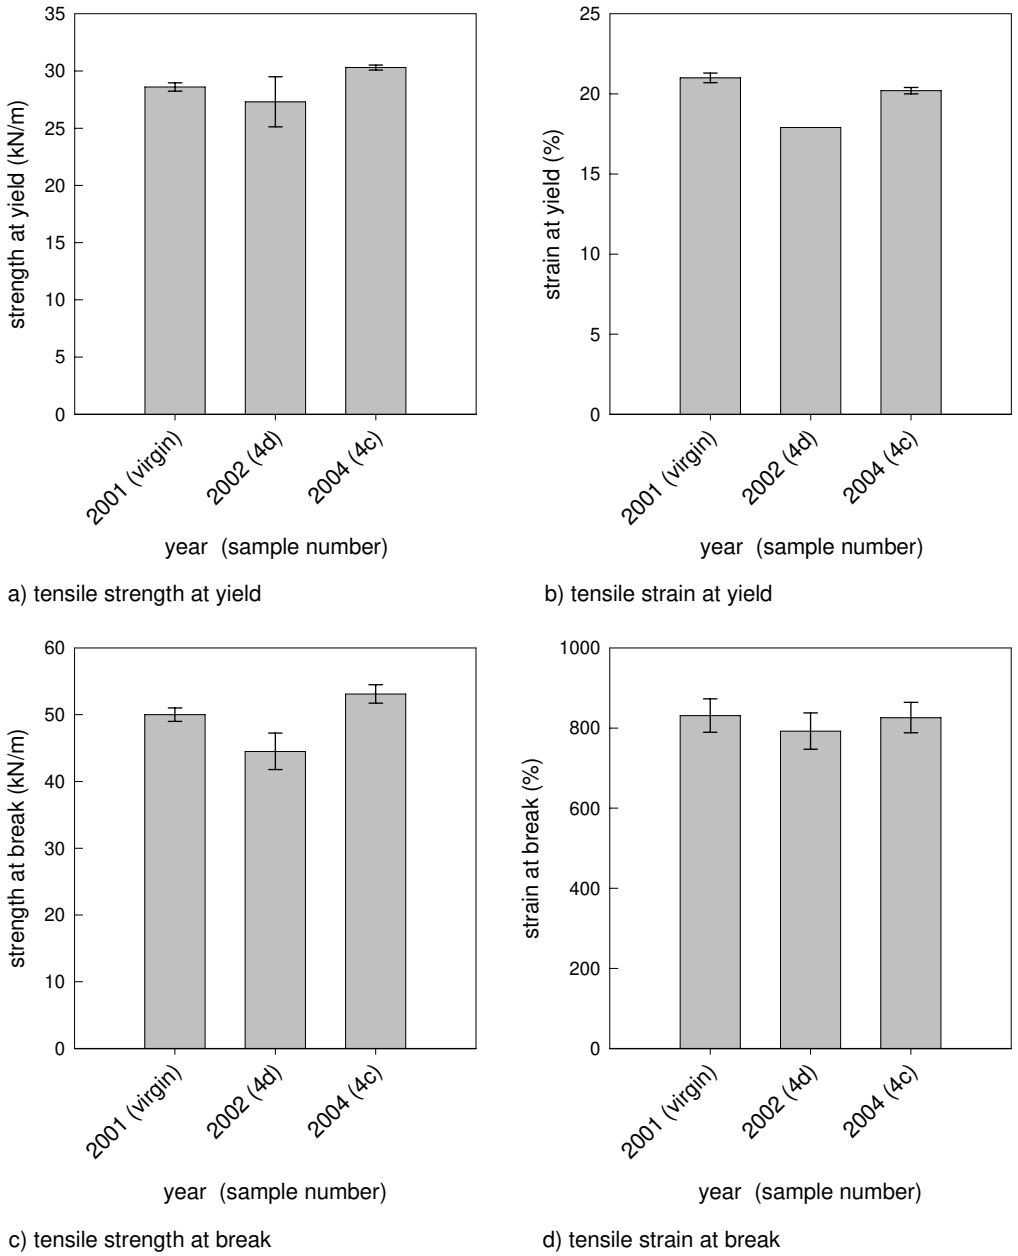
Conventional tensile tests carried out in accordance with ASTM D6693 and a displacement rate of 50 mm/min have been performed on archived and exhumed specimens of the 1.5 mm-thick fluorinated geomembrane material used at the Brevoort site. Tensile strengths at break and yield together with corresponding strain values are reproduced in Figure 15. Based on the data available there is no indication of a systematic and significant change in the index tensile properties of the f-HDPE geomembrane since installation.

Figure 15. Mechanical load-strain properties of virgin and exhumed 1.5 mm-thick fluorinated HDPE geomembrane samples. Notes: 5 specimens per sample; error bars represent ±1 standard deviation.
