# Geological Engineering Reconnaissance of Damage Caused by the October 15, 2006 Hawaii Earthquakes

**Edmund W. Medley**, *Senior Consultant, Geosyntec Consultants Inc., Oakland, CA, USA, Email: emedley@geosyntec.com*

**ABSTRACT**: *Two strong earthquakes shook the Island of Hawaii, Hawaii on the morning of October 15, 2006. Peak Ground Accelerations reached 1.2g, and earthquake felt intensity of MMI VIII. Earthquake damage of public and private property totaled about $200 million, with no fatalities. Geological engineering reconnaissance of earthquake damage resulting from the earthquakes focused on the apparent relationships between the observed geology and the damage. Some roadway embankments failed causing temporary closure of Island highways. Landslides were common at steep coastal cliffs. Liquefaction and lateral spreading occurred in coralline fill at Kawaihae Harbor. There were extensive road cut failures, in which the performance of road cuts in soil slopes was generally better than that of rock slopes. Where a'a clinker underlay massive a'a basalt blocks in road cut slopes, the loose clinker dislodged thereby undermining the blocks, and causing failures that blocked imp

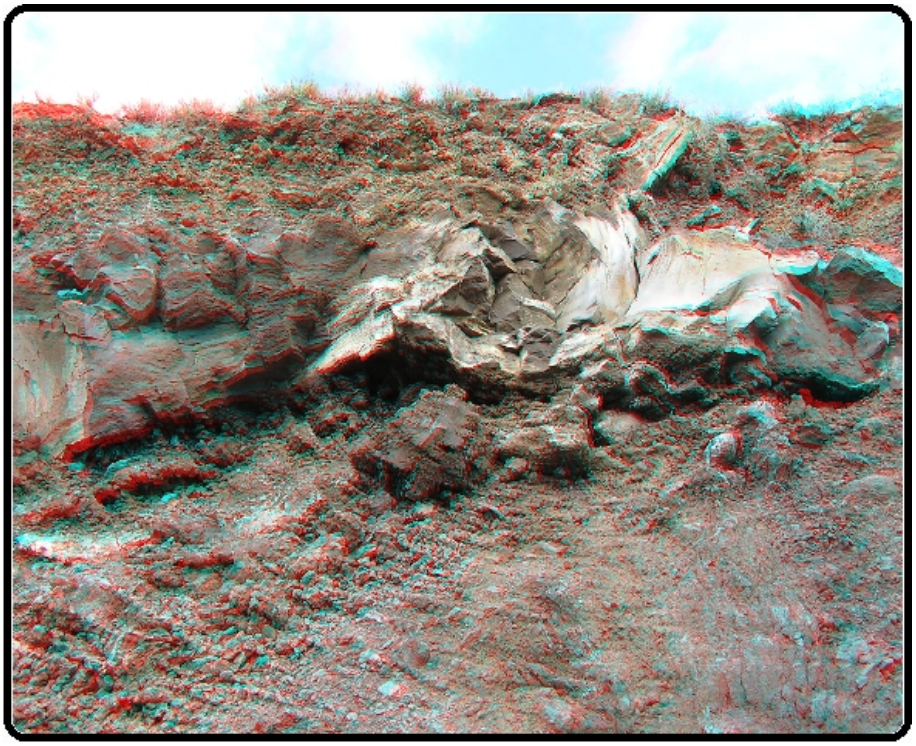
*Figure 12. Location 2, near Kohala Ranch Estates, Hwy 270. View from road of excavation in mixed massive a'a and clinker. See stereo 3-D photographs of Figure 13 and Figure 14.*

*Figure 13. Location 25, near Kohala Ranch Estates, Hwy 270. 3-D stereo pair version of Figure 12. Road cut in mixed massive a'a and clinker.*

*Figure 14. Location 2, near Kohala Ranch Estates, Hwy 270. Anaglyph 3-D image version of Figure 12. Road cut in mixed massive a'a and clinker.*

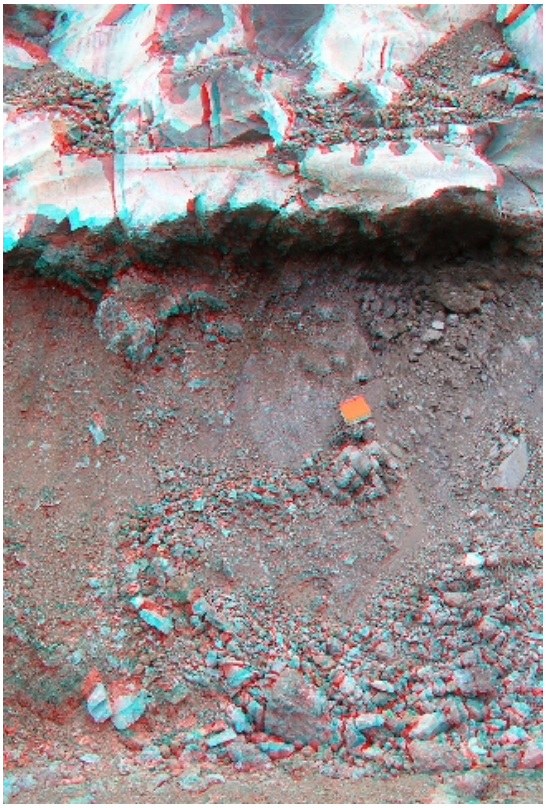
*Figure 15. Location 25, Hwy 270 north of Kawaihae. Cantilevered block of massive a'a basalt, undermined by clinker that raveled during the earthquakes. See 3-D stereo images of Figure 16 and Figure 17.*

*Figure 16. Location 25, Hwy 270 north of Kawaihae. 3-D stereo pair version of Figure 15. Cantilevered block of massive a'a basalt, undermined by clinker that raveled during the earthquakes.*

*Figure 17. Location 25, Hwy 270 north of Kawaihae. 3-D anaglyph stereo version of Figure 12. Cantilevered block of massive a'a basalt, undermined by clinker that raveled during the earthquakes.*

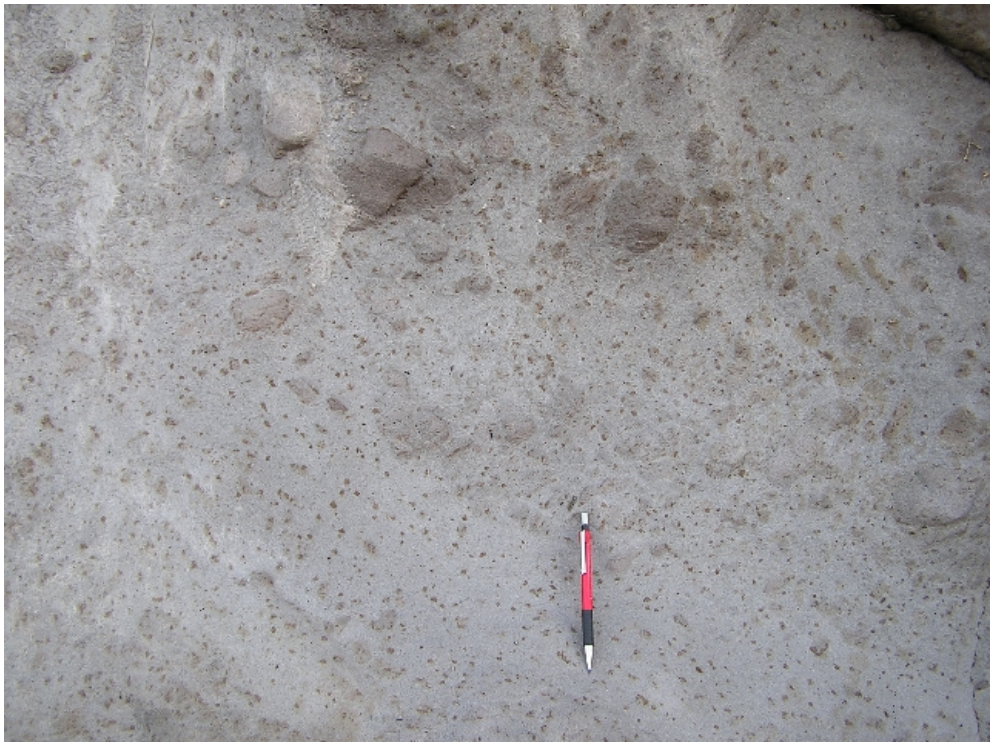
*Figure 22. Location 13, Milepost 8, Hwy 250. Road cut in a pyroclastic assemblage of ash and other volcanic debris.*

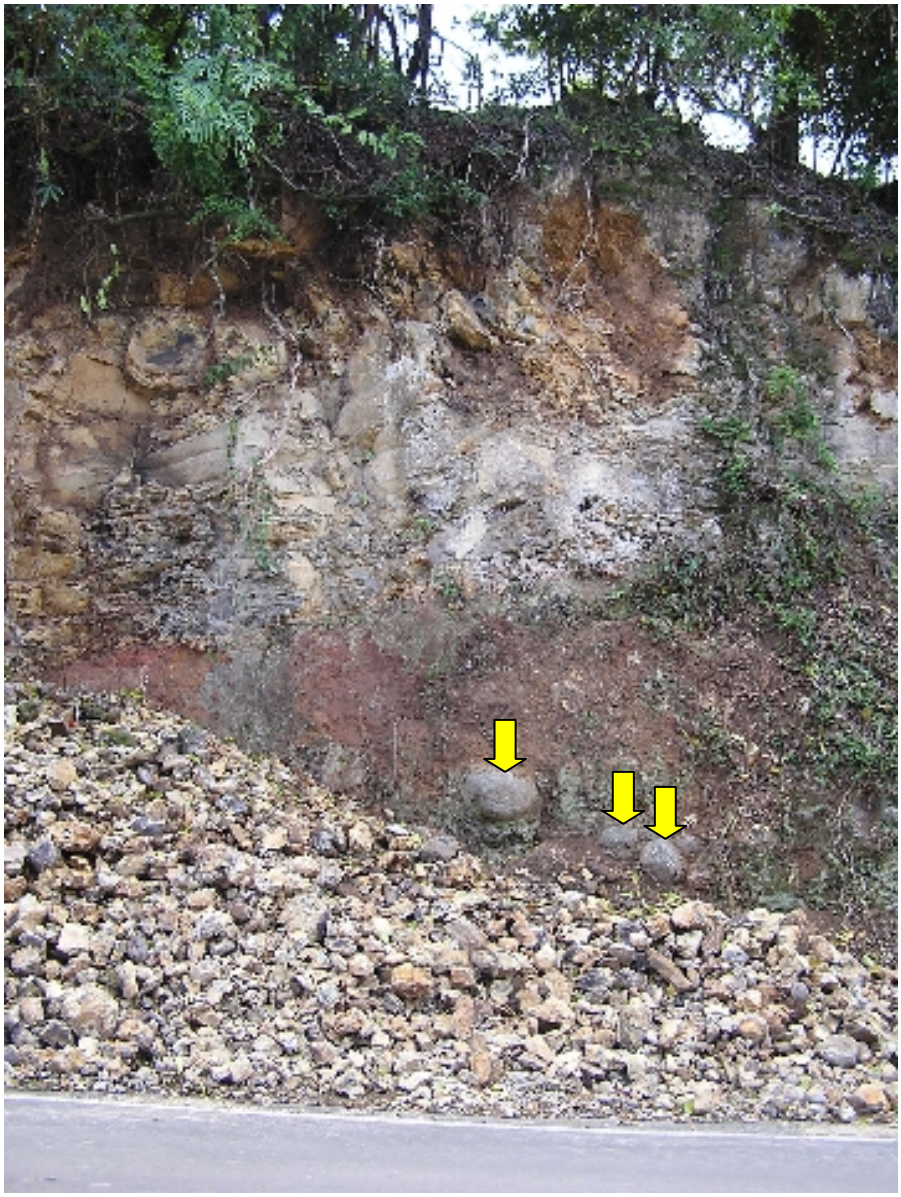
*Figure 24. Location 18, Hwy 270 at Makapala. Failure (pile of rock fragments at front) of stronger rock underlain by baked zone soil, with weathered corestone boulders (arrowed).*

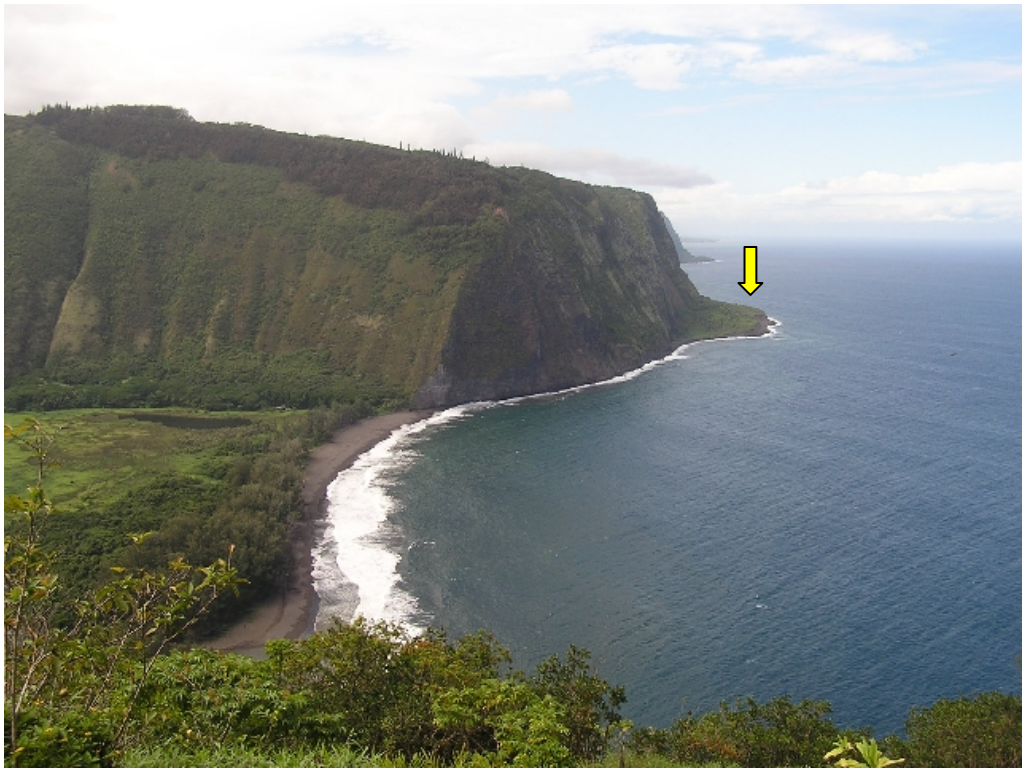
*Figure 31. Location 8, Waipi'o Valley cliffs. Debris from an older slide (arrow) intrudes into the sea in the background. Scars in the closer, truncated spur are apparently not a result of the earthquakes since the water is not muddy.*

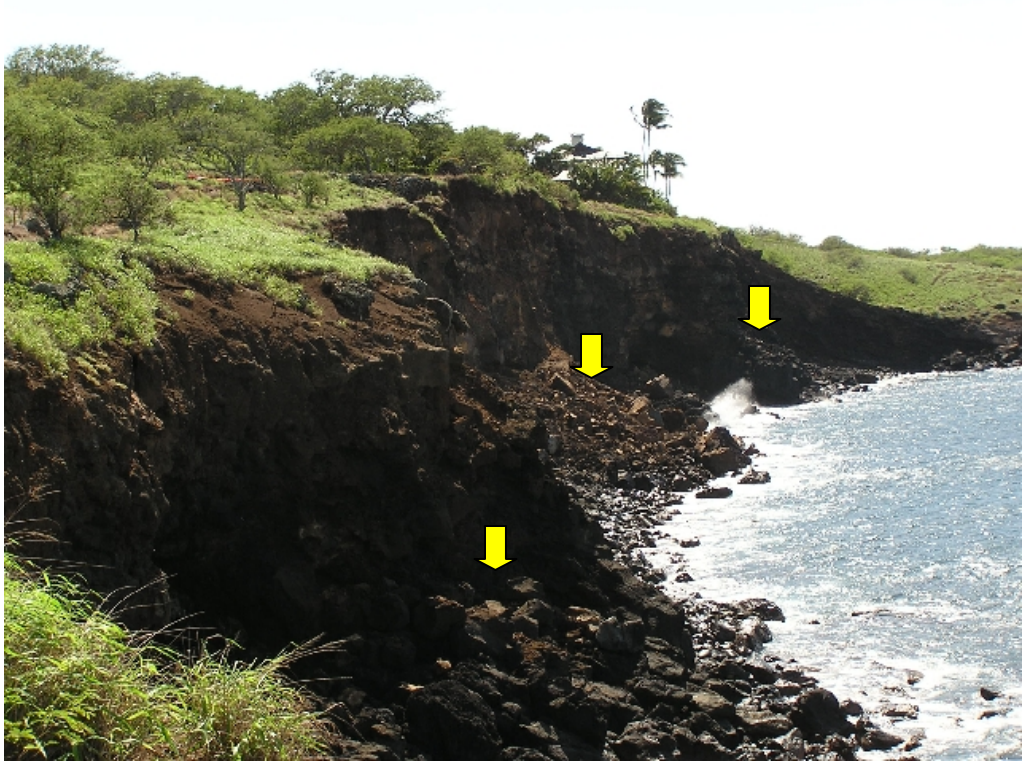
*Figure 34. Location 23, failed cliffs (arrowed) south of Honoipu Landing (Ala Kuakini Trail).*

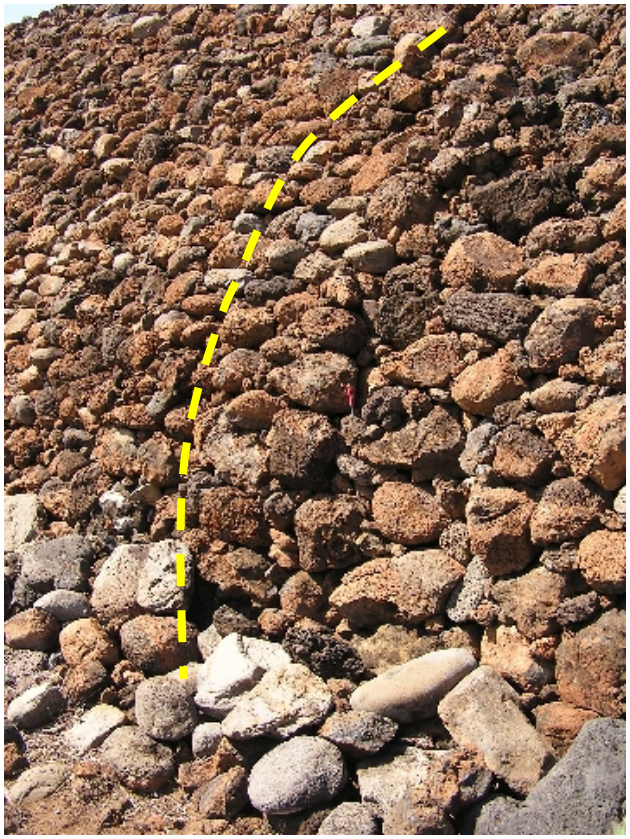
| Sta. | Location | Lat. (N degs) | Long. (W degs) | Feature | Comments |
|---|---|---|---|---|---|
| 29-2 | Pu'ukoholā heiau: east side, NE corner | 20.0279 | -155.8213 | Failures of stacked rock block slopes | East side and NE corner, major bulging, slumping and raveling failures |

*Figure 53. Location 29, NE corner Pu'ukoholā Heiau. Bulging of rock face approaches 90 degree inclination as indicated by yellow line. Bulge is clearly seen in 3-D stereo versions of Figure 54 and Figure 55.*

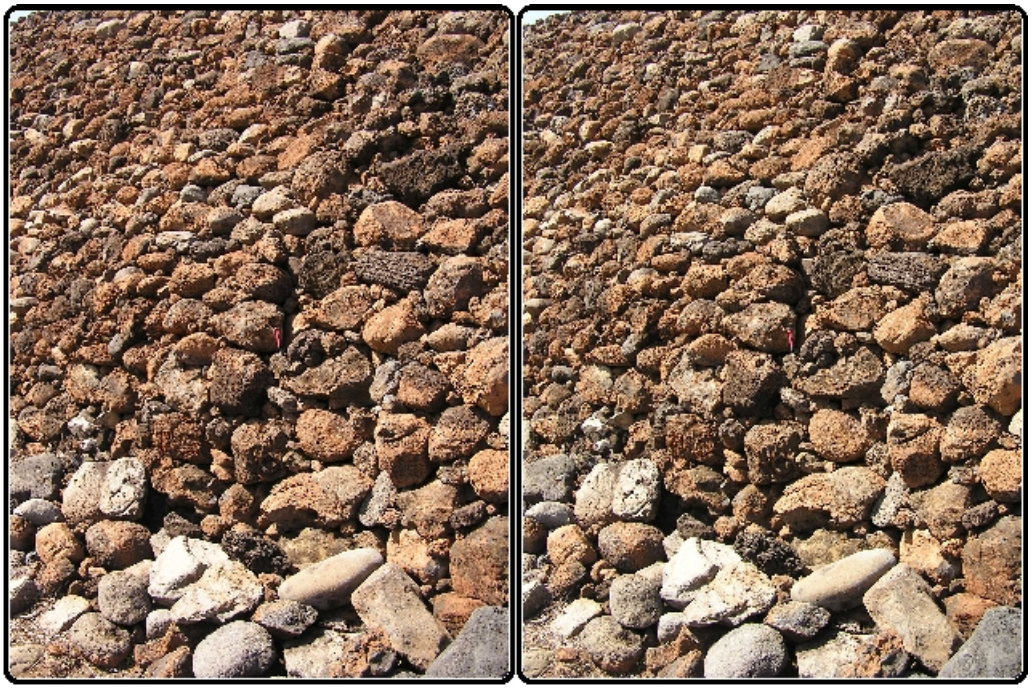
*Figure 54. Location 29, bulge at NE corner of Pu'ukoholā heiau. 3-D stereo pair version of Figure 53.*

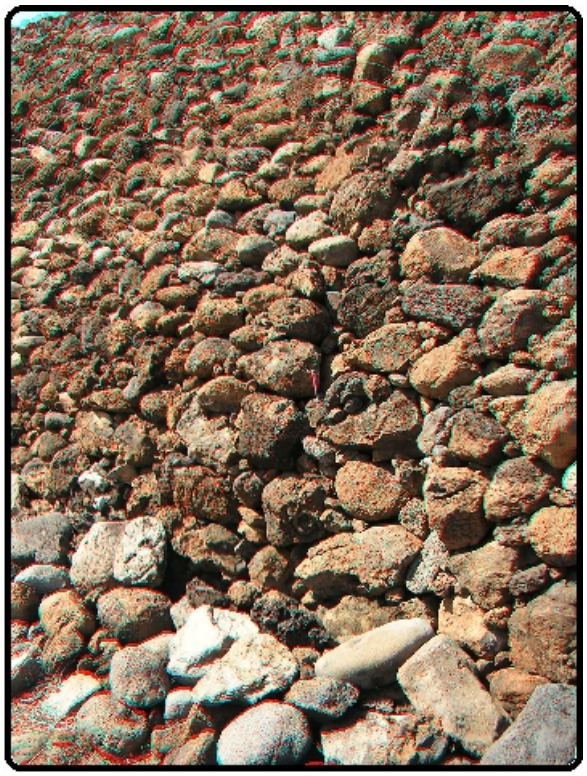
*Figure 55. Location 29, bulge at NE corner of Pu'ukoholā heiau. 3-D anaglyph stereo version of Figure 53.*

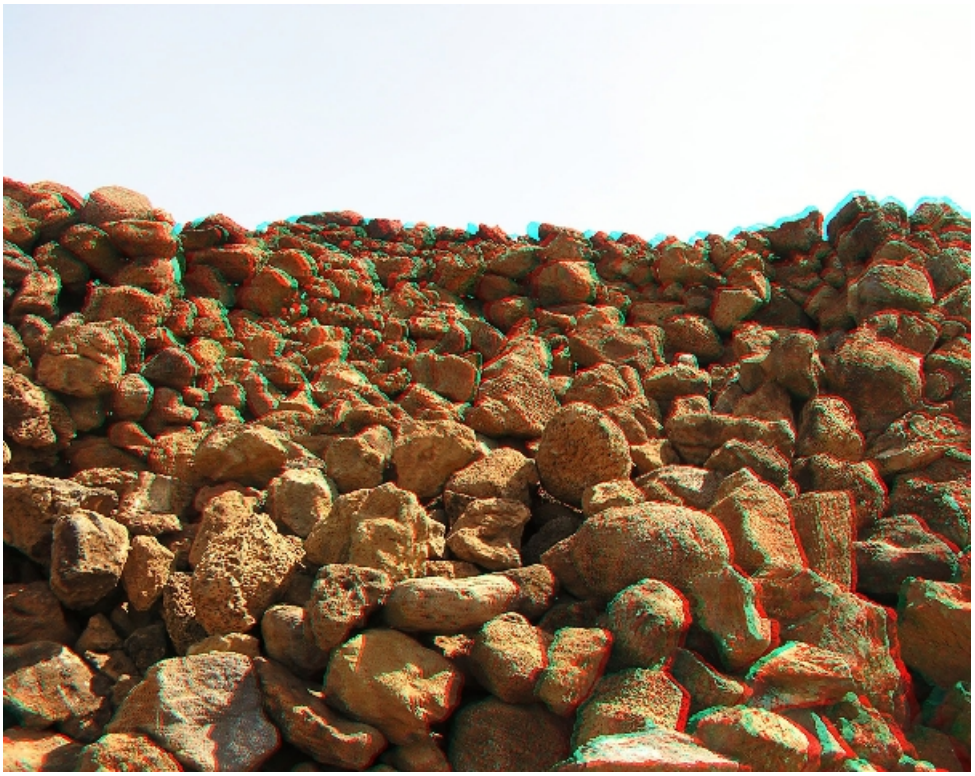
| Sta. | Location | Lat. (N degs) | Long. (W degs) | Feature | Comments |
|---|---|---|---|---|---|
| 29-4 | Pu'ukoholā heiau west side heiau, SW and NW corners | 20.0276 | -155.8217 | Failures of stacked rock block slopes | West side, SW and NW corners: slumping and bulging failures |

*Figure 57. Location 29, slump failure in high rock wall of Pu'ukoholā heiau, west side.*
*See 3-D stereo images of Figure 58 and Figure 59.*

*Figure 59. Location 29, slump failure in high rock wall of Pu'ukoholā heiau, west side. 3-D anaglyph stereo version of Figure 57.*

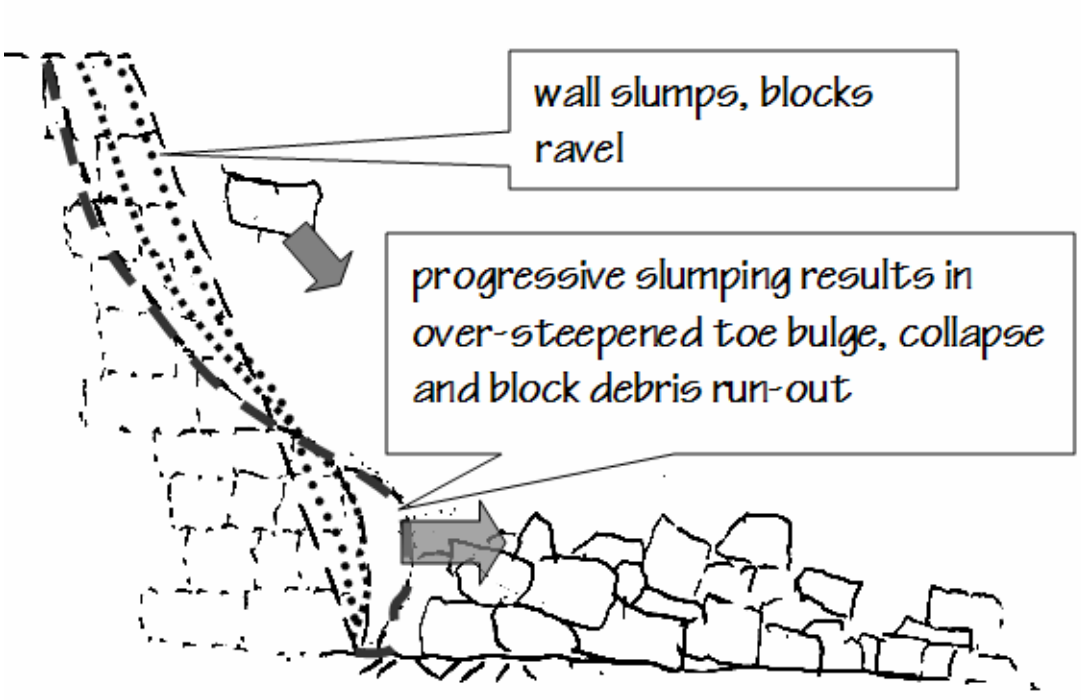
*Figure 60. Raveling, bulging and slumping of the face of a rock block edifice (Medley and Zekkos, 2007).*

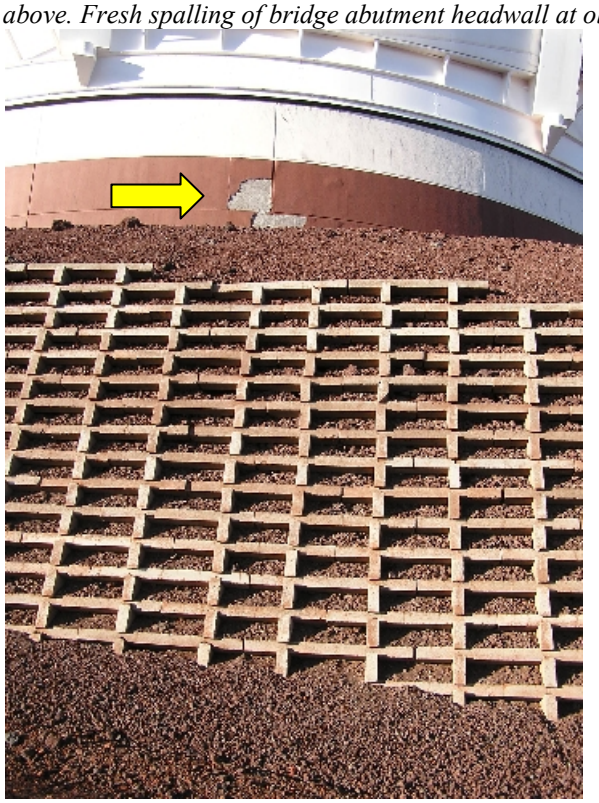
| Sta. | Location | Lat. (N degs) | Long. (W degs) | Feature | Comments |
|---|---|---|---|---|---|
| 28 | Mauna Kea Keck Observatory | 19.8260 | -155.4747 | Structure damage, | Some damage observed to stucco at Keck Observatory; none obvious at adjacent high crib retaining wall. |

*Figure 67. Location 28, Keck Observatory, Mauna Kea summit. No apparent distress to high embankment beside the observatory. Spalled stucco evident at two places on the exterior wall of the building (one arrowed).*
