Leaning Tower of Pisa: Behaviour after Stabilization Operations

KEYWORDS: Leaning Tower of Pisa, leaning instability, stabilization works

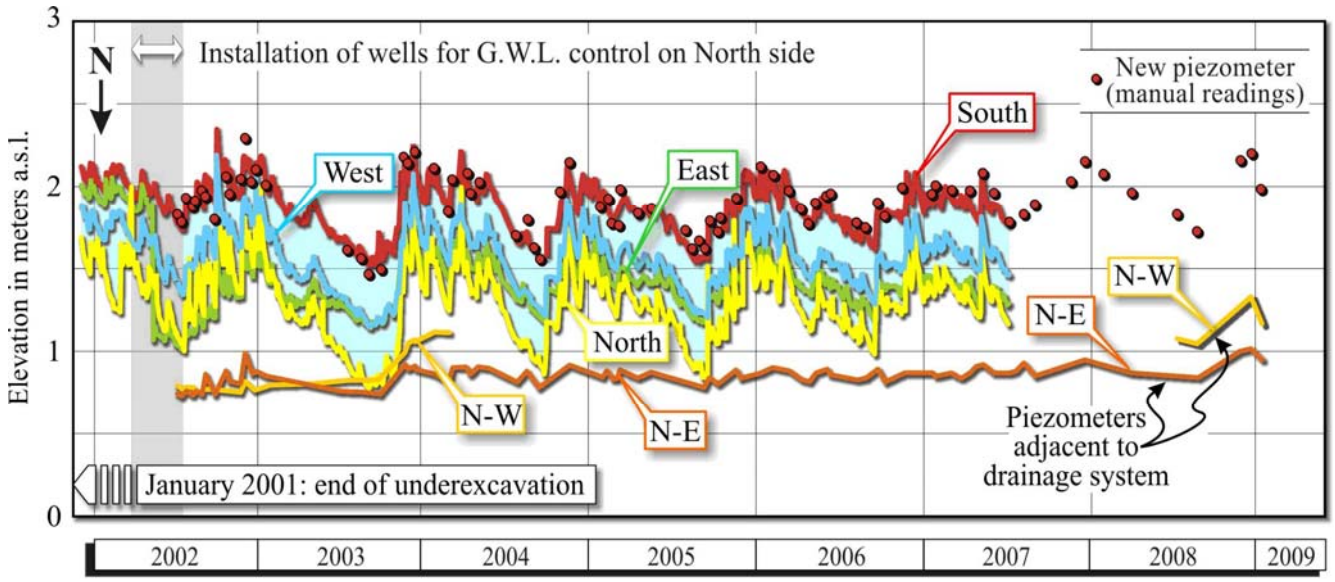
Figure 14. Perched ground water table in horizon "A".

As mentioned previously, the deduced motion of the Tower foundation shown in Fig. 5 led to the conclusion that the seasonal fluctuating water table in Horizon A during intense periods of rain was the main factor responsible for this continuing movement, see Fig. 6. It is also of significance that, apart from these intense periods of rain, the average ground water levels close to the South side of the Tower in Horizon A are 200mm to 300mm higher than those to the North, as shown in Fig. 6. This difference generates a small, but not negligible stabilising moment for the Monument which is so close to falling over. In the autumn and winter, when rainfall events are more intense, the water table rises sharply, reduces the difference in piezometric level and thereby produces southward rotations of the Tower which are not fully recoverable. To minimise this effect it was necessary to eliminate the fluctuations of the water table and, with this objective, a drainage system was installed consisting of three wells sunk on the north side with radial sub-horizontal drains running into them from beneath the north side of the catino, (Fig. 13). The water levels in the wells are controlled by the level of the outlet pipes. The drainage system was implemented in April and May 2002 and lead to a decrease in the pore water pressure as well as a significant reduction in its seasonal fluctuations, as shown in Fig. 14. The installation of this drainage system induced a further northward rotation of the Tower as can be seen in Fig. 15.
