Leaning Tower of Pisa: Behaviour after Stabilization Operations

John B. Burland, *Emeritus Professor of Geotechnical Engineering, Imperial College London; email: j.burland@imperial.ac.uk*
Michele B. Jamiolkowski, *Emeritus Professor of Geotechnical Engineering, Technical University of Torino; email: michele.jamiolkowski@polito.it*
Carlo Viggiani, *Professor of Geotechnical Engineering, University Federico II, Napoli; email: viggiani@unina.it*

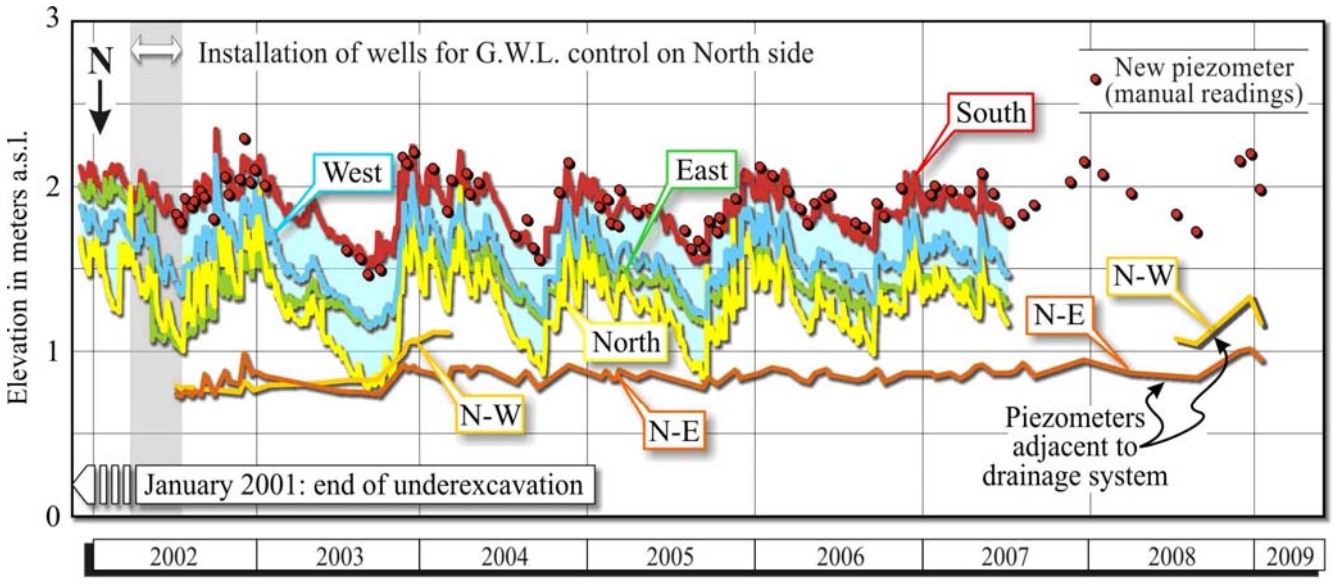
Figure 14. Perched ground water table in horizon "A".

As mentioned previously, the deduced motion of the Tower foundation shown in Fig. 5 led to the conclusion that the seasonal fluctuating water table in Horizon A during intense periods of rain was the main factor responsible for this continuing movement, see Fig. 6. It is also of significance that, apart from these intense periods of rain, the average ground water levels close to the South side of the Tower in Horizon A are 200mm to 300mm higher than those to the North, as shown in Fig. 6. This difference generates a small, but not negligible stabilising moment for the Monument which is so close to falling over. In the autumn and winter, when rainfall events are more intense, the water table rises sharply, reduces the difference in piezometric level and thereby produces southward rotations of the Tower which are not fully recoverable. To minimise this effect it was necessary to eliminate the fluctuations of the water table and, with this objective, a drainage system was installed consisting of three wells sunk on the north side with radial sub-horizontal drains running into them from beneath the north side of the catino, (Fig. 13). The water levels in the wells are controlled by the level of the outlet pipes. The drainage system was implemented in April and May 2002 and lead to a decrease in the pore water pressure as well as a significant reduction in its seasonal fluctuations, as shown in Fig. 14. The installation of this drainage system induced a further northward rotation of the Tower as can be seen in Fig. 15.
