Reconstruction of Konstantinovsky Palace in a Suburb of Saint Petersburg

ABSTRACT: *This article describes a complex approach to the condition survey and design executed as part of the remedial works on Konstantinovsky palace in the suburb of Strelna (Saint Petersburg)--one of the most beautiful historic monuments of 18th century Russia. The palace was almost completely destroyed in the 1940s. In 2000 the decision was made to reconstruct the palace, and the project for palace reconstruction was developed. The project was completed in 2003. The following important stages of the project are discussed in this paper: palace condition survey and site investigations, analyses of the palace retaining structures, design project of palace reconstruction, and phases of the remedial works.*

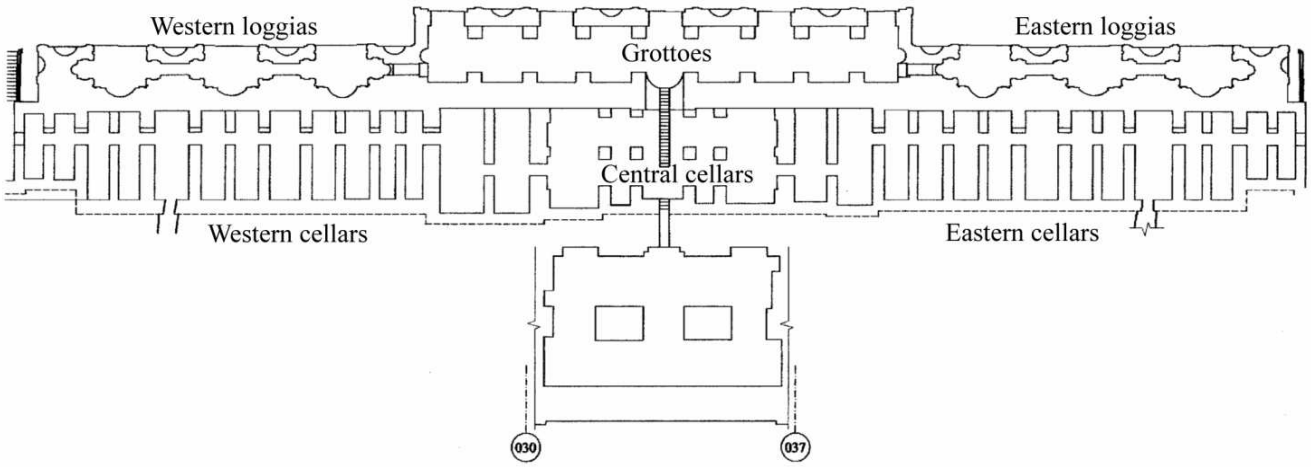
Figure 3. Plan of cellars, grottoes, and loggias of Konstantinovsky Palace.

Symmetrically on each part of the central grotto there are 3 loggias (see Fig. 3 and 4). The gable wall for both the grottoes and the loggias is the actual retaining wall. The loggias retaining wall contains half-sphere niches forming the volume of every loggia. In these locations the retaining wall is especially thin (around 1.5 m), but gradually increases up to 3.2 m elsewhere.

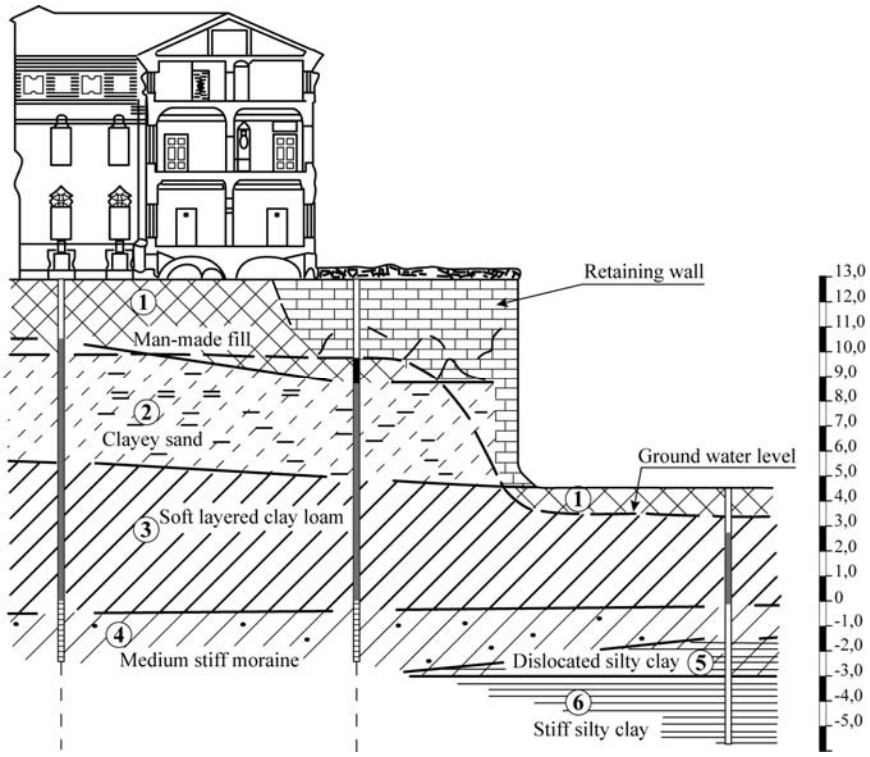
Figure 8. Cross-section of the palace and subsoil profile: 1. Made-up fill, 2. Clayey sand, 3. Soft varved clay loam, 4. Medium-stiff moraine clay loam, 5. Dislocated stiff Cambrian silty clay, 6 . Stiff silty Cambrian clay.

As attested by site investigation in the park, underneath 1 m of fill there is a 3-m layer of soft varved clay loam, underlain by medium stiff moraine clay loam (Fig. 8). Still deeper, at the level of around 14.0 m (absolute – 1.3 m), there are medium stiff and stiff deep Cambrian clays.

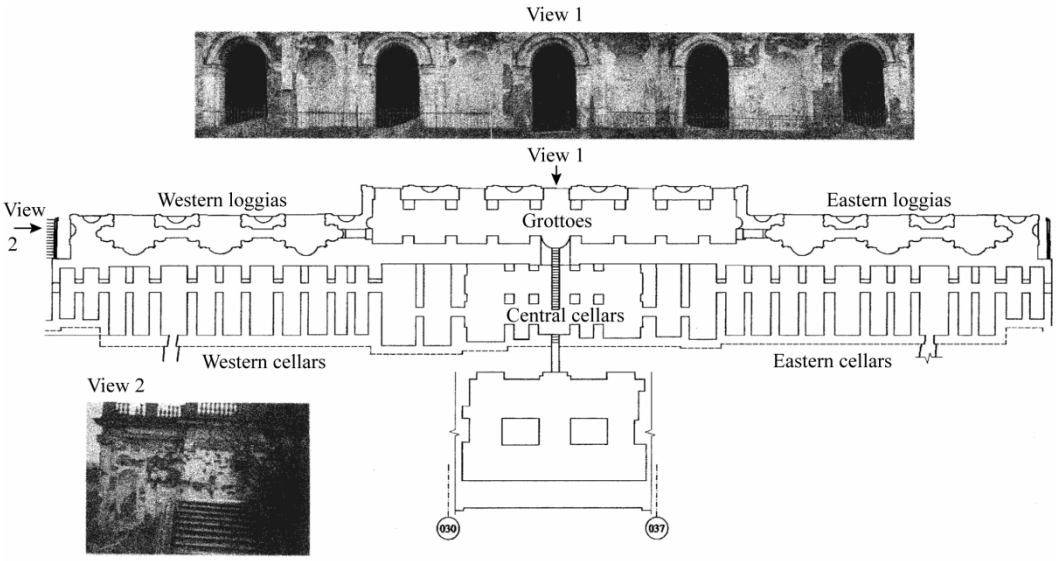
Figure 9. Dilapidated cellars, grottoes, and loggias of Konstantinovsky Palace.

1. Foundations of the dilapidated retaining walls were constructed of bricks. The foundations were no longer capable of being classified as a structure. There was imminent danger of crushed brickwork movement with formation of local bulges.

2. The entire brickwork structure was soaked in water, causing dilapidation through cycles of freezing and thawing.

3. There were no foundations of the transverse walls of the cellars. Footing was level with the cellar's floor. Decomposed timber pile heads supported the transverse walls.

4. Dilapidated terrace gutters had caused weakening of some retaining wall sections adjacent to niches of the loggias and grottoes.

5. The precipitation sewer consisted of three straight courses underneath the retaining structures, designed to divert precipitation and groundwater from the palace. There was water flow through the ground underneath the cellar walls, and through dilapidated retaining wall sections.

6. Most structural damage (fallouts) was associated with the destroyed drainage sections underlying the retaining structures.

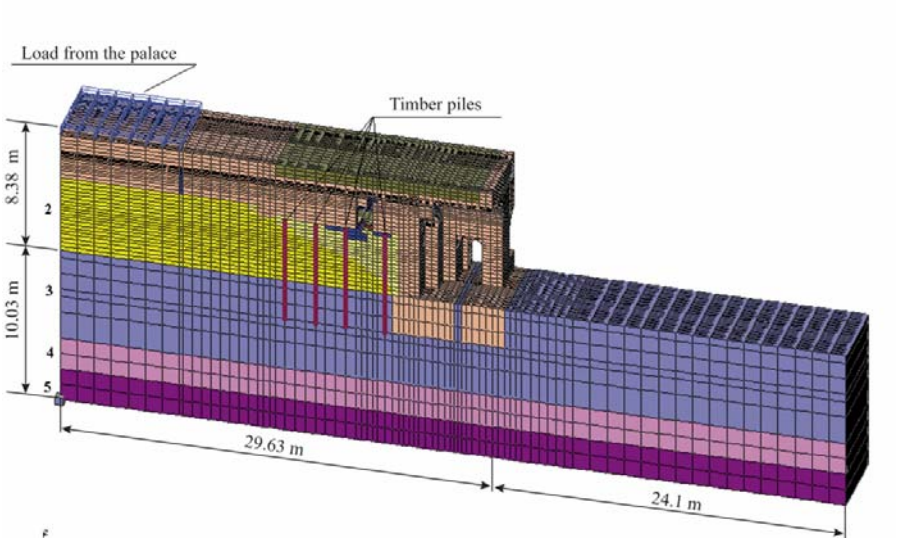
Figure 11. Calculation profile of the cellars' and loggias' deformation with account of intact timber piles.

1. Provided that the piled foundation is kept intact underneath the cellar walls (Fig. 11, 12) and the loggia structures remain in stable condition, with settlement of exterior loggia structures not exceeding 3.4 cm, and the settlement of the cellar walls not exceeding 5.8 cm, the building would be stable.

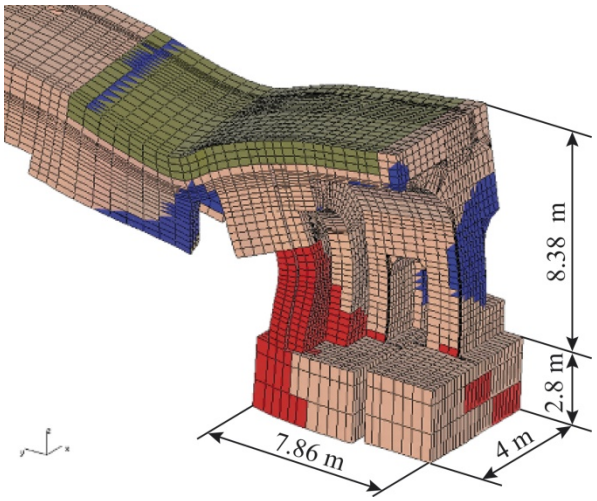
Figure 13. Deformation scheme (scale of deformations enlarged 500 times) and limit state areas in brickwork (defined by Mohr-Coulomb criteria) accounting for subsoil ground wash-out and decomposed timber piles. Shaded sections denote limit state areas generated by compressive and tensile stresses.

3. In the case of ground piping and foundation brickwork loosening, if the settlement reached 8.3 cm and the deformation profile resembled that shown in Fig. 13, then the brickwork material would be dilapidated. Observed brickwork dilapidation suggested that this mechanism was actually occurring at the site.
