Seismological and geotechnical aspects of the M_w=6.3 l'Aquila earthquake in central Italy on 6 April 2009

ABSTRACT: *The L'Aquila earthquake occurred on April 6 2009 at 03:32:39 local time. The earthquake (M_w=6.3) was located in the central Italy region of Abruzzo. Much of the damage occurred in the capital city of L'Aquila, a city of approximate population 73000, although many small villages in the surrounding region of the middle Aterno river valley were also significantly damaged. In the weeks following the earthquake, the Geo-Engineering Extreme Events Reconnaissance (GEER) international team, comprised of members from different European countries and the U.S., was assembled to provide post-earthquake field reconnaissance. The GEER team focused on the geological, seismological, and geotechnical engineering aspects of the event. We describe the principal seismological findings related to this earthquake including moment tensors of the main shock and two triggered events, the aftershock pattern and its variation with time, tectonic deformations associated with the main shock, surface fault rupture, and the inferred fault rupture plane. We describe damage patterns on a village-

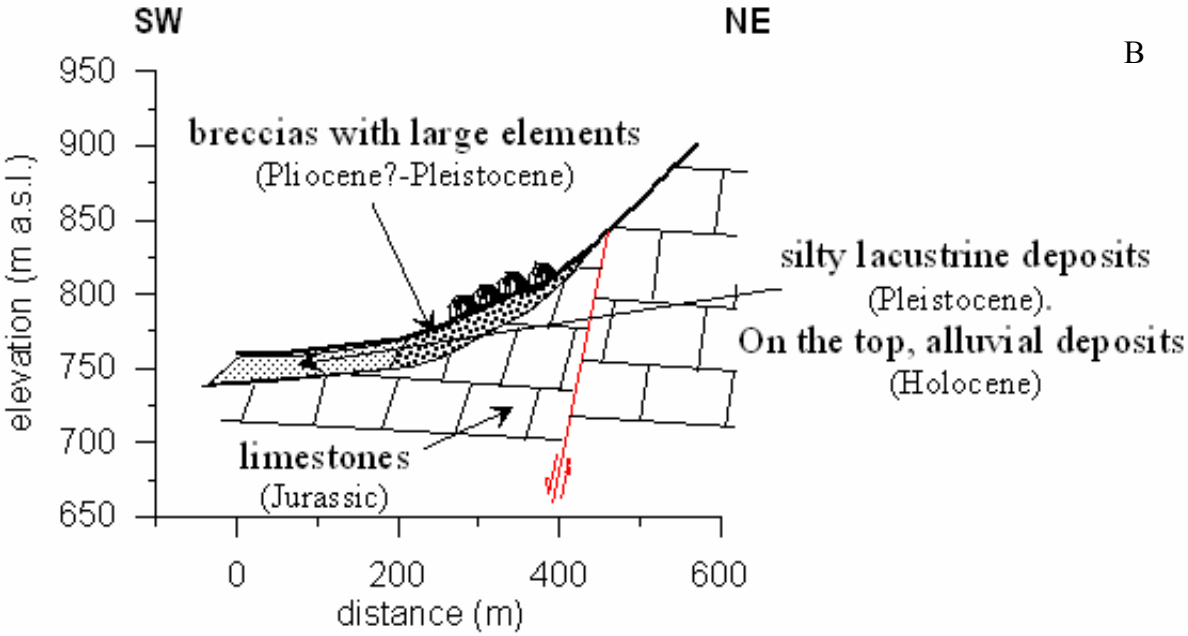
Castelnuovo is located 2 km northeast of the village of San Pio delle Camere, a hill slope village built on carbonate bedrock. This village is at a similar elevation above the valley floor and approximately 7 km from the fault plane. The housing stock of the village is similar to Castelnuovo. This village had no observable significant damage to any of the structures. Several fine cracks were observed in the exterior walls of some of the two-story and three-story residences, as shown in Figures 61 and 62.

Figure 61. (B) Geologic cross section through the village.
