Mississippi River Levee Failures: June 2008 Flood

ABSTRACT: *During the spring and summer of 2008, record rainfall in the Midwest United States led to severe flooding as water overtopped the levees bordering the Mississippi River and its tributaries. The erosion associated with the overtopping resulted in levee breaches in many places. After the flooding, a field reconnaissance team was sent to collect time-sensitive data and provide a comprehensive overview of the performance of the levees during the flooding.*
Two locations where levee overtopping occurred are particularly interesting because of their differing site conditions and performance. This paper presents the levee overtopping case histories of the Winfield-Pin Oak site which was overtopped and severe erosion led to failure, and the Brevator site which was also overtopped but did not fail. Included are a hydrological investigation, documented site conditions, geotechnical soil properties, a soil erodibility analysis, and the documented levee vegetative cover. Levee performance is influenced by the flood conditions, the site conditions, and the soil properties. Both sites in this study experienced large levels and duratio

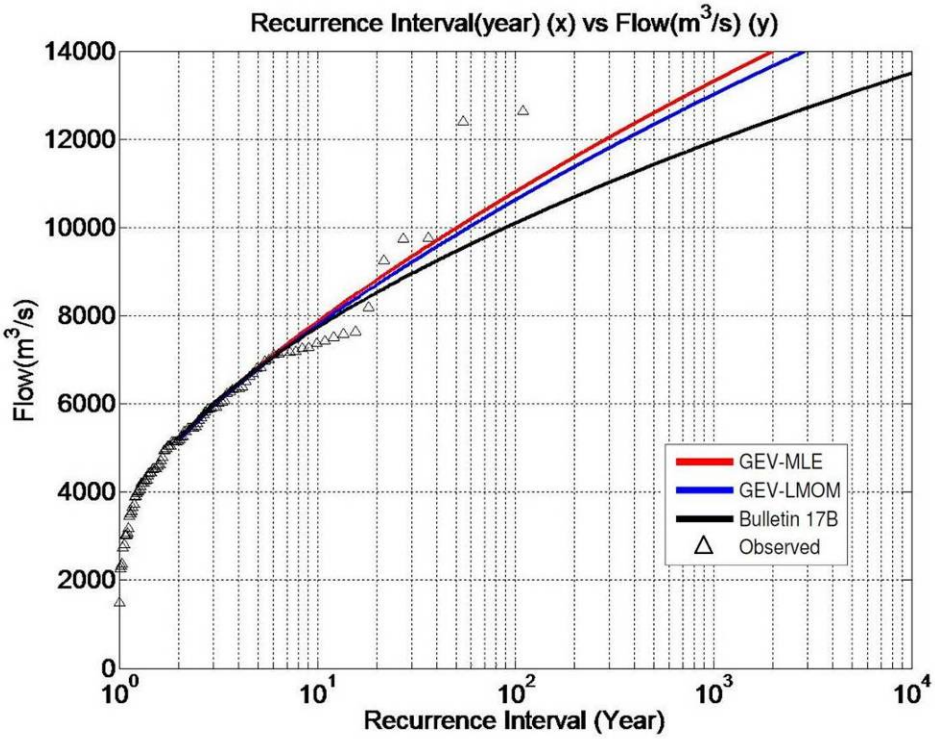
Figure 6. Observed flow peaks versus their recurrence intervals, gage 05474500.

The recurrence interval of the June 2008 flood based on the three different methods can be read on a fitted curve for the observed value of the flow, such as shown for gage 05474500 in Figure 6. To obtain the estimated recurrence intervals, a horizontal line is drawn from the data point with a flow value of 12,400 m^3/s through the regression lines. Each intersection point represents the recurrence interval for that respective estimation method. The results for the 4 gages of Figure 5 are shown in Table 1. As can be seen from Table 1, the predicted recurrence interval for Gage 05474500 varies significantly

among the three methods due to the fact that the data is extrapolated to extreme values. It is clear however, that at this location the flood was very large and in the vicinity of a 1000-year flood.

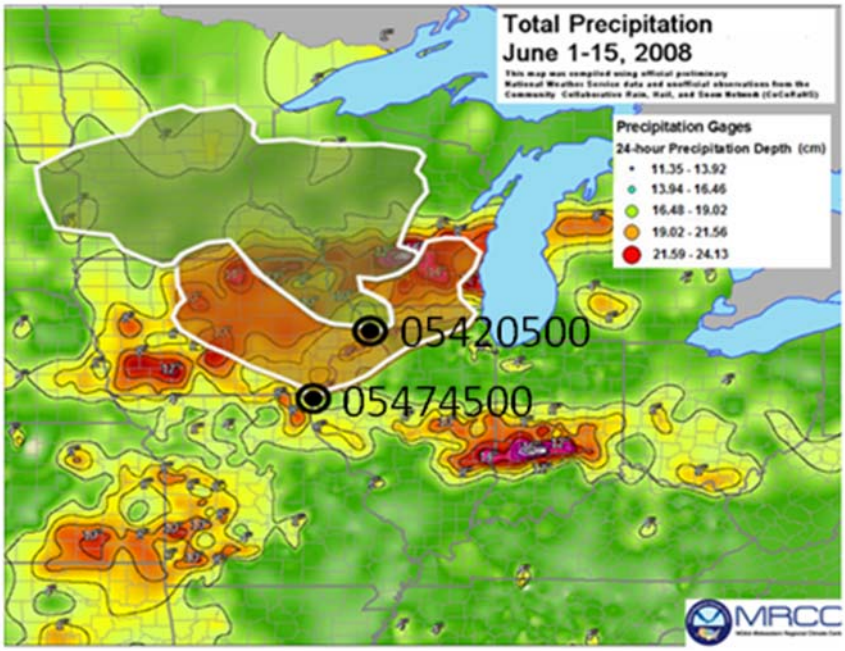
Figure 9. Basin drainage area between two gages (adapted from NCDC 2009).

It was observed that the upstream gage 05420500 experienced a 7-year flood, while gage 05474500 experienced a 1000 plus year flood, and gage 05587450 experienced only a 13-year flood. The large difference in the recurrence intervals determined for the three consecutive gages can be best explained by looking at the drainage areas outlined in white on

Figure 9. The basins were delineated based on stream networks provided by Google Earth. The different colors shown in the background of Figure 9 represent the depths of the precipitation that occurred in the area from June 1 to June 15, 2008.

While the spatial coverage is greater for the northern basin, the southern basin experienced a much larger concentration of rain in which most of the basin saw 24-hour precipitation depths exceeding 190 mm. Also, the northern outlined area drains to gage 05420500 while both the water from the lower basin and the water from the upstream gage contribute to the flood height at gage 05474500. In other words, the lower gage sees the runoff from both drainage areas explaining why the recurrence interval is much higher at this location.

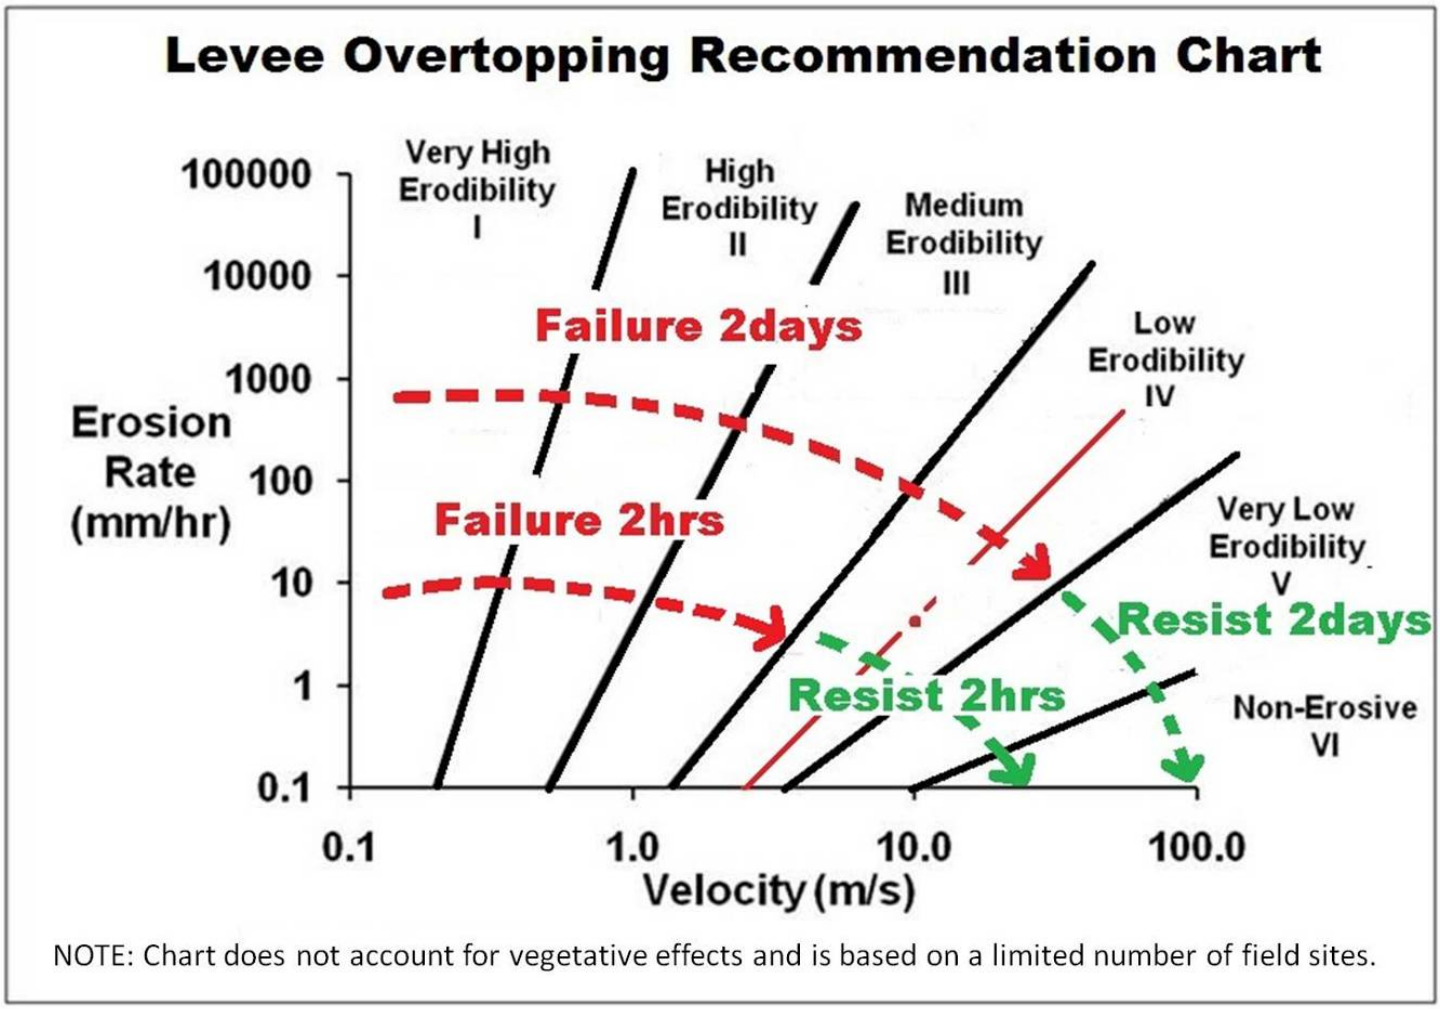
Figure 36. Recommendation chart for overtopping events.

The overtopping recommendation chart given in Briaud et al. (2008) was developed for overtopping periods of less than two hours associated with hurricane events. Based on the findings from this study, the chart was expanded to include the longer overtopping periods of 2 days experienced in flood events (Figure 36). The boundary was determined by considering the data of Figure 34 and setting an erosion limit of 0.3 m over two days for a velocity of 10 m/s. This velocity represents an average value for levees at the bottom of the dry side of the levee. To satisfy this criterion, the erosion rate has to be less than 6 mm/hr (red dot and thin red line shown on Figure 36). It is important to note that the EFA tests used to develop this chart were conducted on barren soil and therefore the chart does not account for vegetation present at a site. Also, this chart is based on a limited number of field sites and may not be representative of every field case.
