Quarry-Induced Slope Instability at a Broadcasting Transmission Plant near Valcava, Lombardia, Italy

Submitted: 21 April 2011; Published: 16 November 2011
Reference: Barbero, M., Barpi, F. (2011). *Quarry-Induced Slope Instability at a Broadcasting Transmission Plant Near Valcava, Lombardia, Italy.* International Journal of Geoengineering Case histories, http://casehistories.geoengineer.org, Vol.2, Issue 2, p.163-181. doi: 10.4417/IJGCH-02-02-04

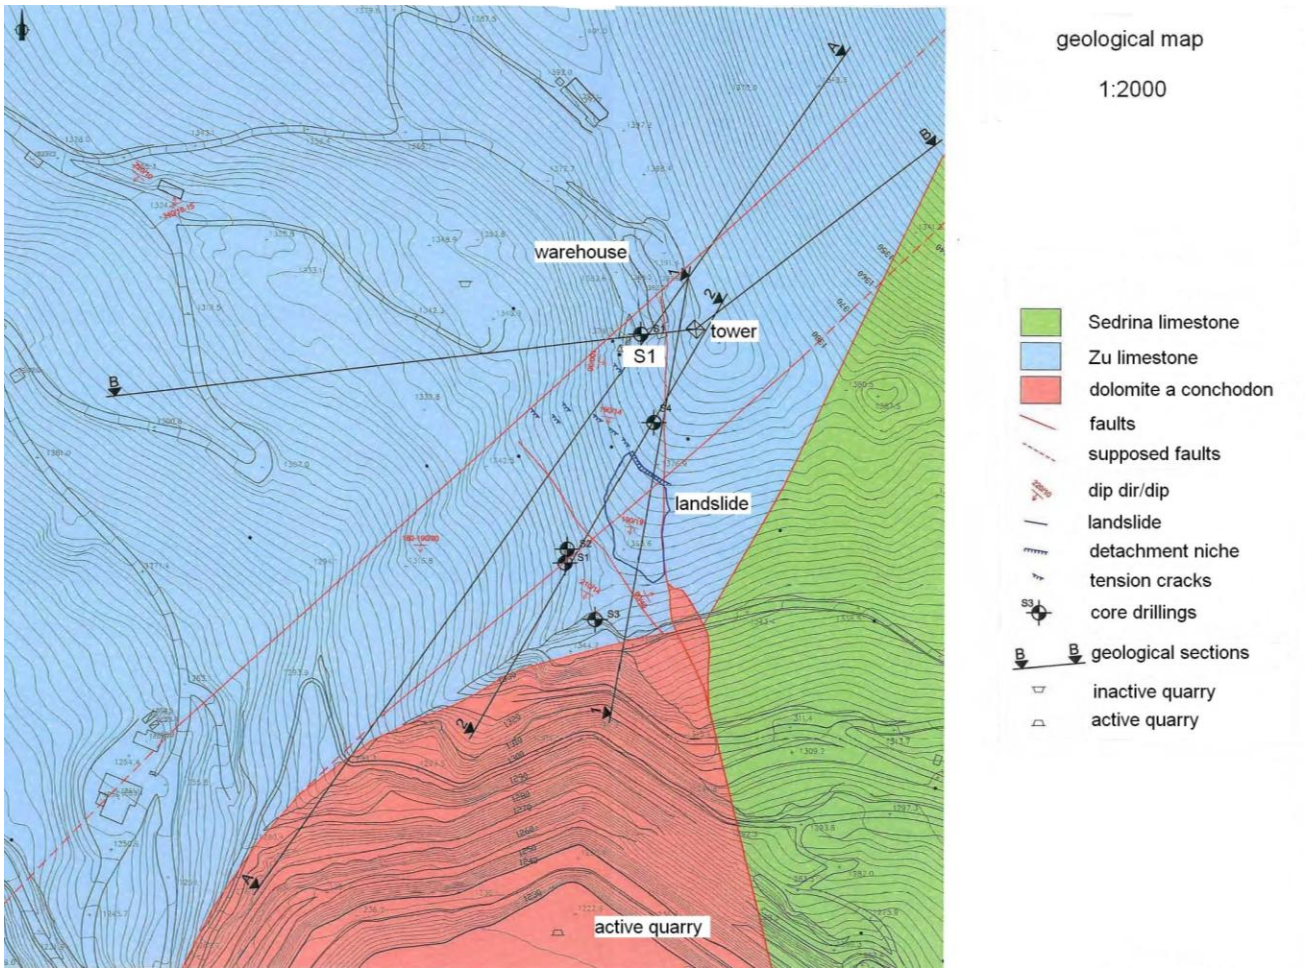
Figure 1. Geological map of the site.

The analysis of the geological map (Figure 1) and the results of the geological survey concluded that:

1. Two limestone facies characterized the slope: the Zu limestone and the Sedrina limestone. The geological boundary has tectonic origin and is represented by fault B, in Figure 6. The landslide occurred in the Zu limestone facies, where the presence of marly and argillitic layers facilitated the sliding along the bedding planes;

A drill core was taken from a 45 m deep hole drilled adjacent to the building (labeled S1 in Figure 1), near the top of the slope (about 1392 m asl). The core drilling analysis allowed to define the rock mass stratigraphy. Four main geological levels were observed, from the plane of the site: a 3 m thick layer of filling material, about 11 m thick eluvium-colluvial sheet, highly fractured limestone until the depth of about 20 m and limestone bedrock. In situ observation of the main scarp depth suggested that the movement occurred at a depth of about 16 m. Comparing these data it was possible to assert that the contact between the 20 m deep weaker layer and the undamaged bedrock is a preferential sliding zone. At the depth of about 20 m, a cavity with air inside was found, indicating the absence of water bed above the depth of 20 m.
The hole was then instrumented with an inclinometer. The first measurements showed a maximum horizontal displacement gradient of about 6 mm between 8 m and 16 m from the site level in a period of about two months. This movement was confirmed by the opening of the tension cracks occurred in the ground since the installation of the inclinometer.

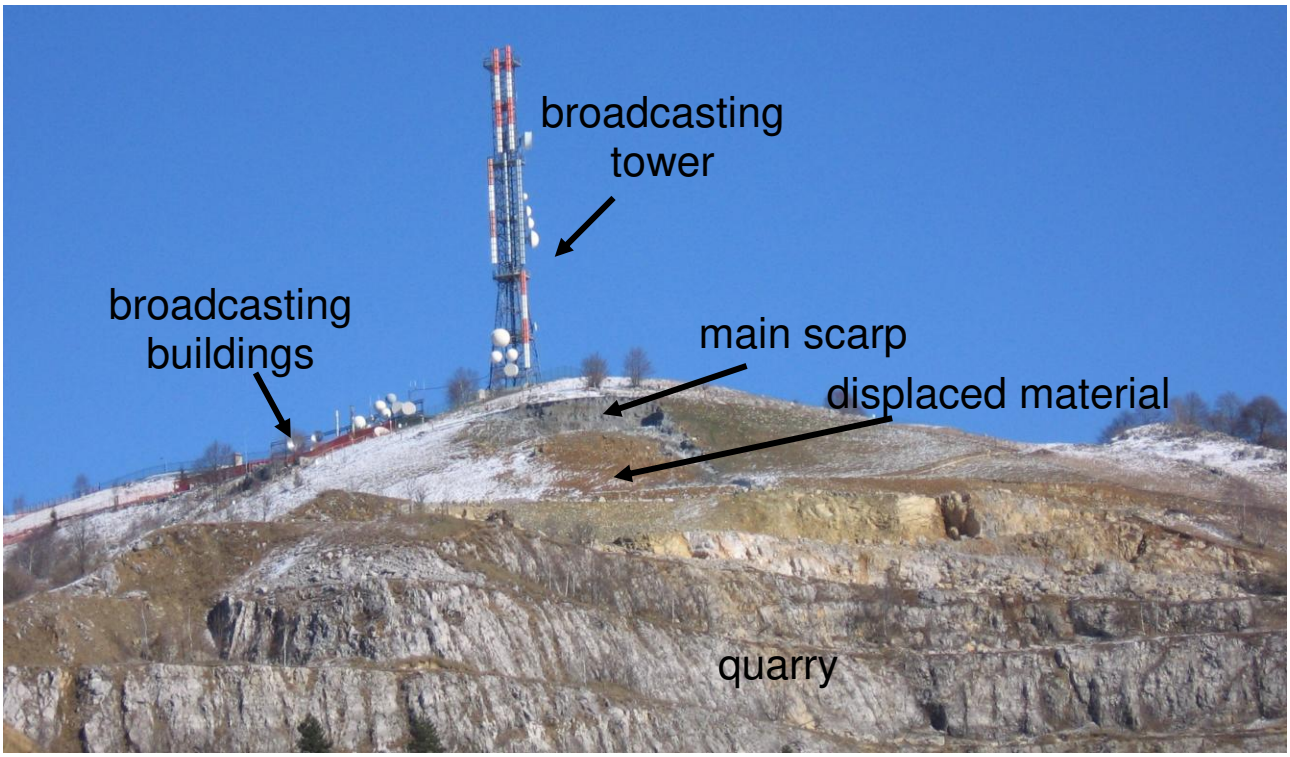
Figure 4. The landslide in the pit area.

3. Fault A marks the eastern boundary of the landslide in the pit area. This involves a 30 m slope height and has a crown length of about 35 m;
4. In the west side of the edge and in the toe of the landslide, many opened cracks were observed, suggesting that the instability phenomenon is not completed yet and potential landslide progression toward the plant is possible;

5. After the event, the landslide was entirely covered by a layer of sprayed-on concrete. In the edge of the landslide, many tension cracks developed with openings of a few centimeters in width. These confirmed that the slope is still moving.

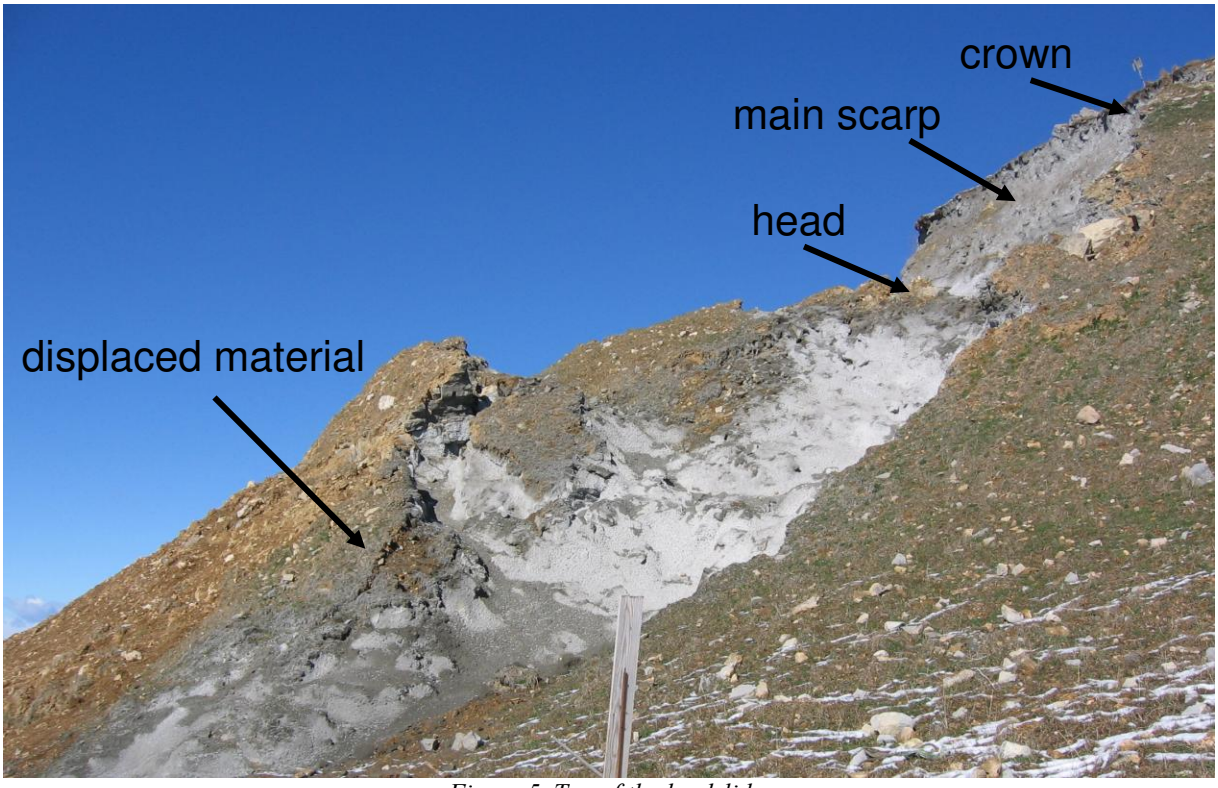
Figure 5. Top of the landslide.

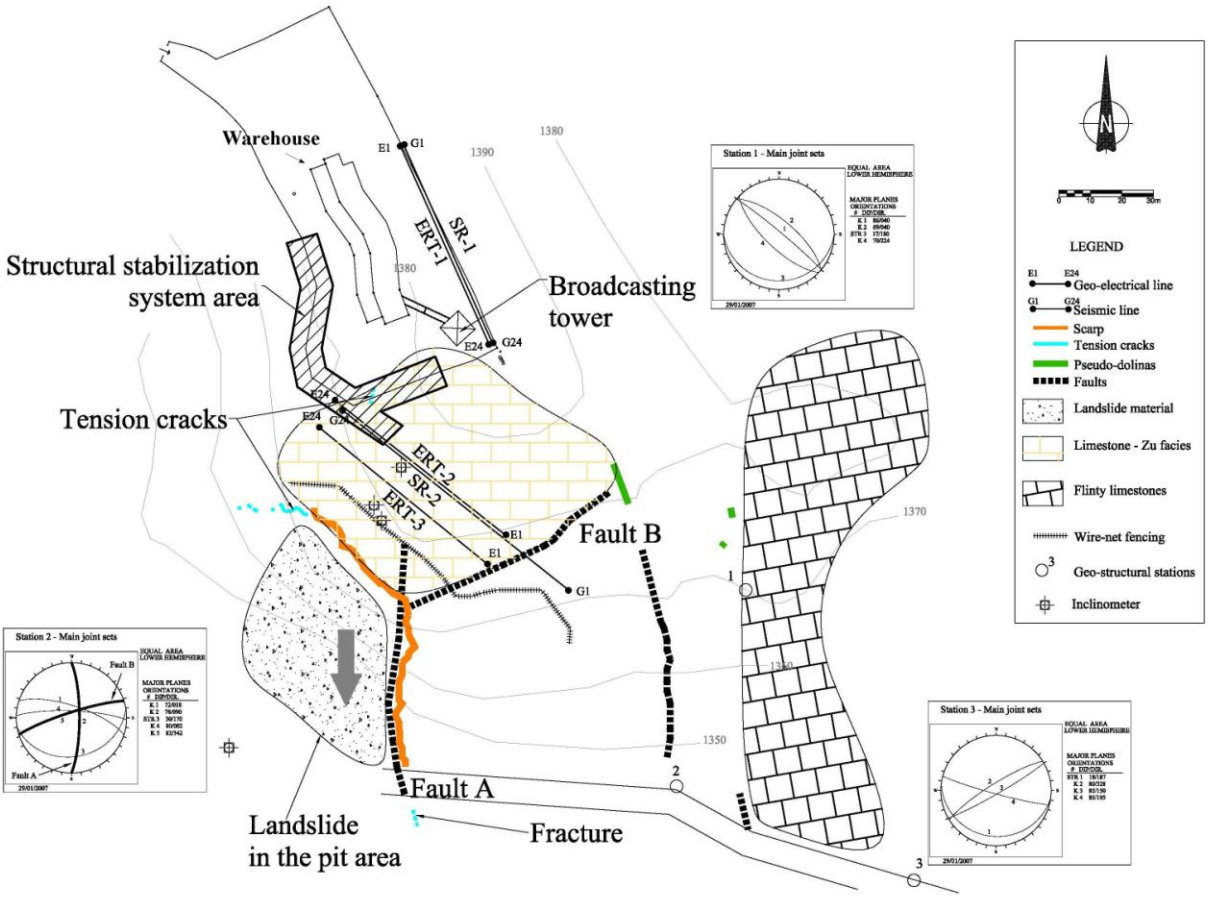
2. A second fault is present in the slope area (fault A in Figure 6) which intersects the fault B causing strong cataclasis in both facies, with a remarkable reduction of the rock mass quality;

The geological-geostructural survey was performed in three structural stations (shown in Figure 6). Four main discontinuities sets were found to characterize the rock mass (stereographic projections in Figure 6): 10°-15° down slope dipping bedding planes, two sub-vertical sets that can be potential tension cracks and a set parallel to fault B.

Figure 6. Map of the unstable area and results of the geotechnical survey.

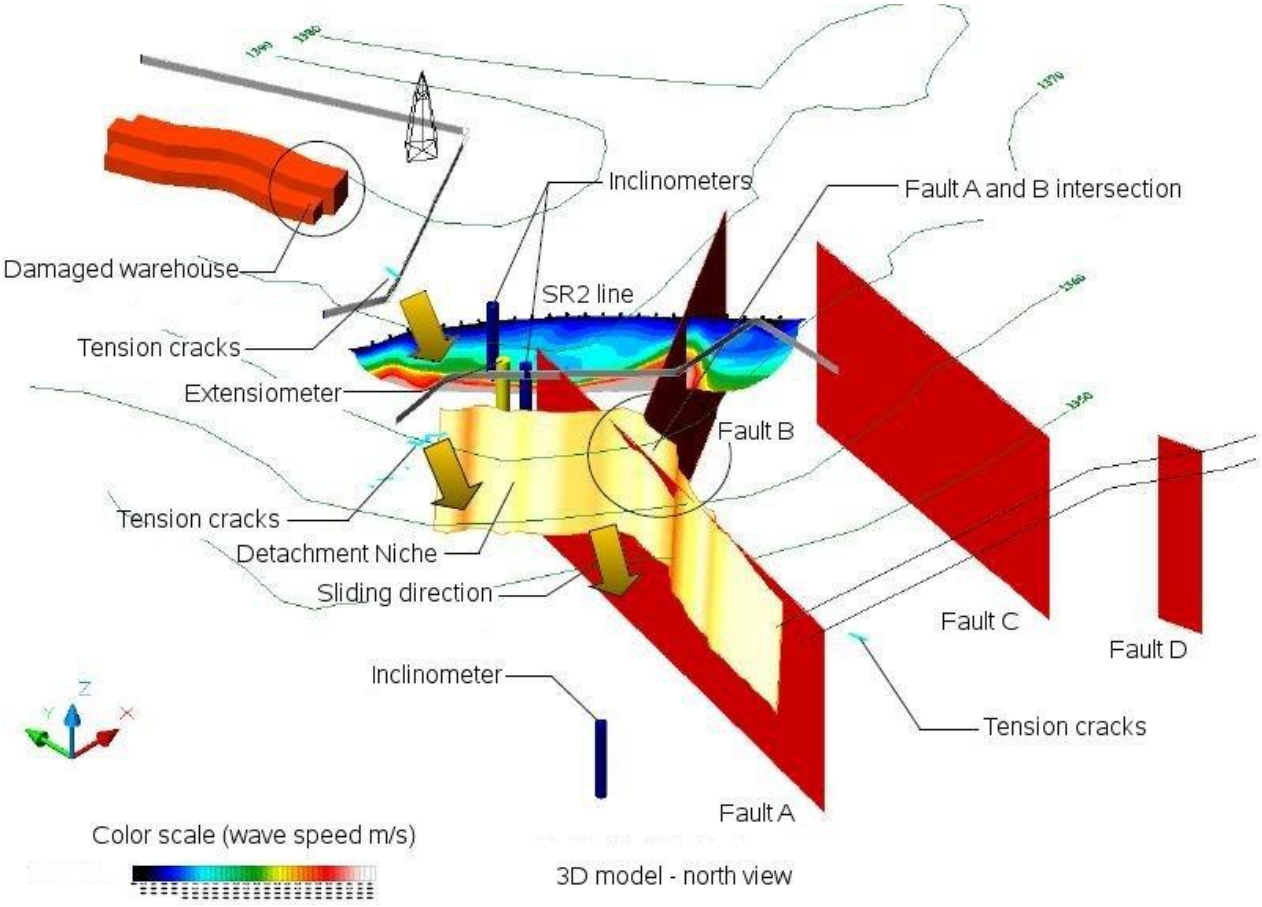
Figure 7. Three dimensional model for the seismic and geo-electrical survey.

These results, together with the observation that neither the tower or the other buildings located nearby at the top of the hill showed any damage, suggested that the instability phenomenon was a sliding along the bedding planes, located strictly in the zone between two main faults (A and B, shown in Figures 6 and 7) that intersect close to the warehouse foundations and induce a high damage in the rock mass.

One seismic refraction and two geo-electrical soundings were located near the warehouse on the unstable slope, toward the pit. Another pair of seismic and geo-electrical outlines was located close to the broadcasting tower base (Figures 6 and 7).
The data were processed with tomographic technique (Hampson & Russel, 1984; Olsen, 1989) and then interpreted considering the conventional exploration with core-drilling data. Similar results were generated in the slope and in the tower area. Upslope of the warehouse, in the tower area, there is a superficial layer of fill about 3 m deep, underlain by a layer of fractured limestone overlying apparently intact bedrock at a depth of about 16 m, as shown in Figure 8. Near the warehouse, upslope from the landslide, a pit showed the same stratigraphic sequence is observed in the tower area, as well as evidence of the two main faults A and B (Figure 9). Because of fault B, the apparently intact limestone is found at a depth of more than 20 m. The seismic survey thus confirmed the likelihood that the sliding surface was located above a depth of 20 m.

The results of the field surveys have shown that many natural weakness elements affect the site. Fault A marks the east boundary of the landslide. Its intersection with fault B (Figures 6 and 7) induces heavy fracturing in the limestone to significant depths contributing to the instability of the area. The downslope dipping bedding planes predispose the slope to sliding and the two sub-vertical sets of discontinuities can become preferential paths for water percolation.
These favorable to sliding conditions, however, do not result in movement of the instable mass, as no cracks or damage occurred in the broadcasting plant before the pit activities initiated towards the plant. Quarrying activities caused relaxation of the rock along the bedding planes in the excavation area, progressively inducing the landslide. The instability involved also the broadcasting area inducing tension cracks and fractures in the soil and in the warehouse. The tension cracks became preferential paths for the water, so the stability of the area got worse with heavy rainfalls during the spring and the autumn 2006 until the collapse in October 2006. This event mobilized the slope slide in the broadcasting site and the growth of the fractures openings was observed.

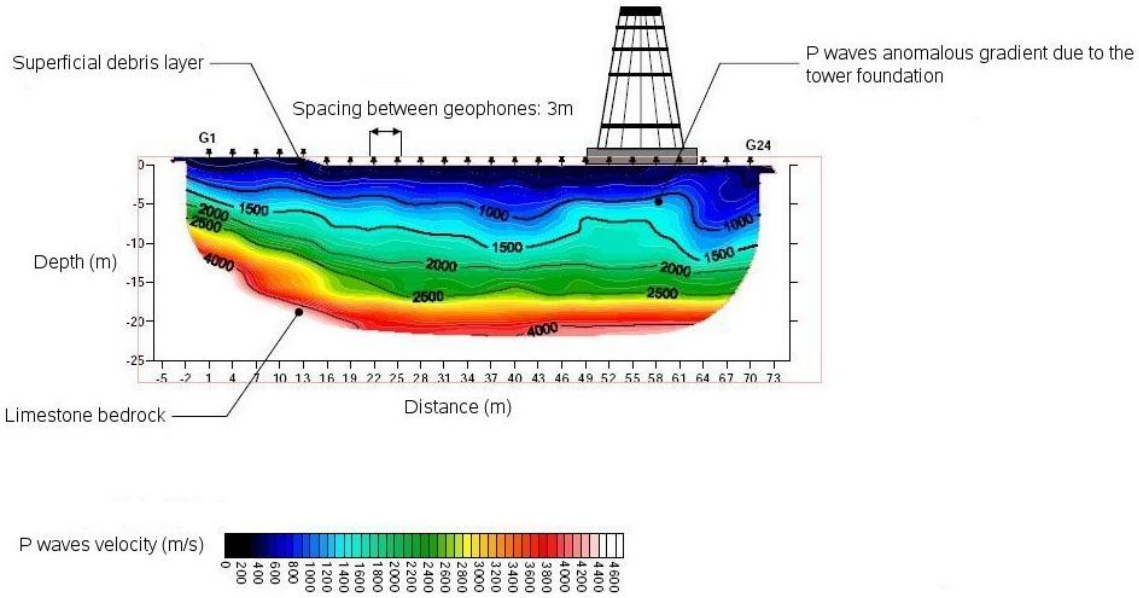
Figure 8. Seismic refraction survey results: P waves velocity trend inside the rock mass near the broadcasting tower.

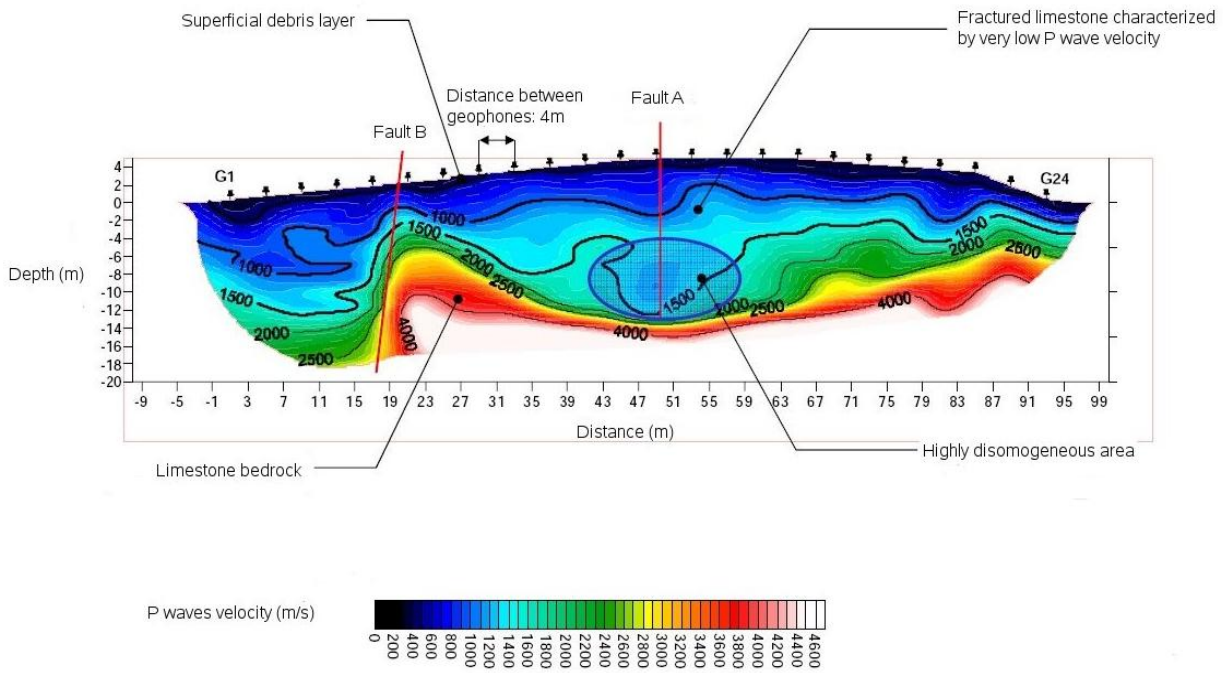
Figure 9. Seismic refraction survey results: P waves velocity trend inside the rock mass, below the warehouse area.

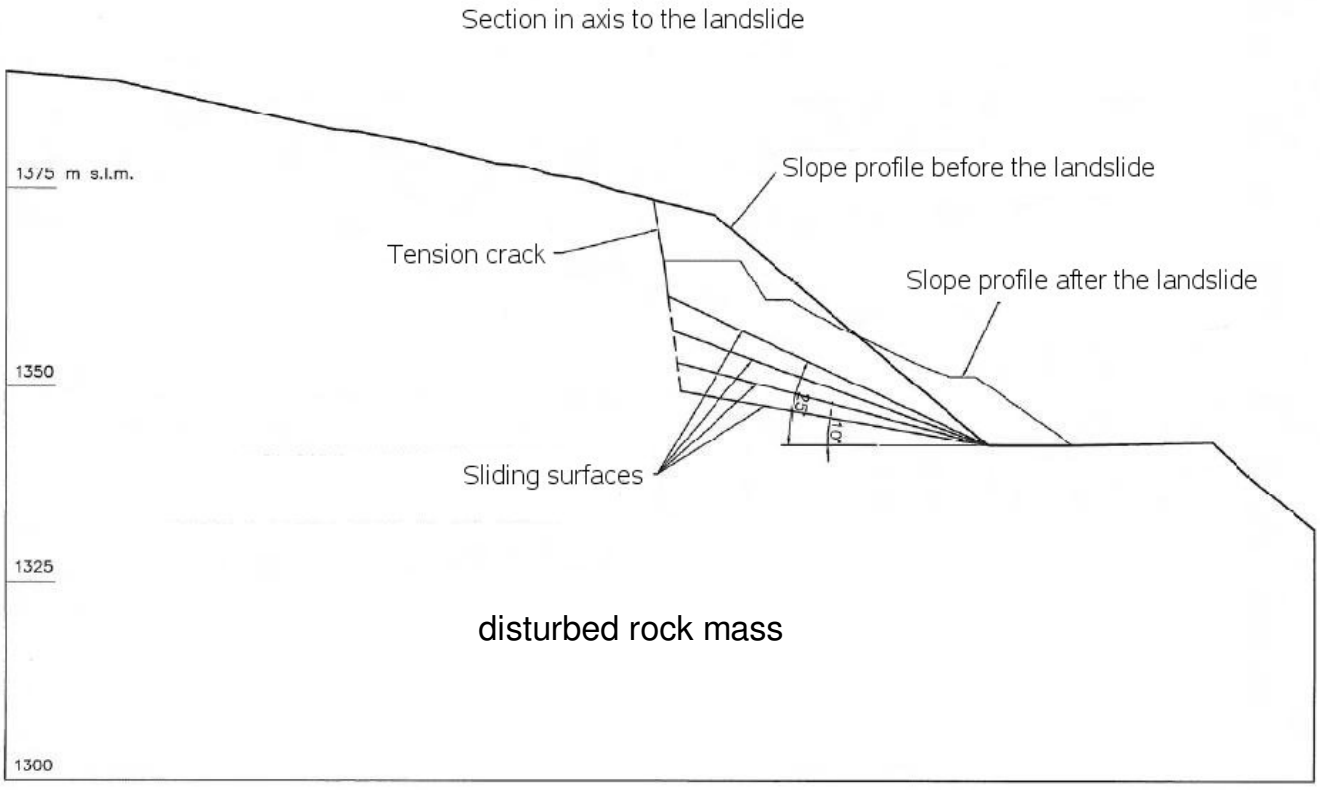
Figure 10. Slope section used for the limit equilibrium analyses (Slope-W).

An assumption had to be made for the discontinuity parameters, for which no experimental measurement was available. In order to confirm the suitability of the geotechnical characterization, a back-analysis of the landslide which occurred in October 2006 in the pit area was carried out, using the limit equilibrium method (LEM). The landslide involved an area of about 1750 m^2, between 1345 and 1375 m over sea level. It was assumed that the movement occurred along a bedding plane. The detachment crown was located along a sub-vertical joint, according to in situ observations. The precipitation data showed that medium-high intensity rain occurred in the area for two days before the landslide. It was assumed that quarrying released the bedding planes and induced tension cracks to propagate, allowing more rainwater to seep in, which

triggered the landslide. An example of a model of rainfall-induced initiation model is presented by Salciarini et al. (2006). A case of a landslide related to prolonged rainfall patterns is studied by Ibsen and Casagli (2004).
The stability analyses were carried out by using the limit equilibrium method (Janbu solution) implemented in SLOPE-W (Geo-Slope International, 1998). A section in the middle of the landslide was considered for the analyses (Figure 10). The model is constituted by a single material, characterized by disturbed rock mass mechanical parameters. The anisotropic function was used to introduce Mohr-Coulomb parameters, obtained by the linearization of the Barton-Bandis criterion, along the sliding surfaces. The parameters listed in Table 4 have been considered.

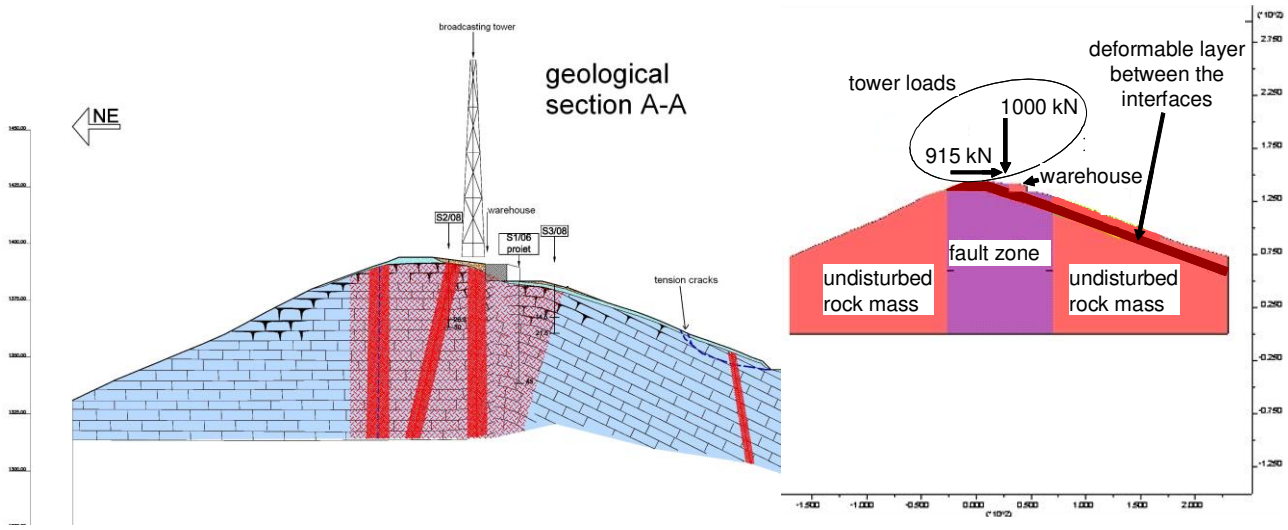
Figure 11. Geological section A-A (left) and model for numerical analyses (right).

Lagrangian Analysis of Continua; ITASCA, 2006). The aim of the simulations was to estimate the global safety factor for the slope by using the SSR method (Shear Strength Reduction), for different hydraulic scenarios.
A section of interest was modeled (section A-A in Figure 1 and Figure 11, left), in the NE-SW direction, between the broadcasting site and the pit, across the zone in which tension cracks were observed and close to the landslide. According to the geotechnical characterization, two materials with different mechanical characteristics were used in the model: one to represent the fractured fault zone in the central part of the model, below the broadcasting plant, and the other to simulate the undamaged rock mass.
Following the inclinometric and stratigraphic evidences, two interfaces were introduced in the upper part of the slope (Figure 12), at about 8 and 16 m from the ground level, to simulate the presence of a more deformable layer. In order to simulate the bedding planes characterized by high persistence and down slope dipping, the rock mass was considered homogeneous and anisotropic, with ubiquitous joints, dipping of 20° and the mechanical properties obtained with the back-analysis (see the previous subsection).

An ideal elasto-plastic model was considered for the rock mass, the interfaces and the ubiquitous joints. Plane strain conditions were assumed in 2D analyses. The strength and deformability parameters used in the numerical analyses, defined by the geotechnical characterization (minimum values), reduced by a partial safety factor of 2 for the cohesion and 1.25 for the friction coefficient, are collected in Table 5. The model was discretized with quadrangular, four-nodes plane elements; the presence of the warehouse on the top of the slope has been simulated using quadrangular elements with linear elastic behavior (unit weight: 10 kN/m^3, elastic parameters equal to those of the undisturbed rock mass). A vertical force of 1000 kN and a horizontal force of 915 kN were applied on the top of the slope, to simulate the broadcasting tower loading, according to the tower design data (Figure 11, right).

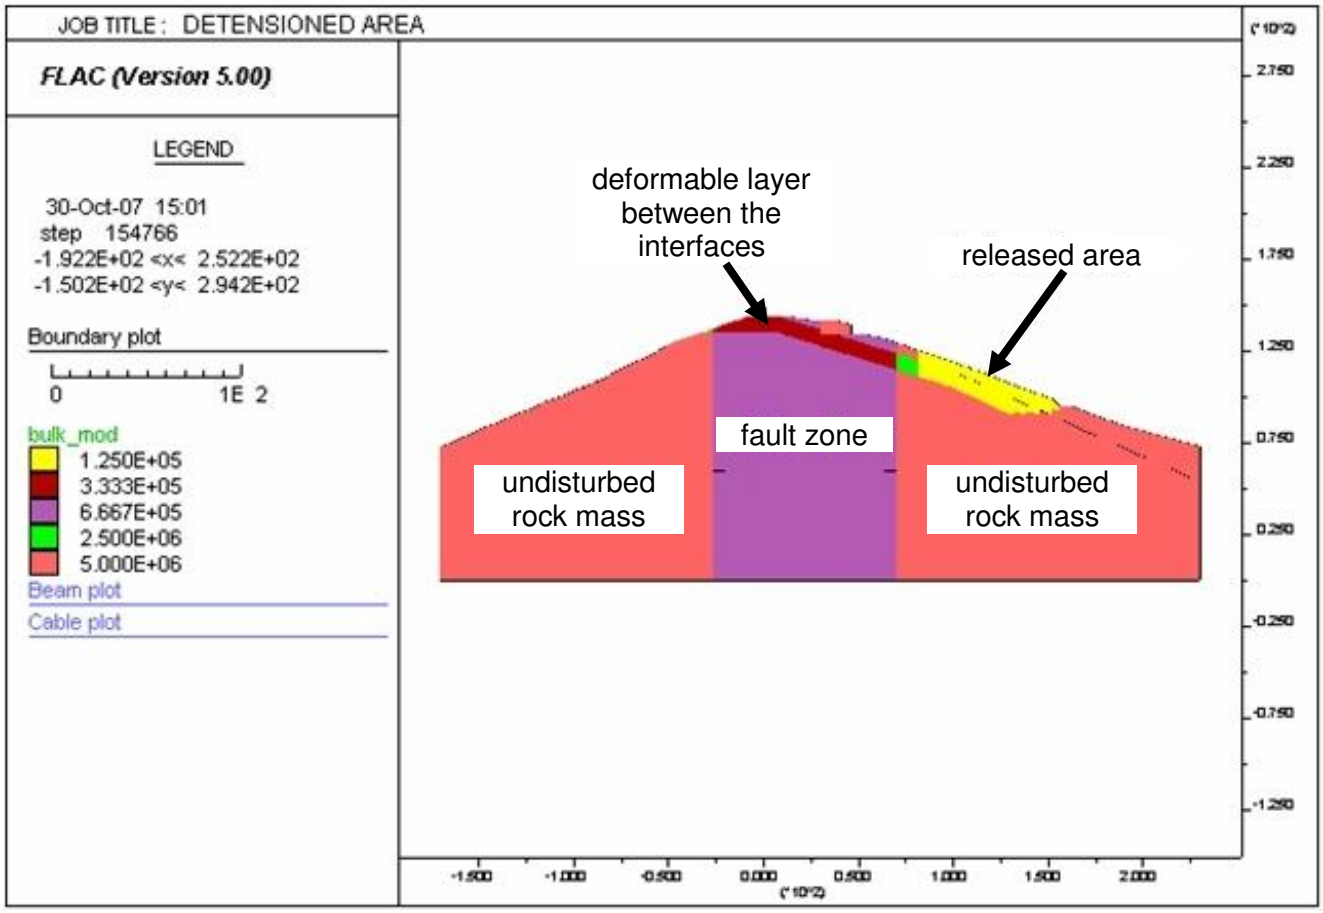
Figure 12. Model with released area to simulate the landslide in the pit (FLAC).

The slope behavior after the landslide in the pit area was simulated. It was assumed that the landslide induced a stress release in the slope beside it, between 1345 m and 1375 m above sea level with down slope displacements. For this purpose, a 20 m thick layer of the rock mass (equal to the estimated depth of the landslide) has been relieved between 1345 m and 1375 m above sea level. In order to simulate the progressive failure along the critical layer, the deformability and strength properties of the corresponding elements were progressively reduced (Table 6 and Figure 12).
The results show an important displacement increase in the upper part of the slope. The displacements in the warehouse area are appreciable only in the case of water table at 5 m from the level of site (Figure 13). A wide area in the disturbed rock mass reaches the plastic boundary for every hydraulic scenarios. From this, it is possible to reconstruct the slope's stress-strain history. The cuts in the pit area induced a progressive instability in the area immediately below the broadcasting plant, with downwards displacements that started in the pit cut and spread towards the warehouse. The landslide in the pit area quickened the instability phenomenon that worsened with heavy rain falls, leading to considerable displacements in the warehouse area.

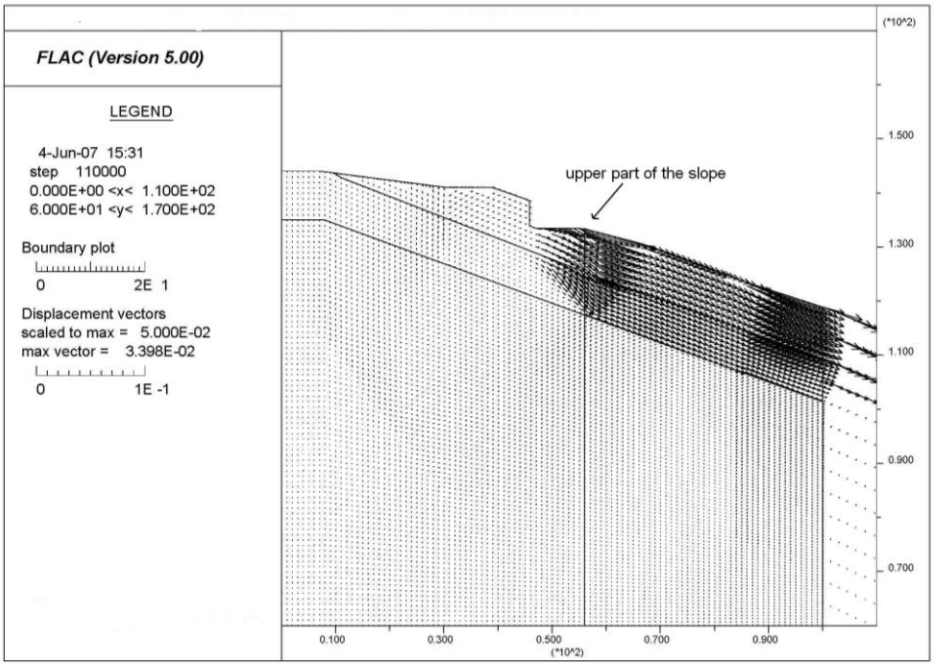
Figure 13. Numerical results: displacements in the upper part of the slope.

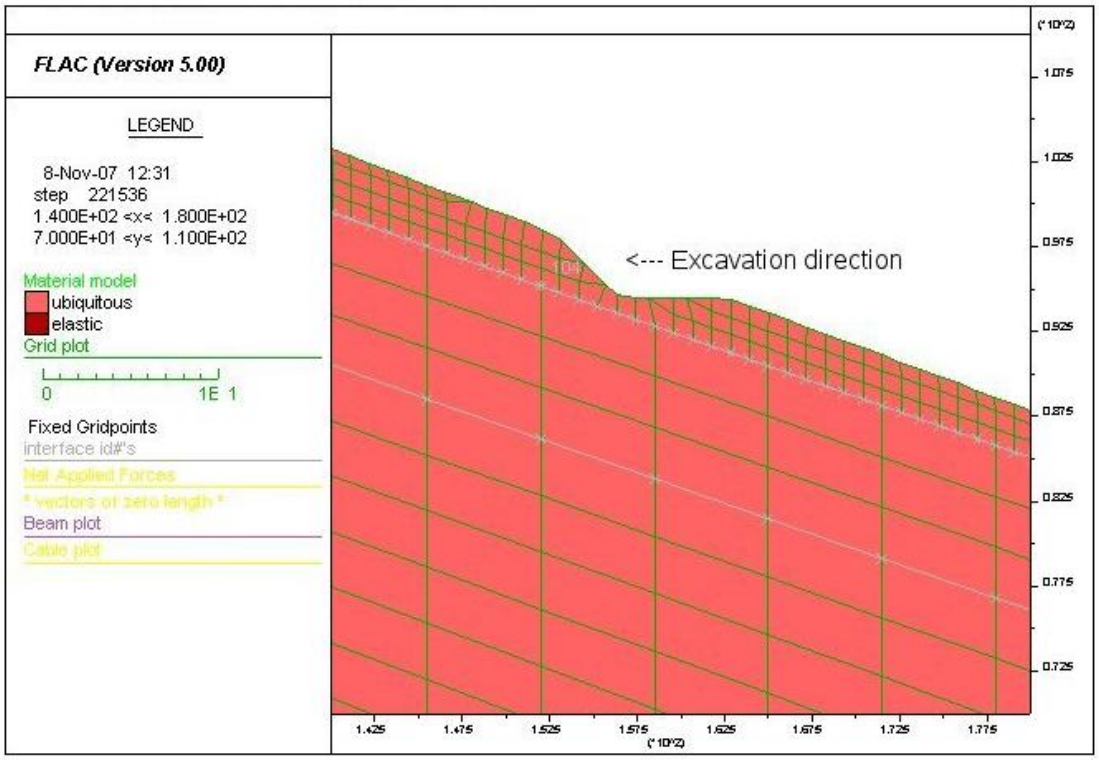
Figure 14. Model for the progression of the mining activities analysis.

In order to understand the effects on the broadcasting plant stability of the progression of the mining activity toward it, additional numerical analyses were carried out on the same model considered for the previous analyses. The progressive excavation of the pit until it reached section A-A, in the horizontal direction with a 45° face dip was simulated (Figure 14), progressively removing the mesh elements belonging to the excavation area.
The obtained results pointed out that, with the extension of the pit area, the displacements in the upper part of the slope increase. Close to the warehouse they become in the order of a few centimeters. In particular, the displacements become considerable when the excavation involves the deformable layer.
The results allow to assert that a progression of the mining activity toward the broadcasting plant would induce its instability. For this reason, it can be considered as a triggering cause of the slope movement. As such, it should not to be authorized.

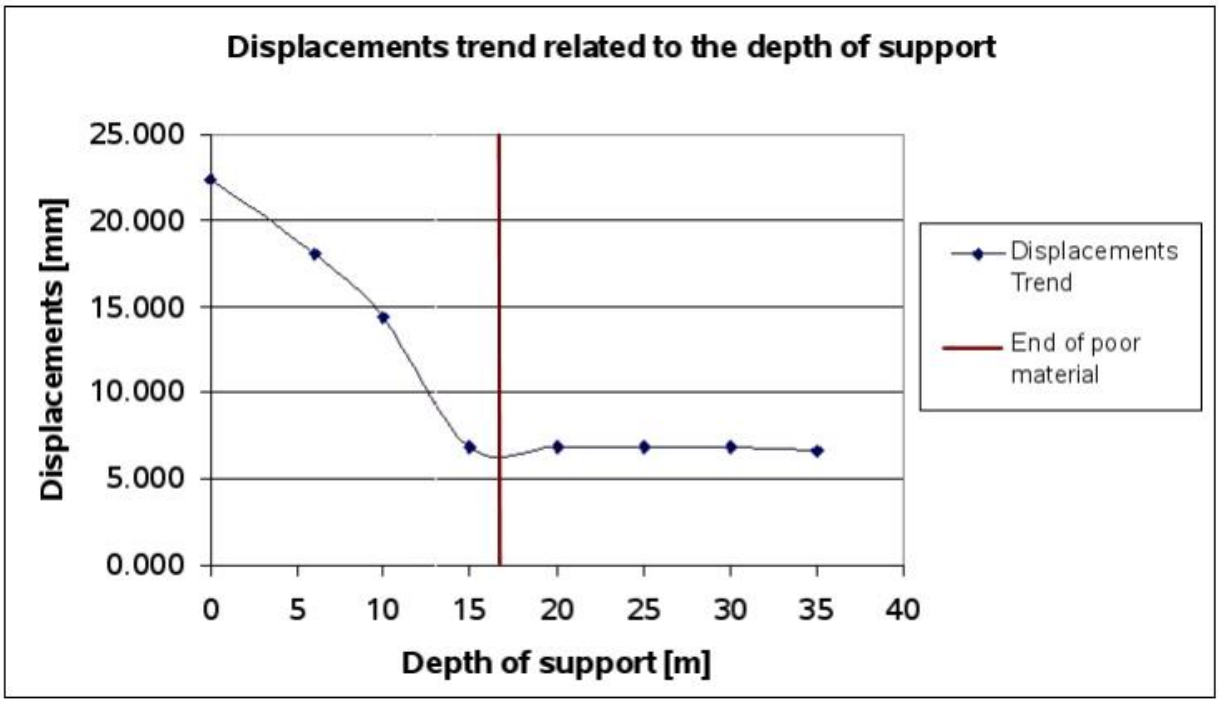
The results (Figure 16) confirm that the minimum length for the micropiles is about 16 m (the depth at which the boundary between the weaker layer and the undisturbed rock mass is located). On the other hand micropile lengths greater than 20 m don't provide further benefit to the plant stability. It is possible to conclude that 27 m is a good estimate of the length for the micropiles.

Figure 16. Model displacements in the area upstream the bulkhead, related to the length of the micropiles (assuming that in-situ bedrock is at 16 m depth).
