Embankment Failure in Residual Soils at Nivsar, Ratnagiri

ABSTRACT: *The Nivsar Yard embankment was constructed by the Konkan Railways in 1994. Near the station building, the 22m high embankment runs parallel to the Kajali River for a stretch of about 100m. This stretch has experienced failure and settlement related problems since the record-breaking July 2005 rainfall. Corrective ground improvement measures were implemented immediately after the monsoon. However, these measures were inadequate because the failure surface reappeared during the following monsoon. The failure surface mirrored the shape and size of the failure observed in 2005. Since then after nearly every monsoon, the embankment has moved despite precautionary measures taken by the railway to arrest the movement. The hydrogeological and geotechnical properties which affect slope stability are first discussed. The stability of the embankment is then evaluated at 5 sections drawn along the slope. Two cases are considered. In the first case, the stability of the unreinforced slope is calculated. In the second case, calculations are done using the slope reinforced with soil nails and micropiles installed in 2005 and 20

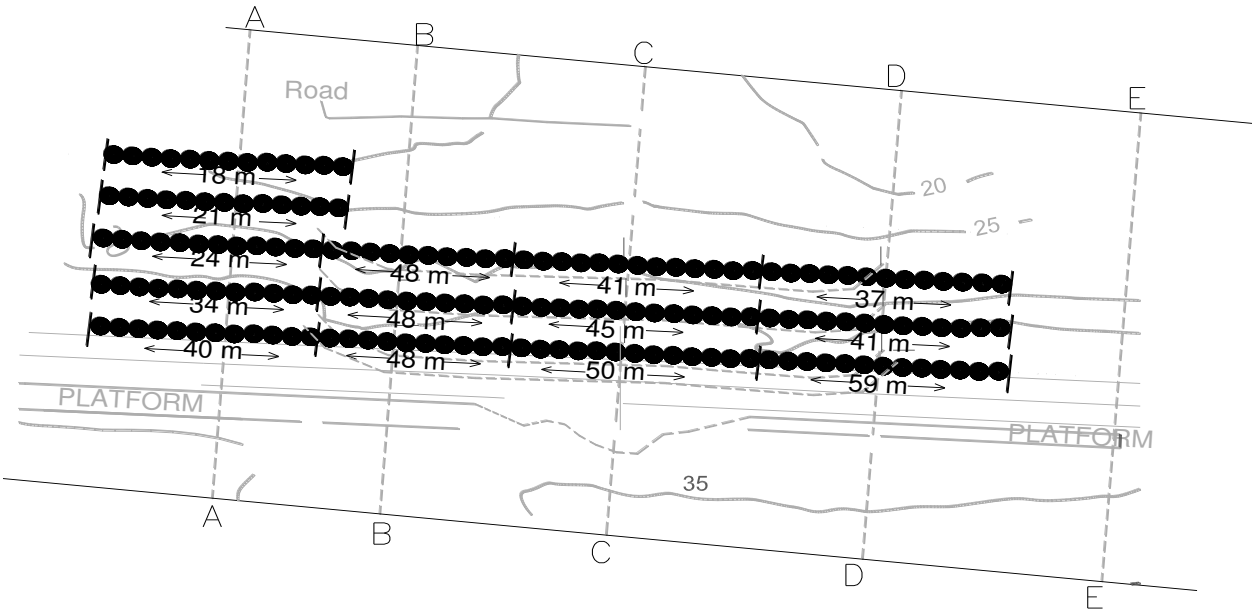
Figure 16. Schematic layout of the proposed 1.2m diameter bored pile wall at 1.2m c/c (contiguous bored pile wall). Note: Numbers below the piles indicate length of the piles.

One possible solution to enhance the stability of the slope was with the use of large diameter piles to retain the (failed) soil mass. In this case, safety factors of sections A-A to E-E were also deduced by assuming that the slope was reinforced with single or multiple rows of contiguous bored pile wall constructed parallel to the platform. Figure 16 shows the schematic layout of the proposed bored pile wall. The 1.2m diameter piles terminated below the slightly-to-moderately weathered basalt rock because of which sections B-B and C-C had long piles to provide adequate anchorage (Table 3). Table 9 shows the location and length of the piles used in the analysis. Figures 17a-d show the minimum safety factor and the location of critical circles in sections A-A to D-D for the wet season when the slope is reinforced with contiguous bored pile wall. As can be seen, the minimum safety factor increased up to 1.2 and 1.38 with the use of contiguous bored pile wall.

The cost to use the bored pile wall was over 200 million Indian Rupees (US$ 3.6 million) and appeared to be prohibitive. As an alternative to this design, the old rail alignment was removed and replaced by a new alignment. The new alignment consisted of 3 loop-lines and 1 main-line. Figure 18 shows section C-C along with the location of the new alignment. In this section, the top left side of the hill was slightly levelled to accommodate the main line and the loop lines. Section C-C was chosen because the new alignment was closest to the failure surface at this section. The horizontal distance from the vertex of the failure surface and the 4 lines was 16m, 21.3m, 26.2m and 46.4m, respectively. The stability of the slope was then reinvestigated using the computer program Talren-4 (Terrasol 2005). As in the previous case, all the lines were loaded by 125 kN/m^2. This assumption was unduly conservative in absence of strict guidelines (RDSO 2003b). Nonetheless, it permitted trains with more overtaking opportunities on the passing-loops. The ground water level was modeled using the highest RL recorded in Table 5. The failure circles are shown in Figure 19. As can be seen, the minimum safety factor is
