Reclamation and Safety of High Cantilever Strong Box Pipe Pile Seawall in Marine Clay

ABSTRACT: *A high cantilever seawall was constructed in soft clay of 15 m to 32 m thickness and the enclosed water between the shoreline and the seawall was reclaimed. The area was 7 hectare and the reclamation height ranged from 10 m to 20 m. The reclamation methods were controlled and not intended to cause additional incremental deflection to the already high design deflection of -385 mm or 0.89% of H (H = 44 m is defined as rotating and not cantilever height). However the different methods of reclamation had a significant influence on the slurry clay flows and thus caused additional incremental deflection. The slurry clay flows pushed the deflection of seawall to an additional maximum magnitude of -353 mm or 0.80% of H. The maximum seawall deflection of -526 mm or 1.20% of H was based on inclinometer IW1903 readings. At such high seawall movement, the inclinometer deflection profiles indicate safety in the design and the long term deflection is stable. This reclamation experience indicates that it is difficult to control slurry clay flows in future high reclamation filling of 10 m to 20 m heig

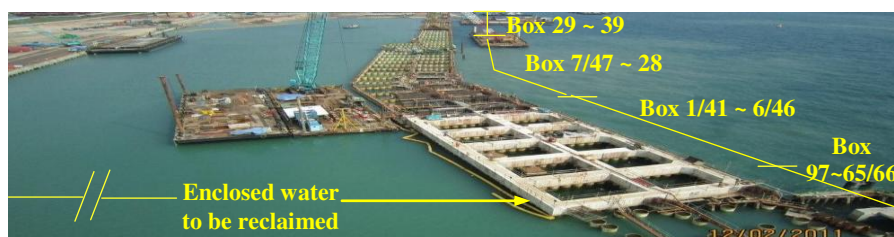
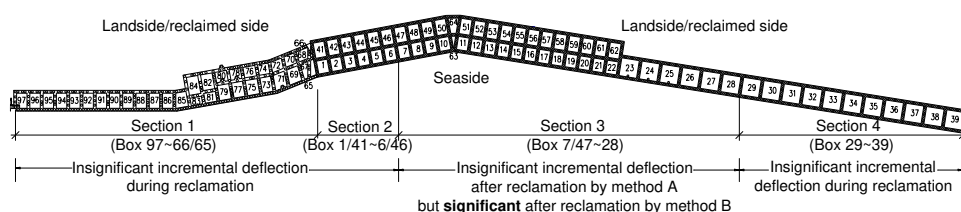
*Figure 1. Photograph showing the enclosed water to be reclaimed.*

Figure 2. Various sections of strong box pipe pile seawall.

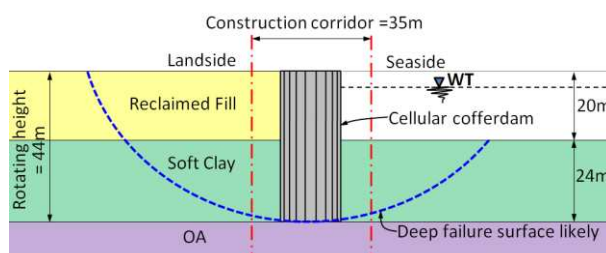
(a) A Cellular cofferdam

The applicable strong box seawall that is buildable in these physical circumstances are detailed by Soh et al. (2014). The high rotating height and the construction corridor of 35 m limit the seawall solutions. A cellular cofferdam is not able to resist the deep seated failure as shown in Figure 3(a). Ground improvement such as stone column or deep soil mixing are impossible to construct in the marine condition and also likely to fail by tensile breakage as shown in Figure 3(b).

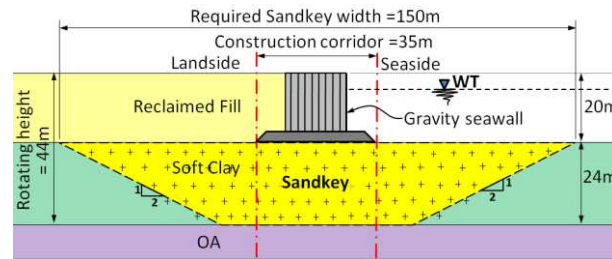
* 150 m wide and 44 m deep sandkey is necessary to cut off the deep slip failure plane.
(c) A safe sandkey solution but not buildable.

A safe sandkey of 150 m width is impossible to build within the 35 m construction corridor as shown in Figure 3(c). A-frame tie-back as shown in Figure 3(d) is not able to derive the adequate pull-back force and there is no single row steel structural wall strong enough to resist the high active force. It is necessary to design an integrated strong box structure with the adequate geo-structural turning back capacity above the rotating point, adequate geotechnical passive resistance below the rotating point, and buildable within the 35 m construction corridor as shown in Figure 4.

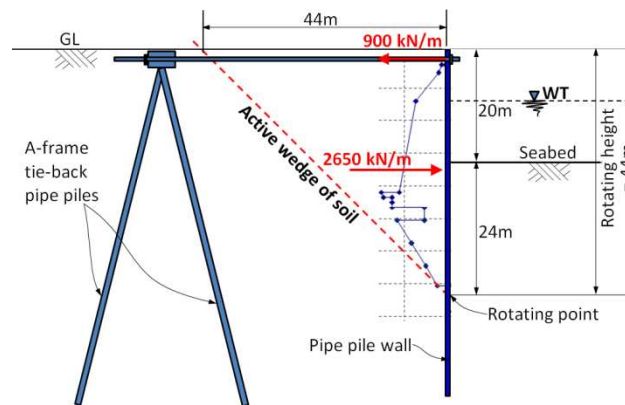
* Not applicable to provide a horizontal pull back reaction in the A-frame and an adequate single row steel structural wall.

*(d) A-frame tie-back system is not applicable.*

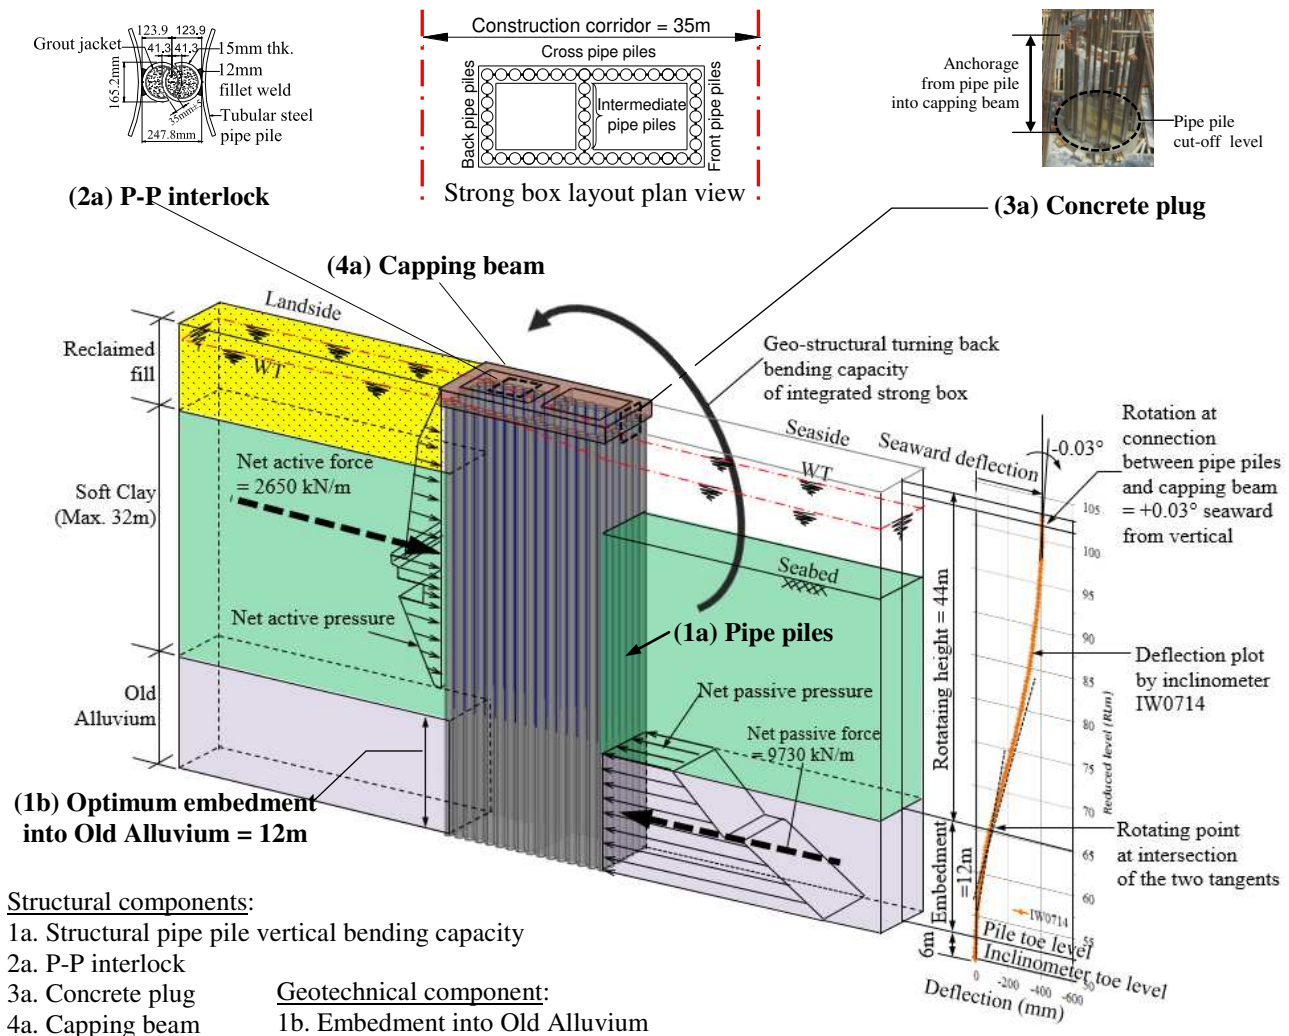
Figure 4. Four structural and one geotechnical components that define the geo-stability of the seawall.

Rotation at connection between pipe piles and capping beam = +0.03° seaward from vertical
-0.03°
Deflection plot by inclinometer IW0714
Rotating point at intersection of the two tangents
Reduced level (RLm)
IW0714
Pile toe level
Inclinometer toe level
Deflection (mm)
0 -200 -400 -600

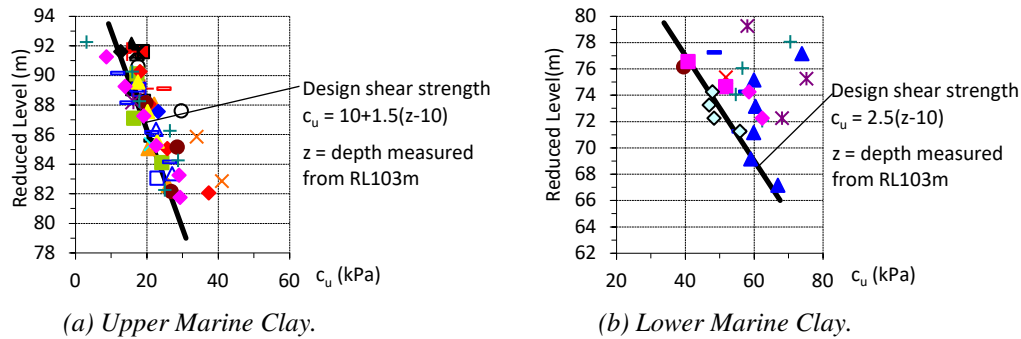
(a) Upper Marine Clay. *(b) Lower Marine Clay.*

The strength parameters of soil layers are indicated in Table 2. The undrained shear strength based on field vane test is shown in Figure 5. The inappropriate reclamation method resulted in significant clay flows, and the tremendous drop from undrained strength to slurry consistency.

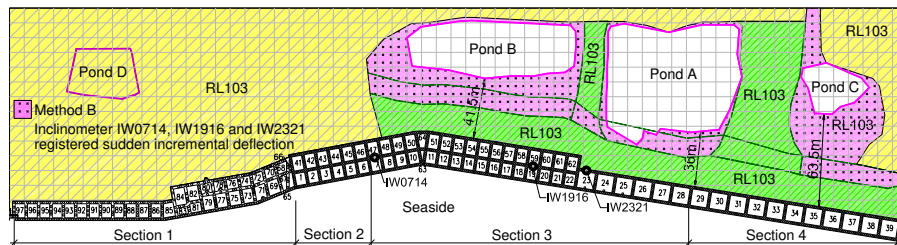
Figure 7. Stage 2 reclamation - Extent of reclamation where three inclinometers IW0714, IW1916 and IW2321 showed significant incremental deflection or sudden plunge (Method B ▥).

Figure 7 shows stage 2 reclamation, where three inclinometers IW0714, IW1916 and IW2321 of the seawall were observed to deflect significant incremental amount or sudden plunge. The surface area of reclamation was noted to be relatively small

in comparison to the stage 1 reclamation of Figure 6. It was interpreted that the full earth discharge method B was applied around the edges of the then created clay slurry ponds beyond the 44 m active wedge and were not observed at that period of time. Figure 8 shows stage 3 reclamation whereby very stringent controlled filling was carried out to prevent the created clay slurry ponds from further slurry flows.

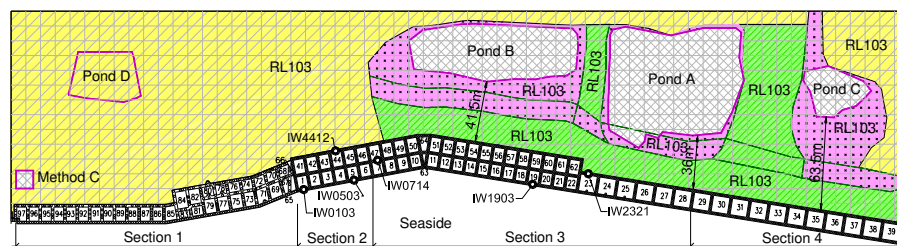
Figure 8. Stage 3 reclamation - Filling of ponds B, A, and C showed insignificant incremental deflection of the seawall (Method C ▨).

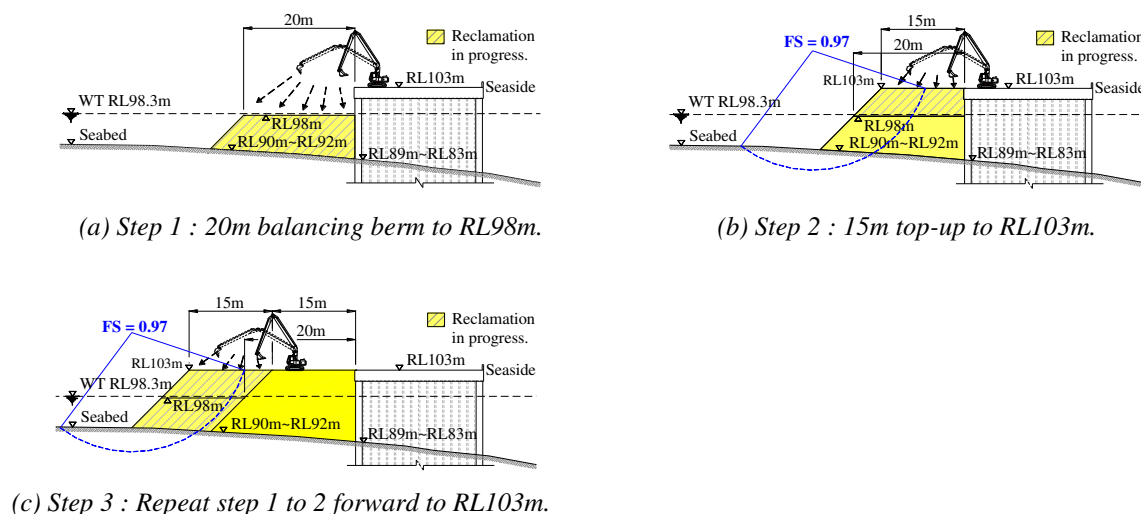
Reclamation steps of limited balancing berm method A1 is shown in Figure 9. The reclamation filling of Grade A material by the limited balancing berm was likely to cause minimal localized squeezing of the soft clay below the seabed. The squeezing effect was probably limited at 1 m to 2 m below the seabed as the factor of safety was slightly less than 1. The lowest factor of safety was at step 2 and step 3 and was localized after completion of 20 m berm to RL103 m.

(a) Step 1 : 20m balancing berm to RL98m.

(b) Step 2 : 15m top-up to RL103m.

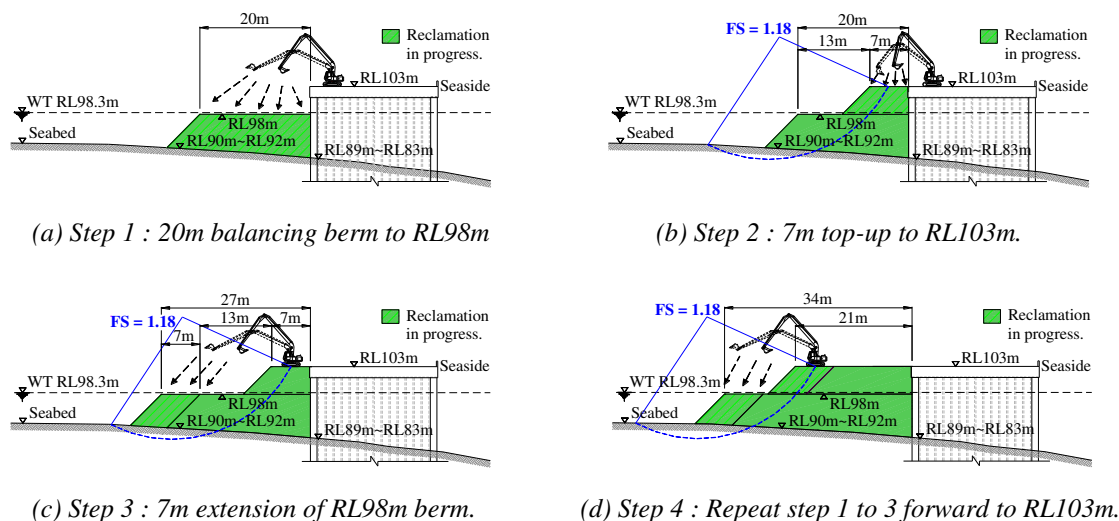
Figure 10. Stringent balancing berm for stage 1 reclamation - Method A2 .

Reclamation by the stringent balancing berm method A2 as shown in Figure 10 was a slower filling of Grade A material. The lowest factor of safety for the stringent balancing berm method A2 at step 2, step 3 and step 4 was 1.18. This method was unlikely to cause any clay squeezing below the seabed.

*(d) Step 4 : Repeat step 1 to 3 forward to RL103m.*

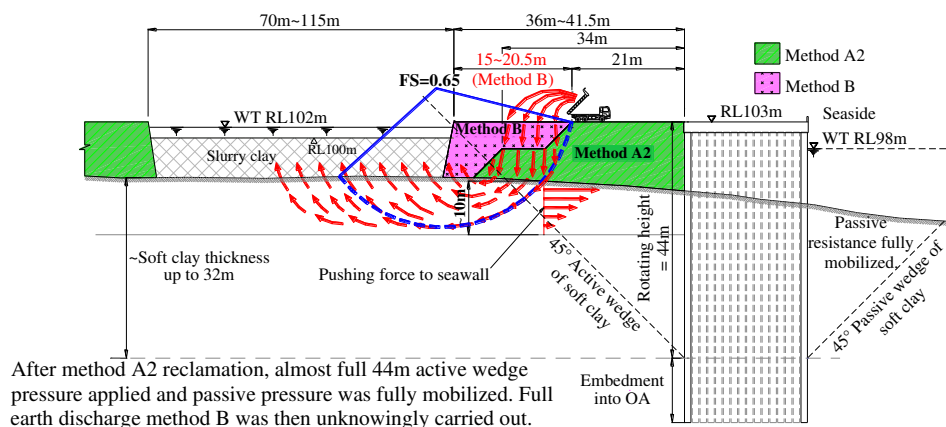
Reclamation steps of full earth discharge method B are shown in Figure 11, after stringent balancing berm method A2. Direct full discharge of Grade B material straight from the lorry was likely to cause significant slurry clay flows during stage 2 reclamation. The extent and depth of the slurry clay flows could be deep, intensive and extensive, if the direct discharge was concentrated on a particular spot. The factor of safety was extremely low for the accumulated lorry load by direct full earth discharge. This method of reclamation was extremely fast. Vast quantity of Grade B material was poured directly into the enclosed water within a very short period as shown in Figure 7, and this caused the massive slurry clay flows at ponds B and A. This method of reclamation was not recorded in the site. The method was interpreted during the period when the inclinometers recorded sudden plunge in the deflection of seawall and the sighting of heaving of clay slurry at pond B on 25 Nov 2011. Chu et al. (2009) reported the slurry clay upheaval in a stringently controlled filling procedure for a slurry pond in Singapore.

Figure 11. Full earth discharge method B for stage 2 reclamation at section 3.

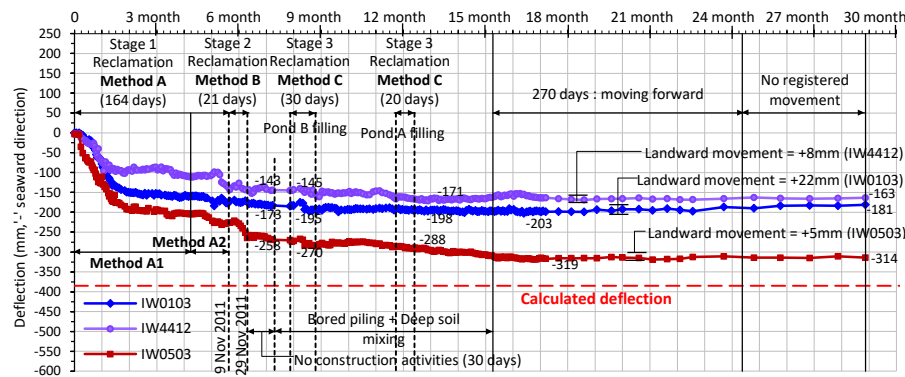
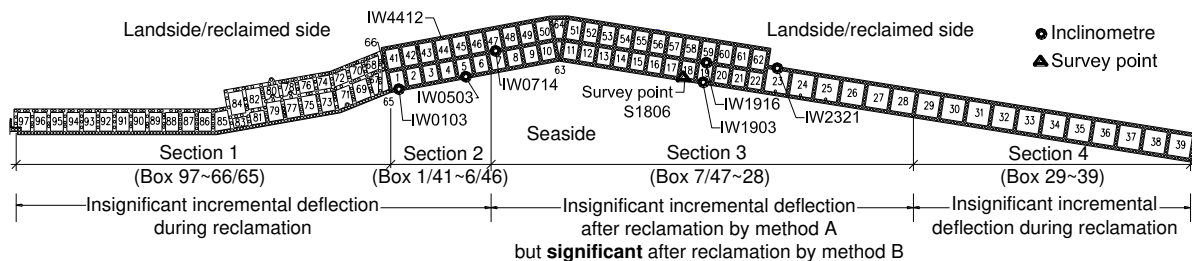
Figure 14. Comparison of deflection of capping beam of section 2 and 3 of seawall.

After the reclamation filling by method A1 and A2, the full active pressure wedge was on section 2 and an almost full 44 m active pressure wedge on section 3. At this stage the passive resistance of soft clay was fully mobilized. Deflection of both sections was lesser than the 60% of the calculated value. Method B was in the proximity of section 3 and caused a plunge in 3 inclinometers IW0714, IW1916 and IW2321, with a maximum value of -353 mm or 0.80% of H as shown in Figure 14b. The plunge was caused by the concentration of the generated lateral force of the slurry clay flow beyond the 44 m active wedge, using the constructed seawall as a reaction. Inclinometer IW1916 suggested that this slurry clay force might be higher than the 44 m active wedge force. This was a transient force which dissipated after the creation of the massive slurry clay ponds B and A.

The average deflection of the stringent balancing berm method A2 was -122 mm at section 3 (Rotating height = 40 m to 44 m) and this was lower than the limited balancing berm method A1 with an average deflection of -156 mm at section 2 (Rotating height = 25 m to 40 m). This lower deflection at section 3 showed that the stringent balancing berm method A2 had the minimum seawall deflection, as shown in Table 4.

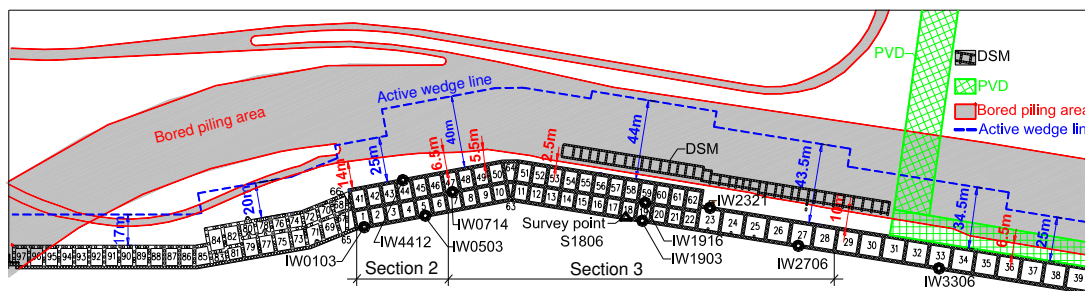
It was noted that high deflection occurred when construction activities were carried out near the seawall and within the 44 m active wedge as shown in Figure 15, with the incremental magnitude in Table 5. A deflection magnitude varying from -17 mm to -166 mm was recorded.

Figure 15. Construction works within 44 m active wedge.

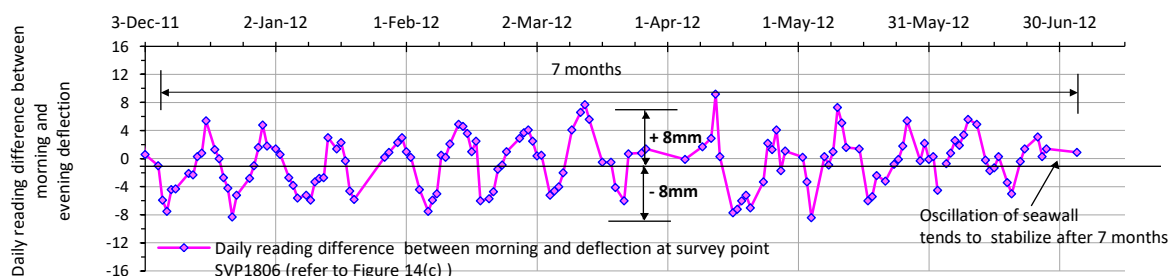
It was observed that the seawall oscillated with an amplitude of ± 8 mm as shown in Figure 16 during tidal fluctuation of 2.55 m. This observation was for a period of approximately 7 months, after which the deflection fluctuation gradually tapered off. A possible explanation of the deflection lies in the mechanism of the very loose partially saturated reclaimed fills. The reclaimed fill was haphazardly and loosely deposited into the enclosed water. While settling under its own weight, slight tension force was created below and higher tension force above the natural water level. The tensile pore pressure will gradually dissipate during each tidal cycle. This would result in higher bulk density and reduction of tension force of the fill within the tidal zone. As the active wedge is 44 m wide, this significant fluctuation in lateral pressure oscillated the wall up to a magnitude of ±8 mm. After a period of seven months this active force came to an equilibrium within the tidal levels and the oscillation movements tapered off.

Figure 16. Difference in seawall deflection registered between morning and evening reading for survey point 1806.

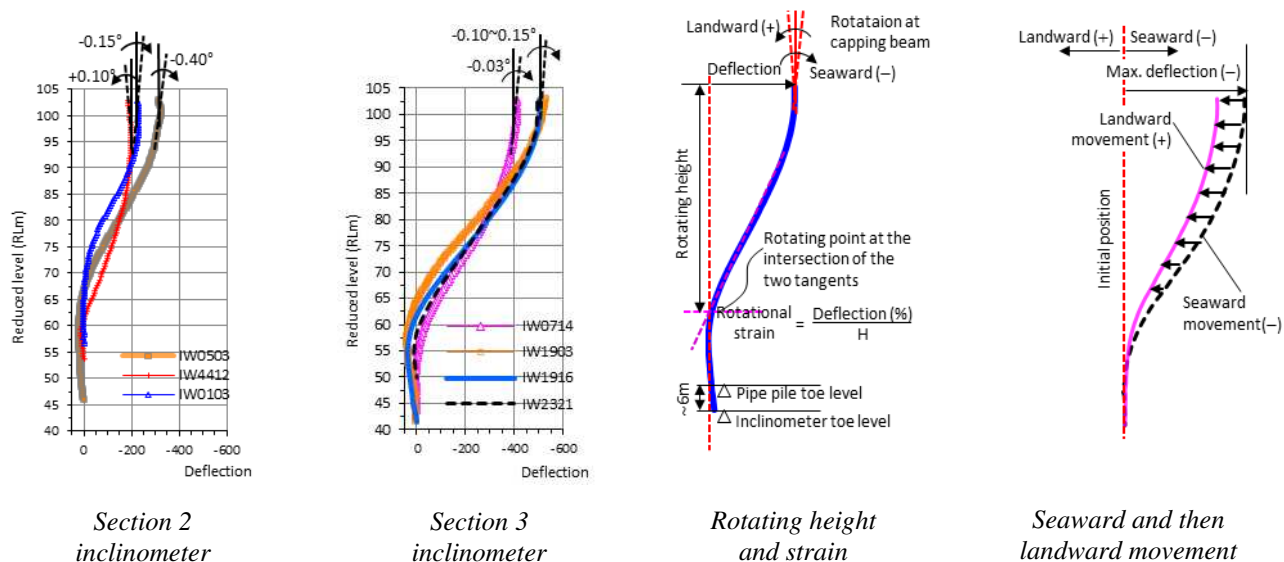
Based on the inclinometer installed inside the hollow pipe piles, the deflection of the seawall for section 2 and 3 are shown in Figure 17. As the cantilever structure rotates just above the embedment into OA, the rotating point is the intersection of the tangent line into OA and above OA. The rotating height is from the rotating point to top of capping beam. The deflection profile of the inclinometers are shown in Table 6. The long-term stability of the seawall is demonstrated by the inclinometer deflection profiles.

Figure 17. Inclinometer profiles at maximum deflection, seaward and subsequent landward movement.

The deflection seaward (-ve) was the accumulation of lateral forces from reclamation within the 44 m active wedge, other construction activities within the 44 m active wedge and the creation of the slurry clay pond B and A beyond the 44 m active wedge. The maximum seaward (-ve) of -353 mm or 0.80% of H was caused by the slurry clay pond B and A. After the lateral push of these forces stabilized, the seawall then moved in the reverse direction towards the landside (+ve) as shown in Figure 17. The landward movement was monitored for a period of 13 months and the maximum magnitude is +46 mm as shown in Table 6. The landward movement suggested that the seaward (-ve) deflection of 1.20% of H is still within the elastic state of the geo-structural turning back moment capacity of the strong box. The landward movement was caused by the vertical consolidation of the 44 m active wedge.
