# Reclamation and Safety of High Cantilever Strong Box Pipe Pile Seawall in Marine Clay

**ABSTRACT**: *A high cantilever seawall was constructed in soft clay of 15 m to 32 m thickness and the enclosed water between the shoreline and the seawall was reclaimed. The area was 7 hectare and the reclamation height ranged from 10 m to 20 m. The reclamation methods were controlled and not intended to cause additional incremental deflection to the already high design deflection of -385 mm or 0.89% of H (H = 44 m is defined as rotating and not cantilever height). However the different methods of reclamation had a significant influence on the slurry clay flows and thus caused additional incremental deflection. The slurry clay flows pushed the deflection of seawall to an additional maximum magnitude of -353 mm or 0.80% of H. The maximum seawall deflection of -526 mm or 1.20% of H was based on inclinometer IW1903 readings. At such high seawall movement, the inclinometer deflection profiles indicate safety in the design and the long term deflection is stable. This reclamation experience indicates that it is difficult to control slurry clay flows in future high reclamation filling of 10 m to 20

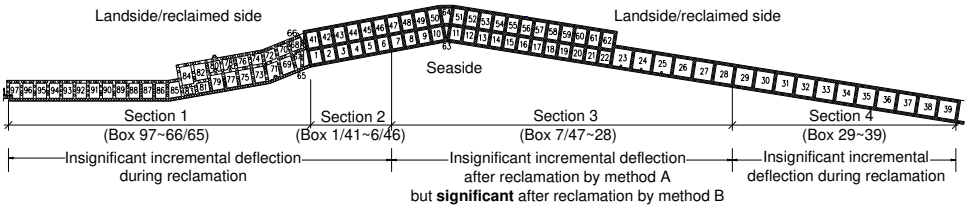
*Figure 2. Various sections of strong box pipe pile seawall.*
