The May 25th 2011 Railroad Embankment Failure in Ann Arbor, Michigan, As a Means for Teaching Geotechnical Engineering

Dimitrios Zekkos, *Associate Professor, Department of Civil and Environmental Engineering, University of Michigan, Ann Arbor, Michigan, USA; email: zekkos@geoengineer.org*
Adda Athanasopoulos-Zekkos, *Associate Professor, Department of Civil and Environmental Engineering, University of Michigan, Ann Arbor, Michigan, USA; email: addazekk@umich.edu*
Athena Grizi, *graduate student researcher, Department of Civil and Environmental Engineering, University of Michigan; Ann Arbor, Michigan, USA; email: agkrizi@umich.edu*
William Greenwood, *graduate student researcher, Department of Civil and Environmental Engineering, University of Michigan Ann Arbor, Michigan, USA; email: wwgreen@umich.edu*

Submitted: 22August 2015; Published: 11 November 2016
Reference: Zekkos, D., Athanasopoulos-Zekkos, A., Grizi, A., and Greenwood, W. (2016). *The May 25th 2011 Railroad Embankment Failure in Ann Arbor, Michigan, As a Means for Teaching Geotechnical Engineering*. International Journal of Geoengineering Case histories, Vol.3, Issue 4, p.234-245. doi: 10.4417/IJGCH-03-04-03

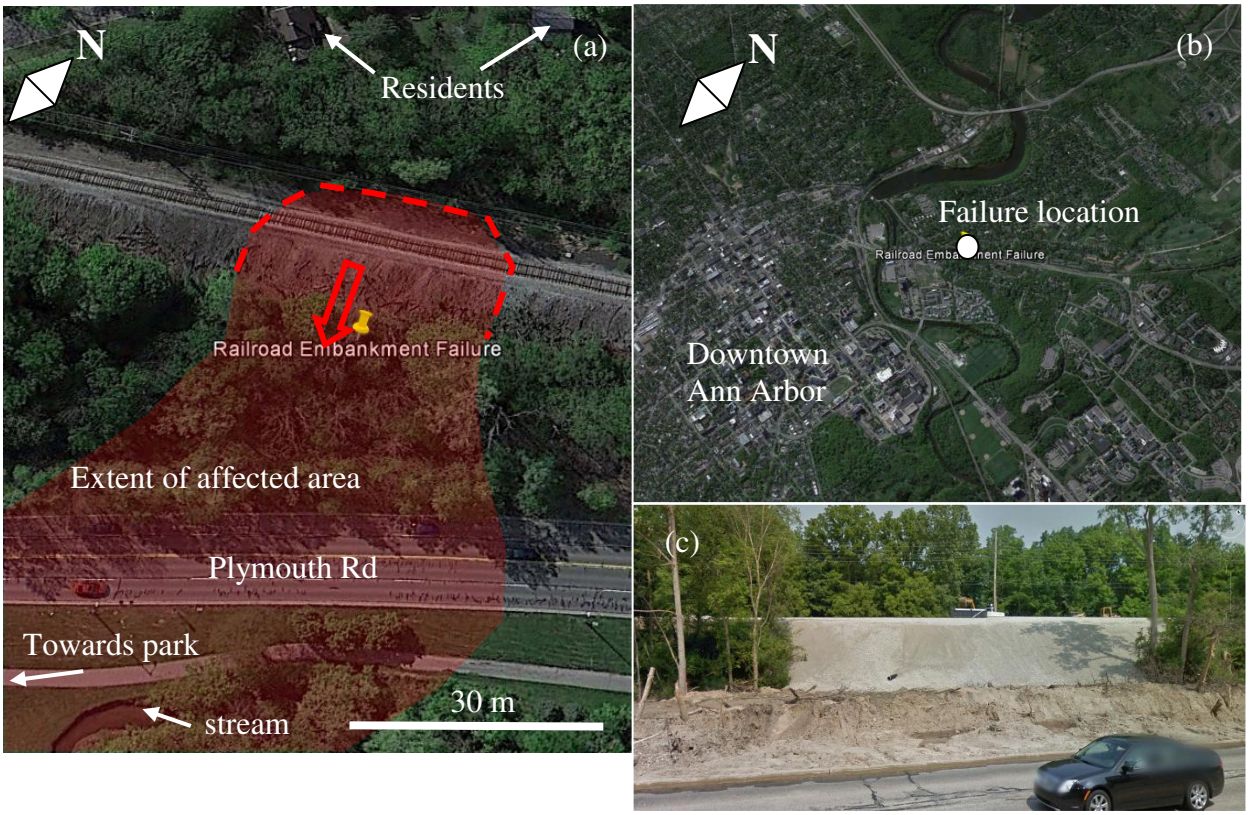
Figure 1. View of the railroad embankment failure looking East.

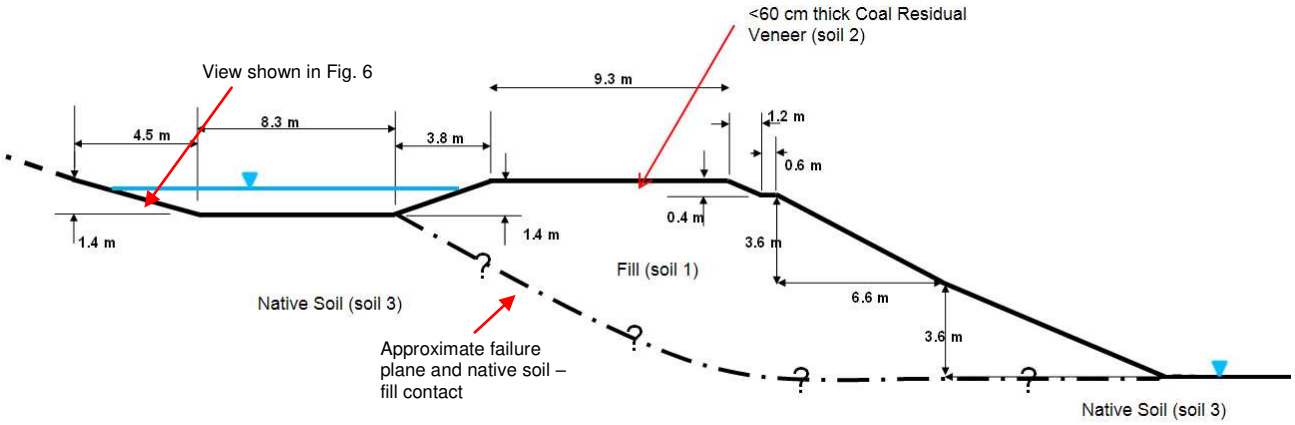
The embankment is constructed partially on a naturally sloping ground and has a total height of 7.6 m as shown in Fig. 5. Its crest, that supports the railroad lines, has a width of 9.3 m. The embankment fill consists of two layers. The main layer (Fill Soil 1) is a silty sand (SM). A surficial layer of very small thickness is also present and consists of coal ash residuals (Soil 2). The natural soil that underlays the embankment is a sandy clay of low plasticity (CL) that geologically is described as very dense glacial deposits (Native Soil-Soil 3).

Figure 5. Cross-section of the railroad embankment at the location of the failure.

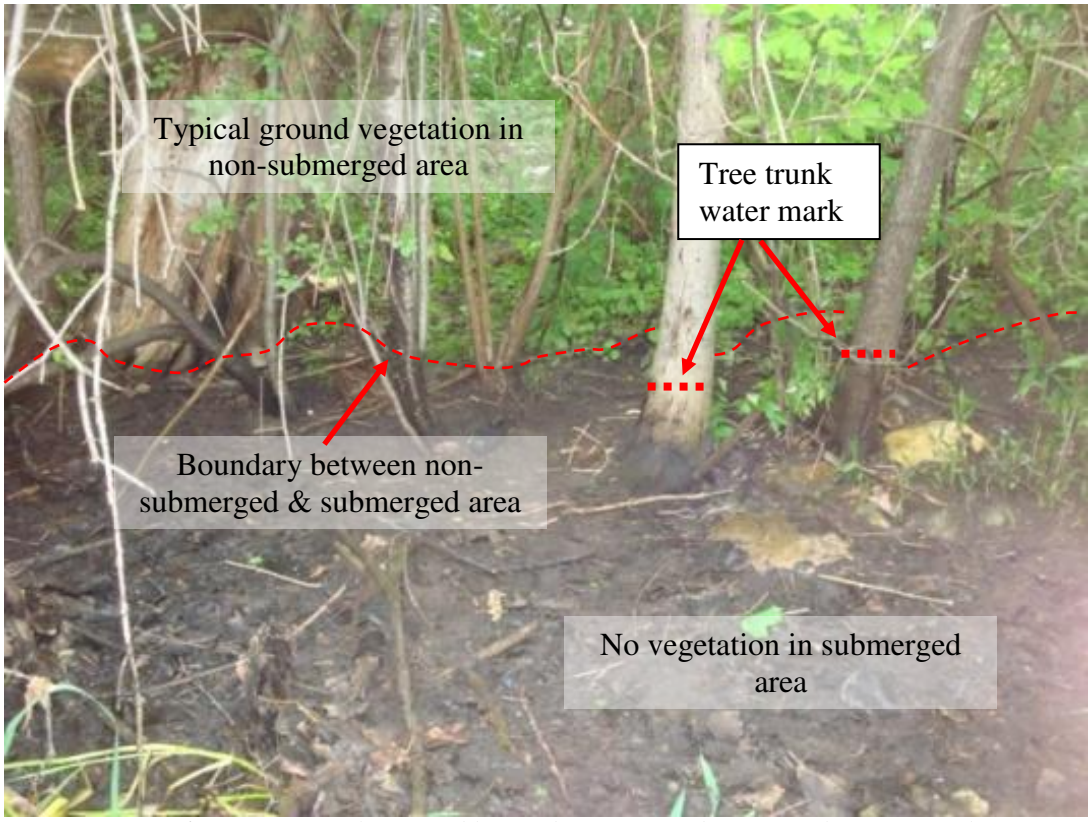
During the site visit, it was observed that the failure location was at a local natural depression that was receiving and accumulating surface water from a wider area. After careful inspection, the authors hypothesized the existence of seasonal ponding water. The surface soil on the uphill side of the embankment was very wet with vegetation that is typical of marshes, such as reeds. Next to the embankment where the water appeared to nearly permanently ponding and below trees there was no vegetation (see web-based supporting information titled “Photos and “Videos”). These conditions were found to be unique compared to other locations along the axis of the embankment. In addition, the level of water could be clearly seen as a watermark on the trunks of trees, as shown in Fig. 6. Based on these observations it was evaluated that the depth of the ponding water could have reached up to 120 cm. Local residents confirmed the existence of ponding water adjacent to the embankment. In fact, it appears that a neighbor used to feed visiting ducks at that location. Retention of ponding water was not part of the original embankment design. It is important to note that ponding water existed for at least some

Figure 6. Area previously covered by ponding water and water mark on tree trunks.

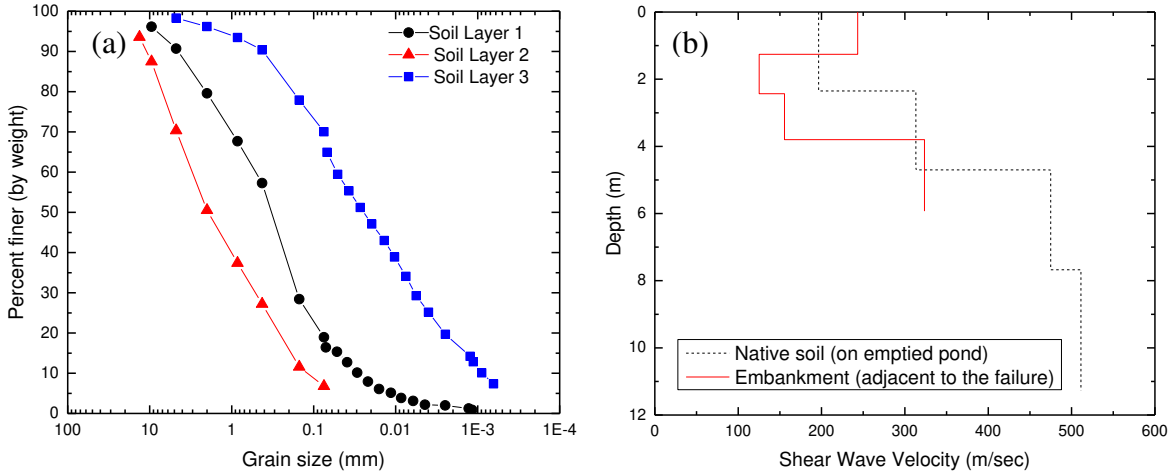
Soil Layer 1: This soil layer represents the main embankment layer, as shown in Fig. 5, and is classified per USCS as silty sand (SM). 18.9% of the material are non-plastic fines as shown in Fig. 8a. Since undisturbed samples were impossible to collect for the sandy fill, tests were conducted on reconstituted specimens at two different density states to evaluate the range of shear strengths expected for these materials. The direct shear tests were conducted in dry conditions. The shear strength of the material at a dense state was evaluated on the basis of direct shear testing, and the peak friction angle was found to be equal to 46°, whereas the post-peak was found to be equal to 38° without any cohesion, as shown in Fig. 9. The large-displacement friction angle at a dense state is approaching the peak friction angle of the soil at the loose state that was found to be equal to 35°. The hydraulic conductivity of the soil at a dry unit weight of 1.71 gr/cm^3, was equal to 5.1*10^{-5} cm/sec based on a falling head hydraulic conductivity test conducted in the laboratory.

Figure 8. Results of (a) grain size distribution analyses and (b) in-situ shear wave velocity

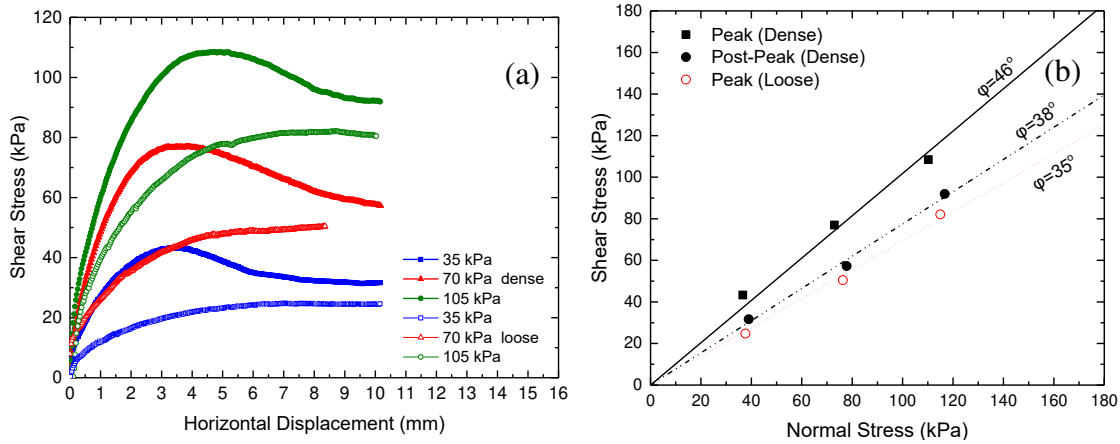
Figure 9. Direct shear results at nominal vertical stresses of 35 kPa, 70 kPa, and 105 kPa on reconstituted specimens of Soil Layer 1.

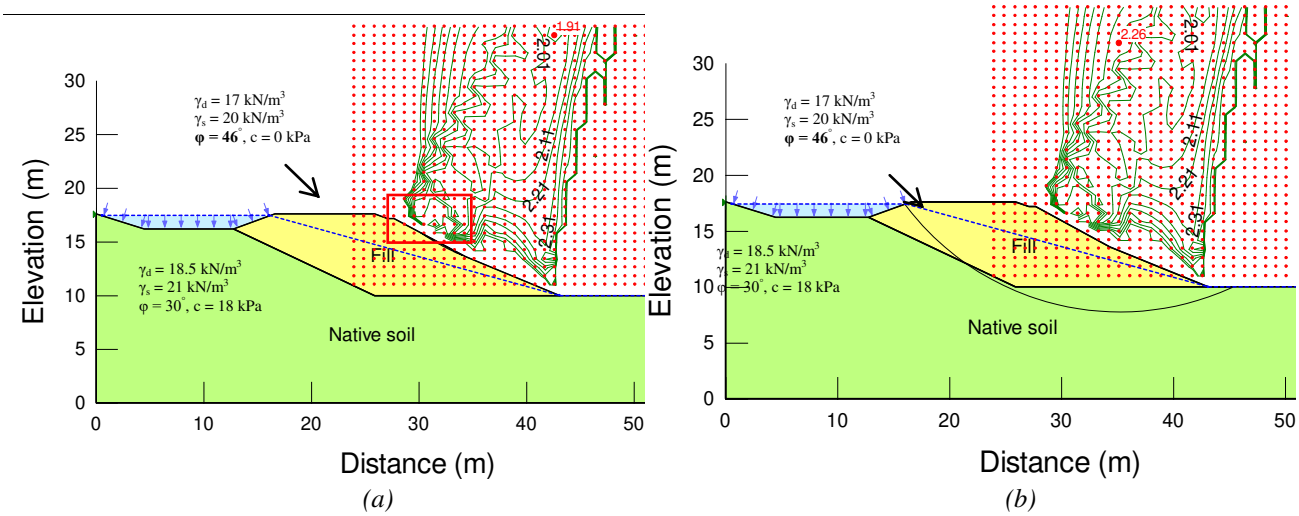
Following site characterization and the assessment of the embankment and failure surface geometry, stability and seepage analyses were conducted using the software programs SEEP/W and SLOPE/W (Geostudio, 2007) and the Spencer method of analysis (Spencer 1967). For stability assessment, parametric analyses were also conducted for reasonable variations of soil properties, as well as variations of the water depth of the ponding water (60 – 120 cm) that is reasonably well documented based on the field observations. These parametric analyses are critical in assessing the impact of uncertainties in the results. The parametric stability analyses indicate that even for the highest ponding water depth, the factor of safety remains significantly higher than one, i.e., it varies between 1.4-1.9 (for friction angles equal to 38° and 46° respectively) for a shallow failure surface that is restricted within the embankment, and is shown in Fig. 11a within the red box. Note that although the failure planes shown are "classic" numerical failure surfaces of purely frictional material with zero cohesion, even for low cohesions of 1-3 kPa, the observation that shallow failure surfaces are most critical remains valid. Higher values of factor of safety that vary between 1.5 and 2.3 were calculated for deeper failure surfaces that intersect the native soil (soil layer 3). Example results of the analyses are presented in Fig. 11.

Figure 11. Indicative results of embankment stability analyses for hydrostatic pore pressures. (a) showing lowest Factor of Safety (FS) of 1.91 for shallow failure planes (in the red box); (b) showing indicative FS of 2.26 for a failure plane that intersects the native soils.

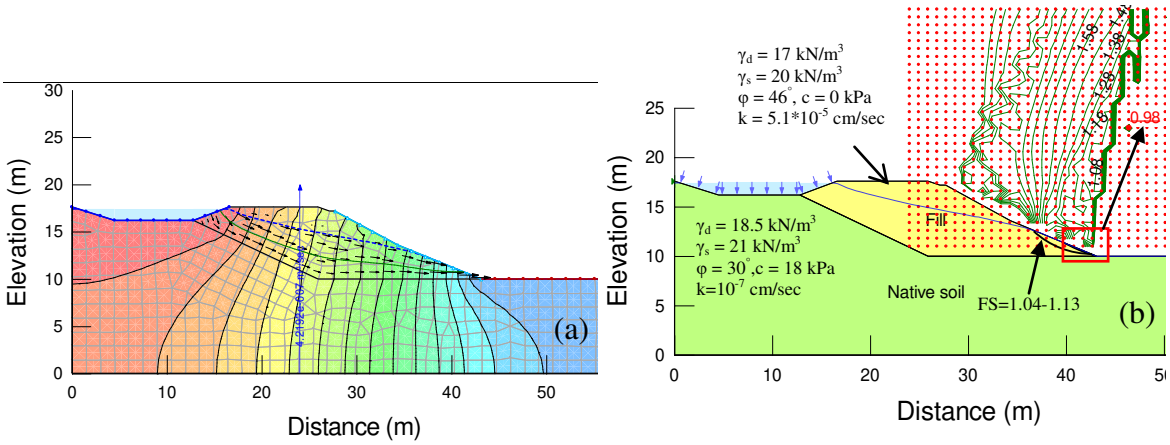
Subsequently, seepage analyses were conducted using the estimated hydraulic conductivities. As described earlier, the natural soil has significantly lower hydraulic conductivity than the embankment soils. Thus, the analyses indicate that when the ponding water depth increases, the exit gradients at the toe of the embankment become high, and vary between 0.48 and 0.78, which are dangerously high and close to critical gradients (~0.9). The stability analyses using the calculated hydraulic pressures, indicate failure of the embankment with factors of safety around one, as shown in Fig. 12. Note that this is not surprising as the seepage analysis gives a more realistic pore pressure profile (Fig. 12a) than that of an arbitrarily assumed piezometric surface (e.g., Fig. 11) with the flow concentrating more on the higher hydraulic conductivity soil. The results, indicate that the failure is caused by the high pore pressures that may even cause piping. The numerical results, are supported by the following interesting field observation: The reeds in the ponding water area adjacent to the embankment were found to be bent sideways and positioned horizontally with a direction that was pointing with great accuracy to the exact location where the ponding water initially drained quickly, as shown in Fig. 12.

Figure 12. Indicative results of combined (a) seepage and (b) stability analyses using seepage analyses results
