A Large Scale Landslide in a Coal Mine in Marly Formations: Evaluation, Analysis and Rehabilitation

KEYWORDS: Landslide, marl, progressive failure, coal mine, rehabilitation

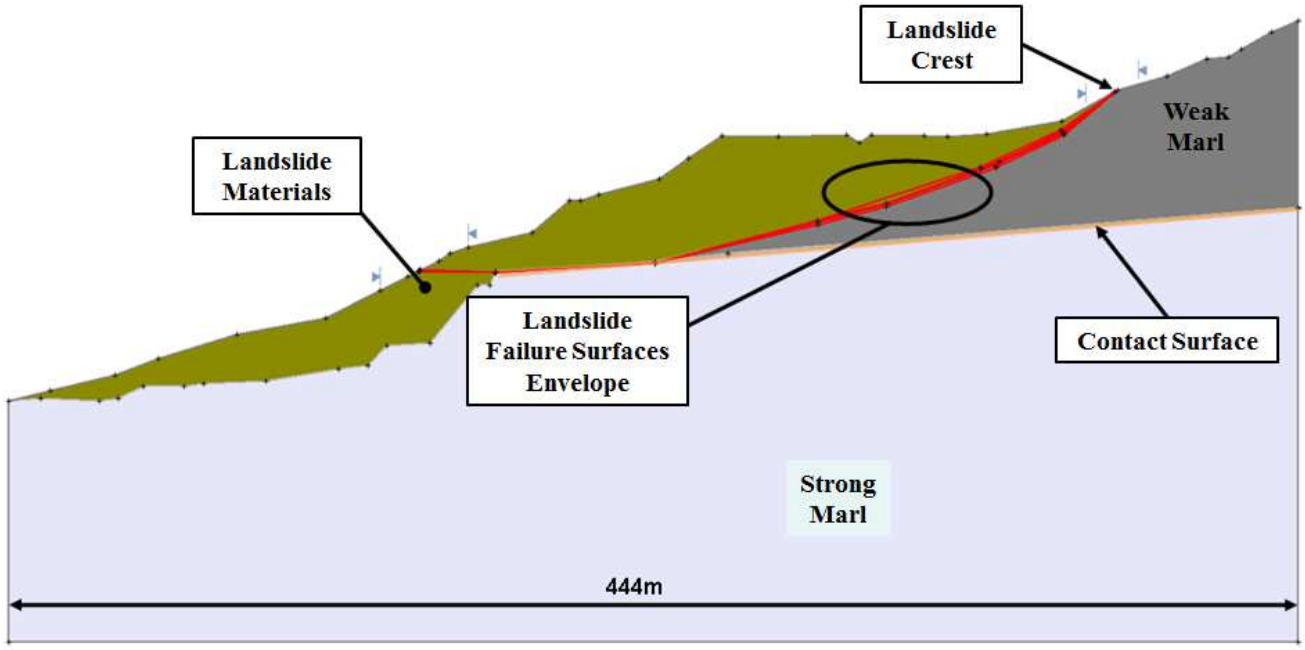
Figure 10. Analysis Section 3 after the landslide

The relevant analyses yielded results of the safety factor between 1.06 and 1.11, which were considered marginal, given the possible further deterioration of the shear strength of the materials involved in the slides, due to ongoing movements, especially during the rainy season in the area. Specifically, analyses of Section 2 resulted in a minimum value of the safety factor equal to 1.11, whereas the corresponding minimum value from Section 3 was 1.06. Analyses with free selection of surfaces by the software were not performed, as these would yield unrealistically low values of the safety factor (considerably <1), under the assumption that the total mass included in the landslide envelope had been downgraded to its residual strength (zero cohesion and low friction), which was not the case due to monolithic, undisturbed blocks existing within the slid mass. The fact that the resulting safety factor values were rational, i.e. marginally larger than unity, indicating a temporarily stable situation after a main landslide event, enhanced our confidence in the assumptions that were made.
