Estimation of the Hydroconsolidation Susceptibility of the Anthropogenic Fill of the Historical Center of Thessaloniki, Greece

KEYWORDS: hydroconsolidation, anthropogenic historical fill, collapse settlement, oedometer simulation, Thessaloniki's Metro

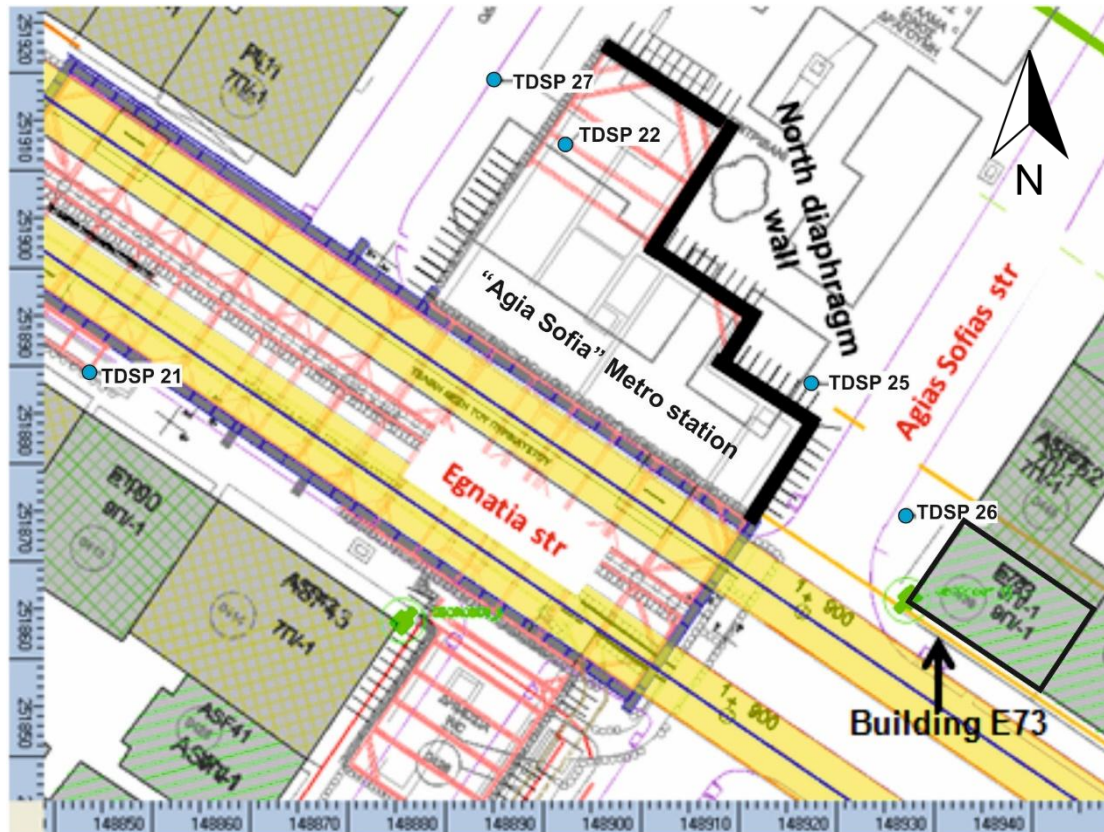
The area of investigation is adjacent to the construction site of the "Agia Sofia" station of Thessaloniki's Metro. During the construction of the station's north diaphragm walls displacements were observed on an adjacent block of flats at the corner of Agia Sofia and Egnatia streets (building E73). The displacements resulted in the deflection of the building towards SW. Systematic measurements of the displacements on the foundation ground were carried out to investigate the phenomenon as well as measurements of the groundwater level in piezometers of the construction area as shown in Figure 3.

Figure 3.Planar view of the construction of diaphragm walls and piezometers (TDSP 21-27) in "Agia Sofia" Metro Station, along with building E73.

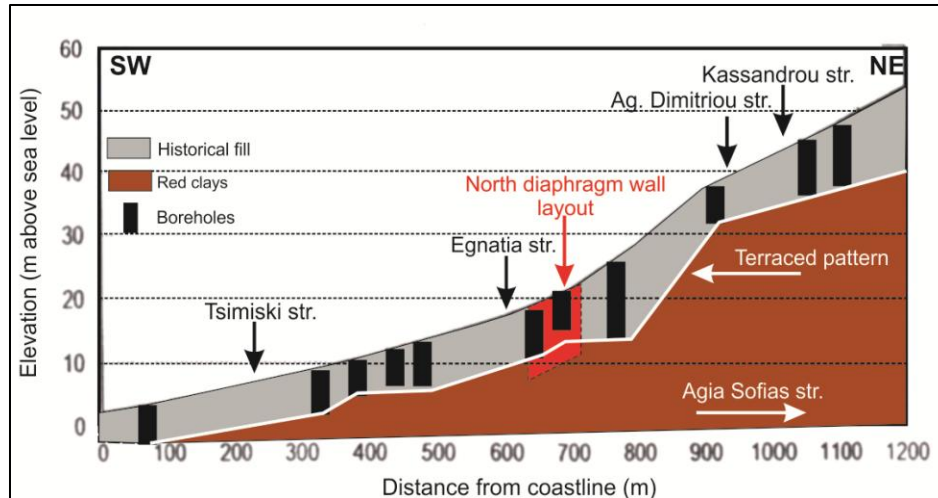
Figure 4. Cross section along Agias Sofias street indicating the terraced pattern of the soil strata underneath the historical fill (modified from Chatzigogos et al, 2006).

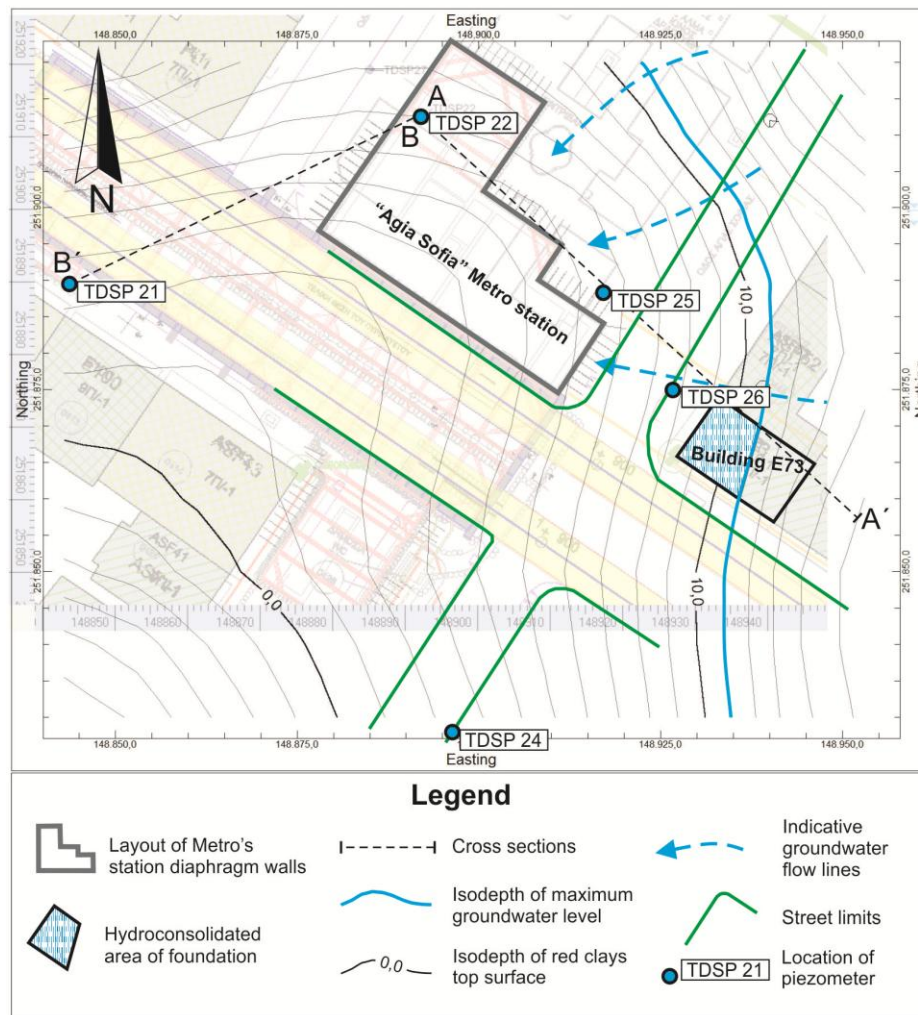
*Figure 5. Map of the investigation area with the isodepths of the red clays.*

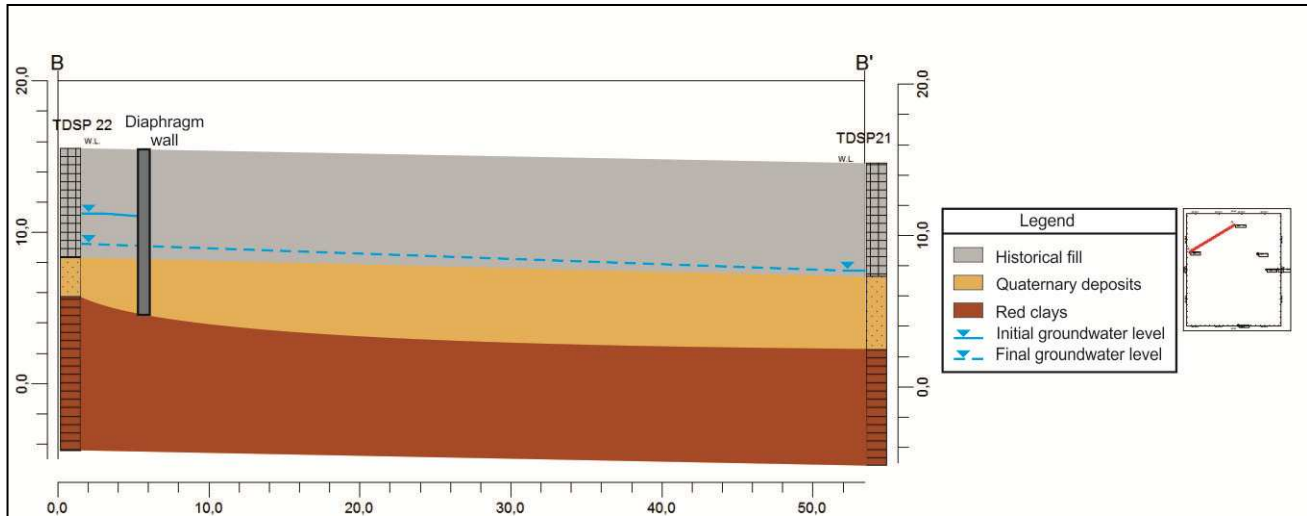
Figure 6.Geological cross section in NE-SW direction along boreholes TDSP22-TDSP21.

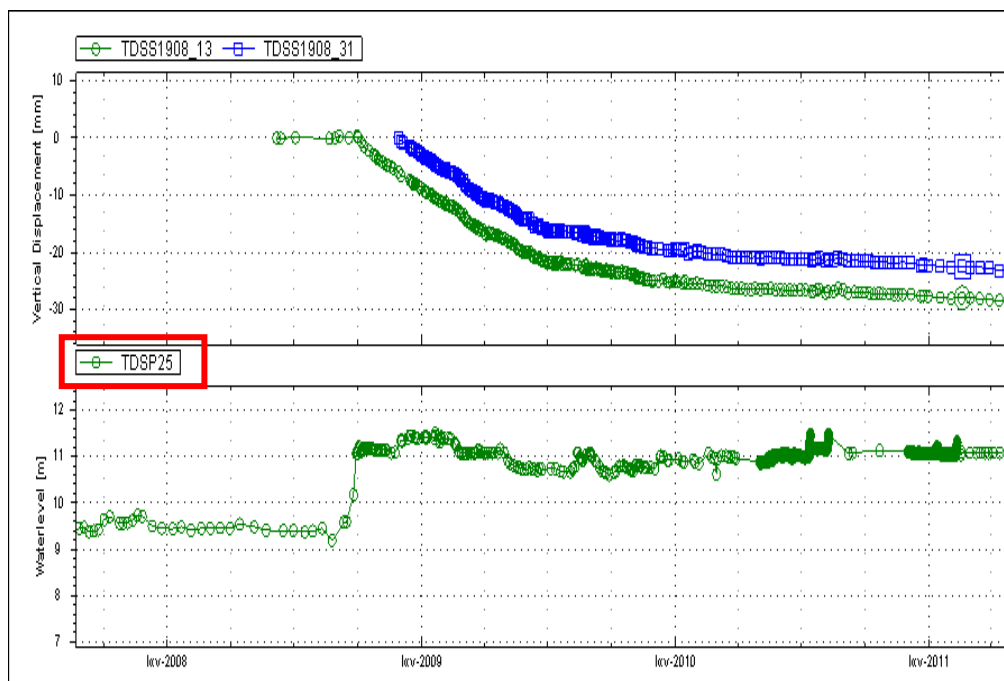
The works in the station begun with the construction of the northern side diaphragm walls. This created a cutoff barrier to the underground flow of the perched water table resulting to a significant local rise in piezometers TDSP22, TDSP25, TDSP26 and TDSP27 shown in Figure 7, as water flow is bypassing around the diaphragm walls. After the bypass to the SW the water level drops back to the normal level and that is why no rise is detected in piezometers TDSP21 and TDSP24 that are located S-SW of the diaphragm walls. The total rise reached 1.5 m and displacements - settlements were simultaneously observed on the aforementioned building (E73) at the corner of Egnatia and Agia Sofia streets. These displacements resulted in a deflection (inclination) of the building towards Egnatia str. (the free face of the building). The displacement reached 30 mm in a time period of 3 years starting from September 2008 (Figure 8). An additional issue that required interpretation was that the displacements did not affect equally the entire area of the building foundation but only its W-SW section and they were observed during a rise and not a drop of the groundwater level.

Figure 7.Settlement in building E73 following the rise of the water table (borehole TDSP25).

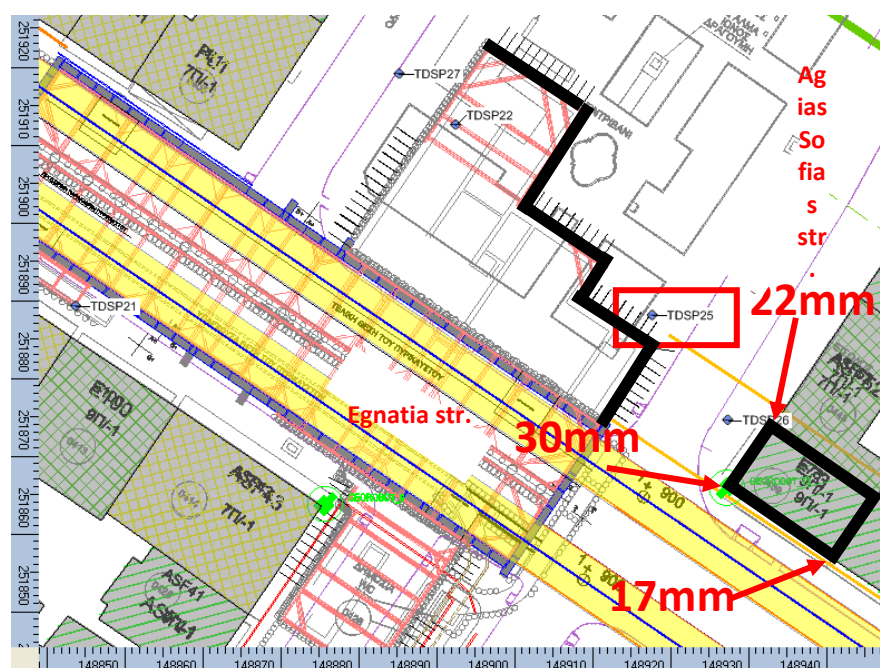
Figure 8.In situ measurements of vertical displacements .

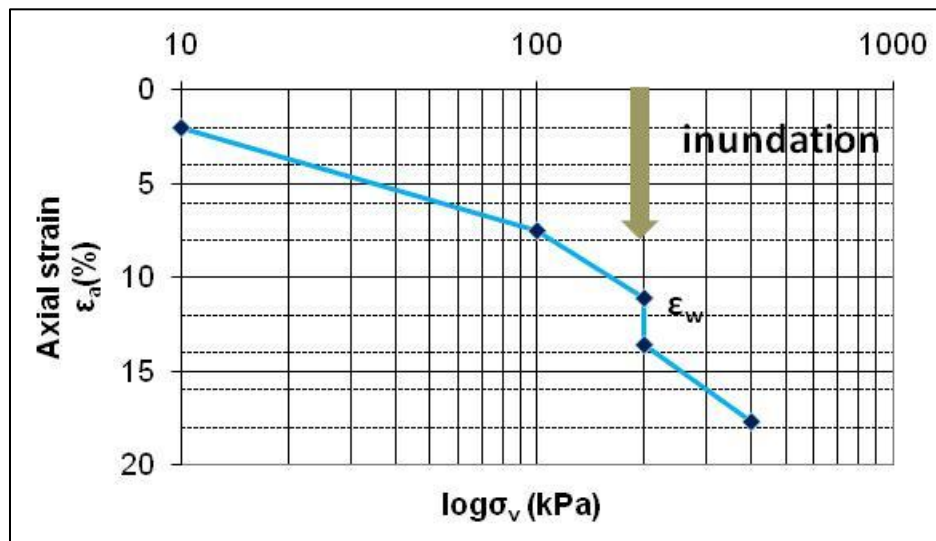
Figure 10.Axial strain due to wetting of Thessaloniki's historical fill at different stresses

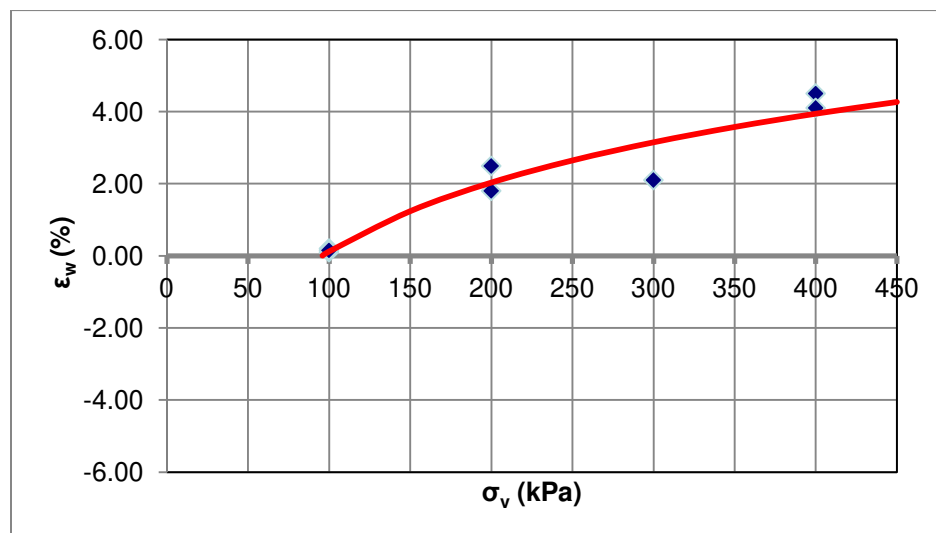
The test program was carried out for samples from the historical layer and Table 1 presents the results for ε_w values due to wetting of the samples under constant load. Figure 9 shows the change of void ratio due to hydroconsolidation of sample 4 for constant load (200 kPa) during wetting. The results of Table 1 produced the characteristic hydroconsolidation curve of the studied layer as seen in Figure 10, which describes the volume change behavior of the layer after wetting under constant load. There is swelling of the layer for stress <95 kPa and volume decrease for stress >95 kPa. As an example, the volume change calculated due to wetting under constant stress of 400 kPa is ε_w=4.1%.

*Figure 9.Axial strain due to wetting under constant load of 200 kPa.*

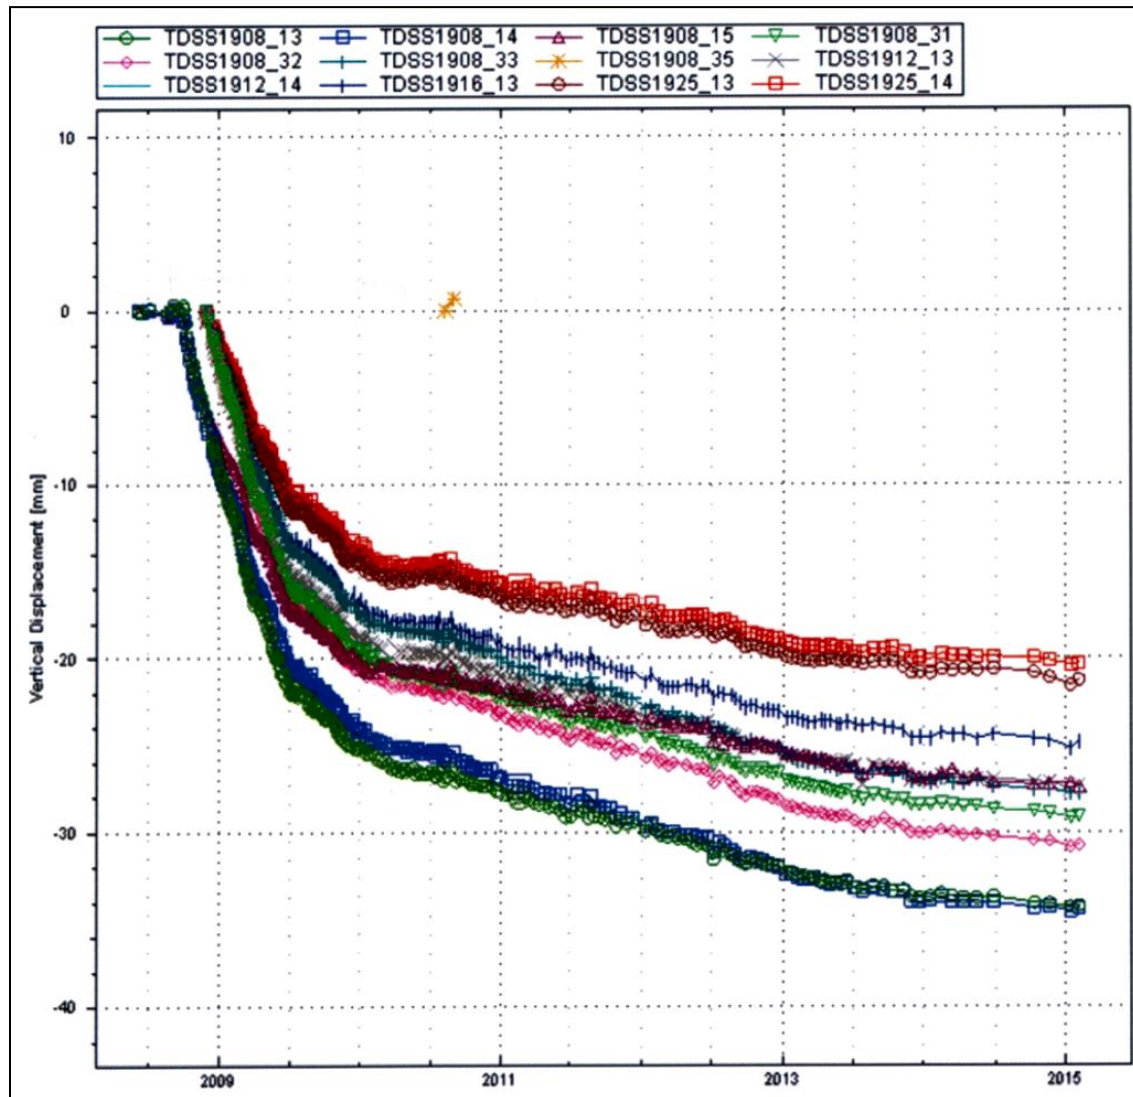
The in situ measured displacements shown in Figure 11 correspond to a maximum deformation of approximately 2.25% due to hydroconsolidation for a groundwater level rise of 1.5 m. The maximum displacement measured at the SW corner of the building for a time period of more than 5 years is 34 mm and still increases. Despite the fact that all measuring points show different magnitude of displacement they all produce displacements of relatively high rate for the initial 9 months and then the rate decreases dramatically. The same mechanism is displayed in the displacement-time curves after inundation in the laboratory tests in Figure 12. An initial deformation at high rate takes place representing the collapse of the structure after wetting and then the soil is consolidated at a much slower rate.

Figure 11. In situ measurements of vertical displacements in the perimeter of building E73.

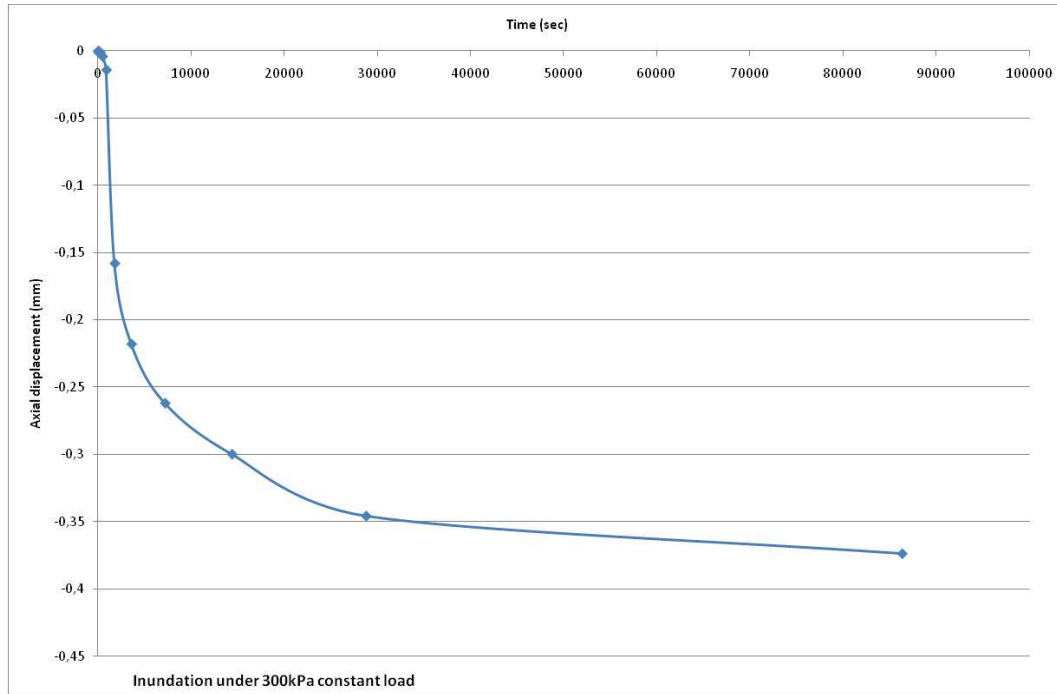
Figure 12. Laboratory displacement-time curves after inundation.

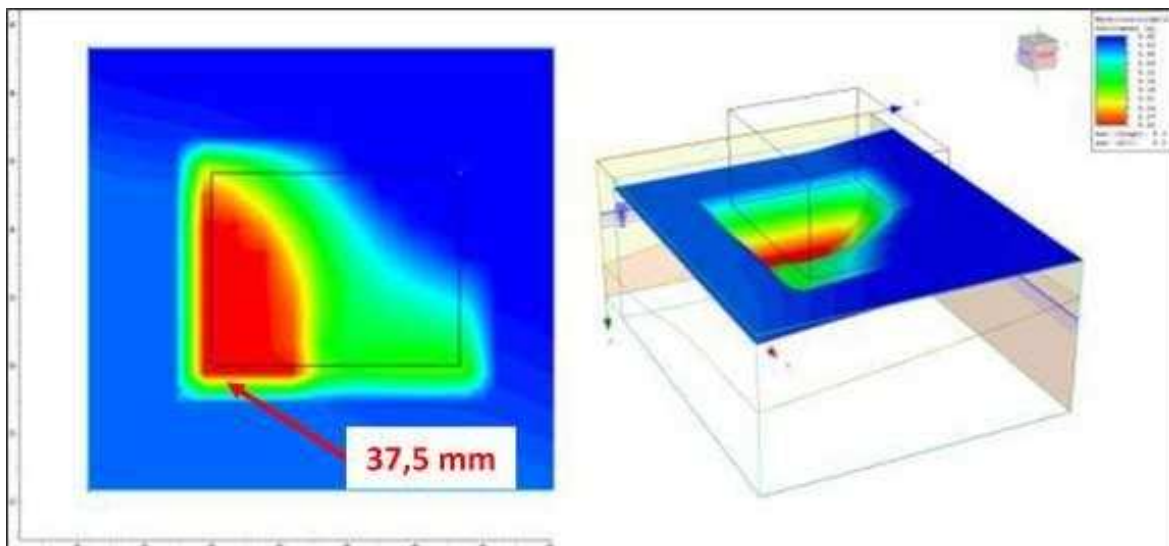
In comparison to the in situ measurements, the anticipated settlements were calculated introducing the layer parameters from the geological model, the groundwater lever rise and the hydroconsolidation characteristics of the layer estimated from the laboratory tests in Settle 3D and the results are shown in Figure 13. As seen from the results there is an uneven distribution of settlements with increased values for the Agia Sofia str. side of the building with a maximum value of 3,75 cm on the SW corner (Figure 13). The Egnatia str. side shows decreasing values of displacements towards E. The calculations correspond to the in situ measurements which also show a gradual decrease of the displacements on the building from SW to NE.

Figure 13. 2D and 3D analysis of hydroconsolidation settlement in building E73.

The differential distribution of settlements is due to the fact that the thickness of the susceptible historical layer (which experienced a maximum groundwater level rise of 1.5 m) is uneven because of its SW dip. Therefore the layer is located

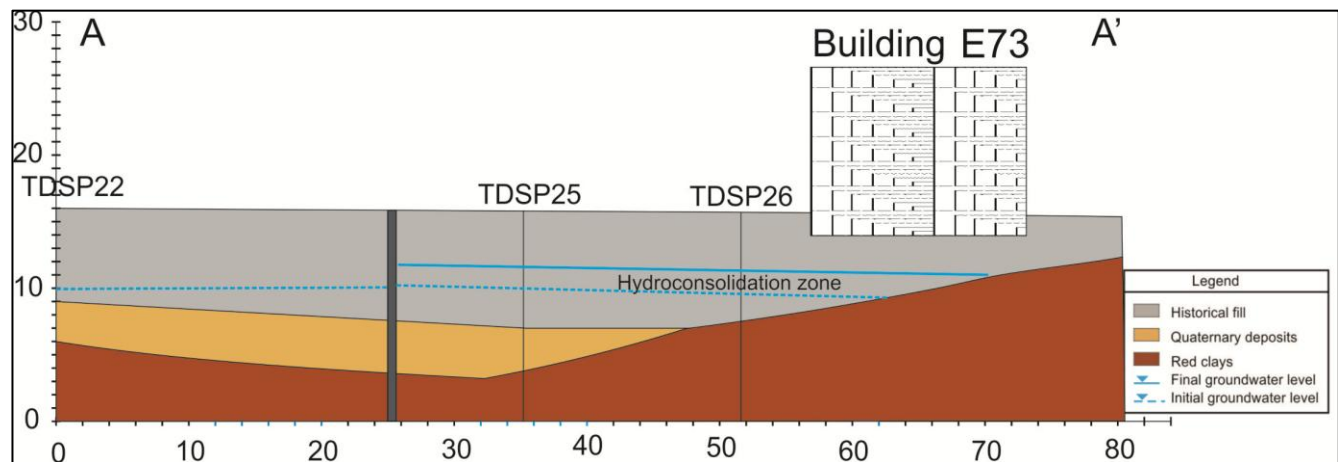
higher towards the NE in respect to the groundwater level and consequently the hydroconsolidated part of the layer becomes less at this direction. Figure 14 shows a characteristic cross section of NW-SE direction that depicts the hydroconsolidated area below the building.

Figure 14. A-A' geological cross-section pointing the hydroconsolidation region.
