Remediation of The
Pissouri Landslide in Cyprus

ABSTRACT*: During the winter of 2001-2002, a landslide of 80.000 m^3 was activated and moved downslope at the Northeast outskirts of the Pissouri village in Cyprus (Limassol prefecture), displacing a section of a country road that was crossing the upper part of the sliding mass and destroying three newly built residences. This paper presents the geologic and hydrogeologic regime of the landslide and its implication on the landslide's mobilization. Geotechnical site investigation and post failure monitoring, in conjunction with slope stability back analysis formed the basis for the study of the slide and subsequently guided the remediation strategy. Various possible interventions to stabilize the slope and allow the safe reconstruction of the displaced road have been investigated and compared considering both economic and environmental criteria. The performance of the remediation measures has been studied in terms of stability safety, using numerical models previously calibrated via back analyses. Observations made during the execution of the stabilization works provided additional data verifying and supplementing the original design.

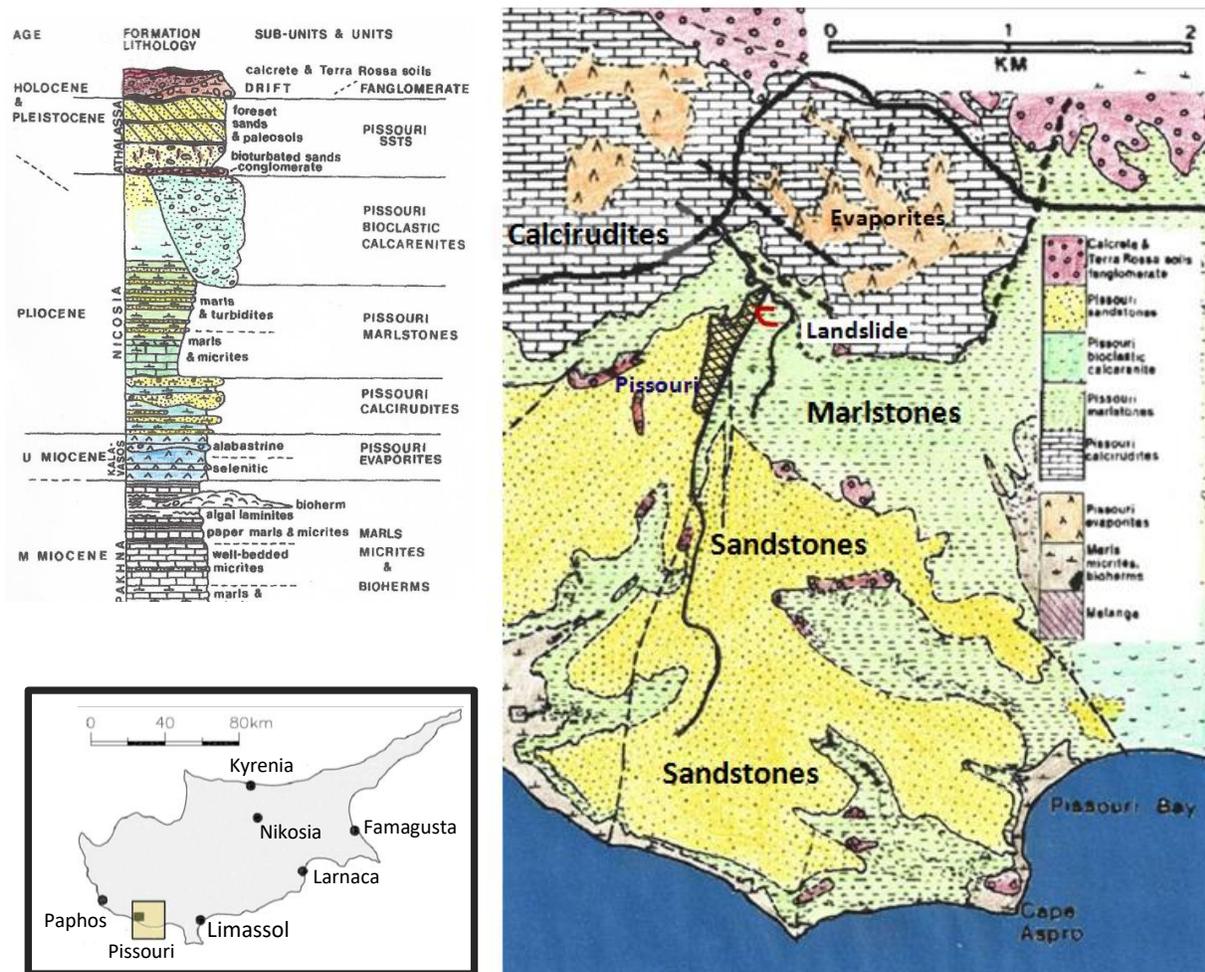
reddish - brown rock which in places disintegrates into a compound of marl blocks within a matrix of stiff fissured silty/clayey soil. The regional distribution of the aforementioned sedimentary units is depicted in Figure 3 (after Stow et al., 1995). The location of the landslide is also noted on the map.

Figure 3. Regional Geology of the Pissouri area. The village is developed on sandstones (yellow) underlain by the Pissouri marls (olive green). Geology after Stow et al., (1995)

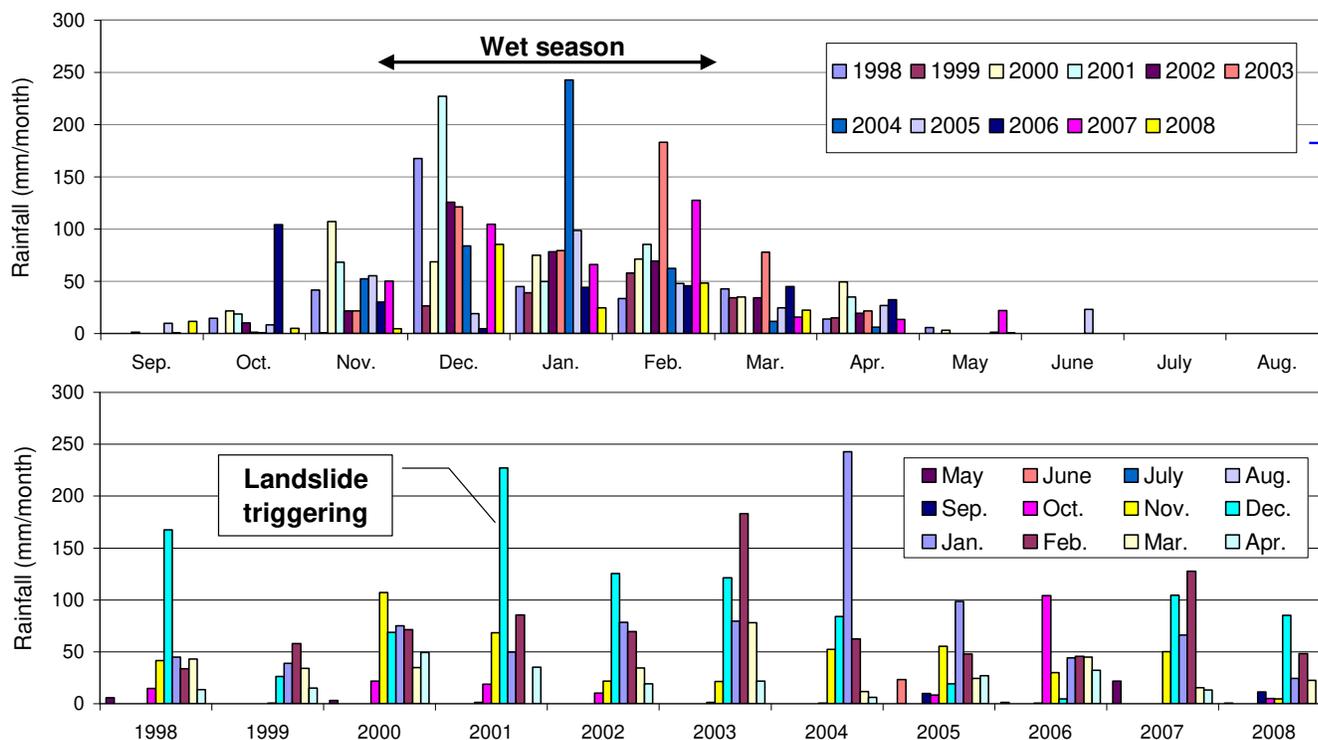
In the Limassol prefecture in particular, the annual precipitation is low, averaging 300-400 mm per year. The monthly rainfall time series retrieved by the Pissouri meteorological station during the 1998-2008 decade is presented in Figure 4. It is observed that during the December of 2001, when the Pissouri landslide was mobilized, precipitation was indeed high, exceeding 230 mm, but not a unique event in the decade. High precipitation undoubtedly triggered the landslide, but the contribution of other factors to slope instability should also be investigated. The high precipitation of December 2001 is associated with subsequent landslide events that took place in other parts of the island, as reported by Hadjigeorgiou et al., (2006) and Kyriakou & Hadjigeorgiou (2008).

Figure 4 Seasonal (upper figure) and annual (lower figure) distribution of monthly precipitation for the decade 1998 ~ 2008. Data from the "Pissouri" meteorological station.

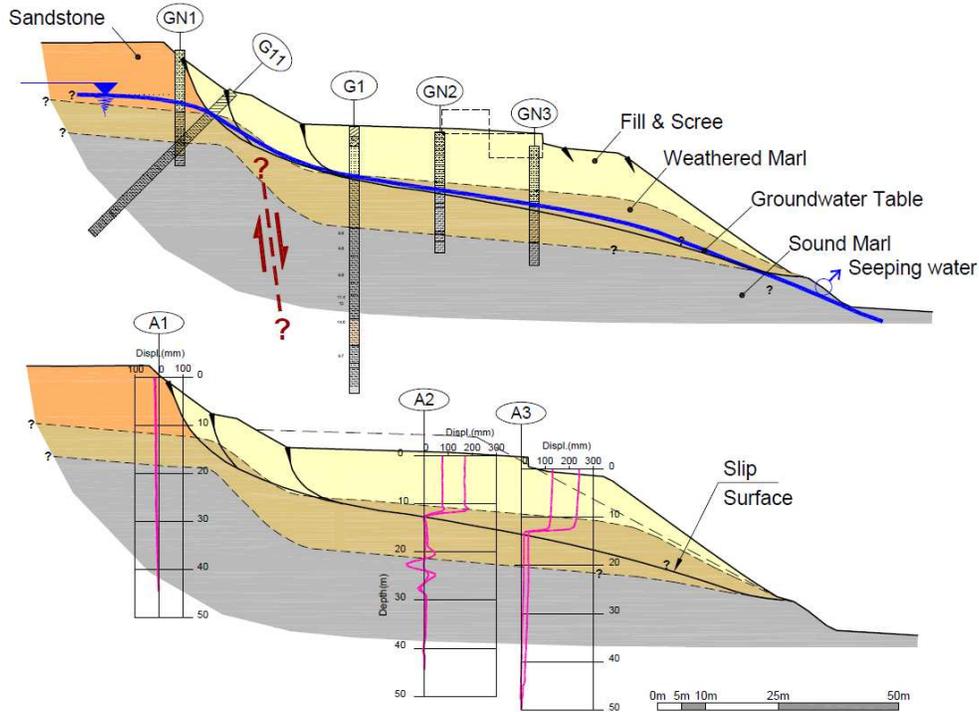
Figure 5. Geotechnical section along the sliding mass. Top: Exploratory boreholes Stratigraphy and ground water table Bottom: Inclinometer readings and location of slip surface.

The slip surface was located by combining the monitoring data from the two inclinometer tubes (A2 & A3) installed within the sliding mass and the careful mapping of slope breaks and cracks, visible on the ground (in some cases), on the cracked pavement of the distorted road, the houses and the paved ground around them. The third inclinometer tube which had been installed further upslope did not show signs of movement (as shown in figure 5) and allowed the identification of the back scarp of the slide with confidence.

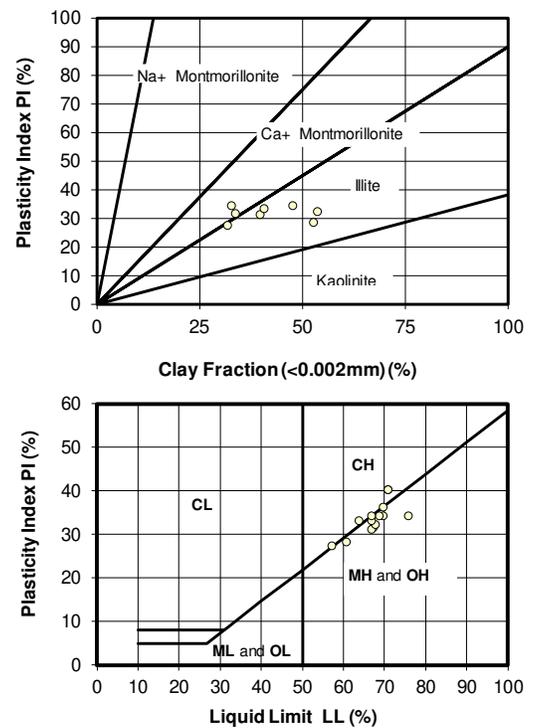
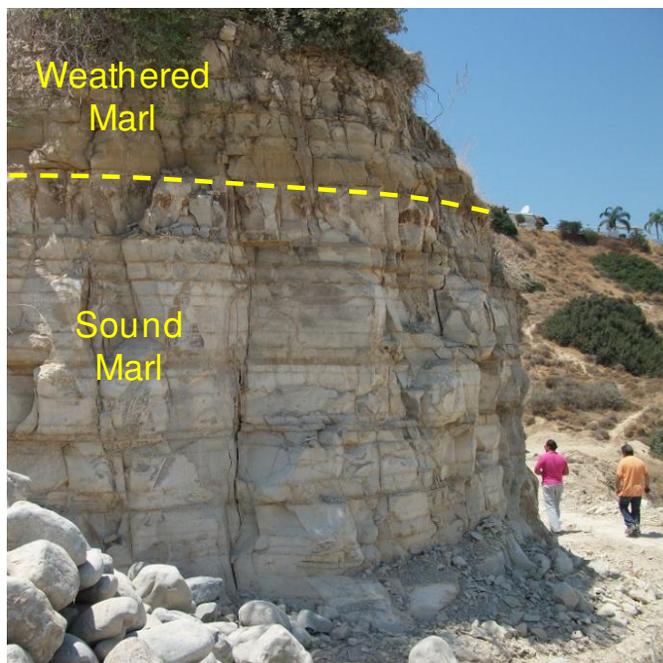
The bedrock is a low strength yellowish calcareous marlstone (UCS≈10 MPa), fairly undisturbed, but marked by a medium to thick bedding (l0 - 100 cm) dipping with a low angle to south-southeast. Stress relief lead to the development of sub-verical joints and fissures and water circulation gradually resulted to the development of a capping weathered crust. Weathering is associated with oxidization and decalcification of the marlstone, the gradual increase in pore volume (further promoting seepage) and subsequent intact strength degradation to that of a stiff soil. In the landslide site the thickness of the weathered marl crust is 5 to 10 meters and the material was encountered in places disturbed and sheared by the landslide movement. The succesion of sound and weathered marl is depicted on the photograph of Figure 6, where the weathered material is noted by the distinct brownish color and its intense fissility. Soil samples obtained from the weathered zone are classified as CH-MH with a plasticity index (PI) ranging from 20% to 35% and clay fraction (CF) between 30% and 60%. Natural water content of the weathered marl does not exceed 30% and the material is generally stiff with SPT values ranging from 25 blows/ft to refusal. Typical classification test results from this zone are also presented in Figure 6.

Figure 6. Left: Typical appearance of the bedded calcareous marl and the overlying weathered crust. Right: Typical soil classification test results performed on samples retrieved from the weathered marl zone.

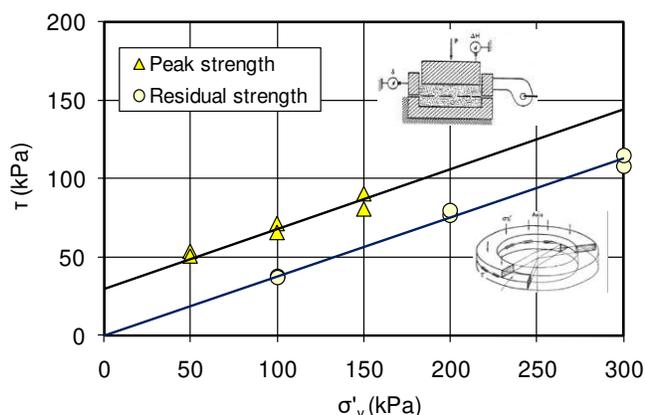
The shear strength parameters of the weathered marl, where the slip surface eventually developed, was investigated in the laboratory by means of a few slow (drained) shear box tests, which averaged to c'=30 kPa and φ'=21º as shown in figure 7. Residual shear strength parameters, were obtained from ring shear tests (Broamhead ring shear apparatus) which yielded values of c_r'=0 and $φ_r$'=21º. The values of the residual angle of shearing resistance determined directly by the ring shear tests are compared with the dataset presented by Skempton (1985) (Figure 8) and are found to be in the upper bound of the scatter. This is probably due to the fact that the particular ring shear tests were carried out on fairly silty samples (classified as MH) and not on clayey ones.

Figure 7. Shear box and ring shear test results on soil samples from the weathered marl horizon. Peak strength c'=30 kPa, φ'=21°. Residual strength c_r'=0 kPa $φ_r$'=21°.

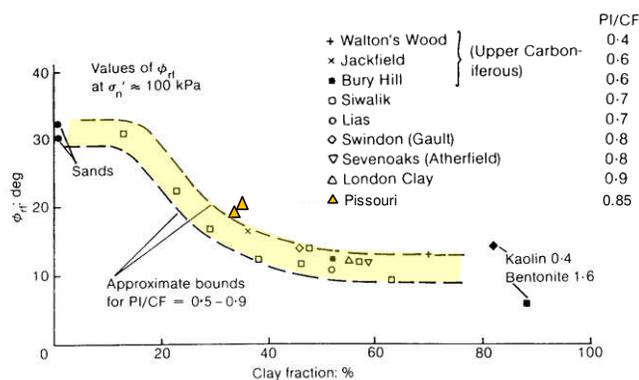
*Figure 8. A comparison of the residual angle of shearing resistance of the weathered Pissouri marl with the dataset presented by Skempton (1985).*

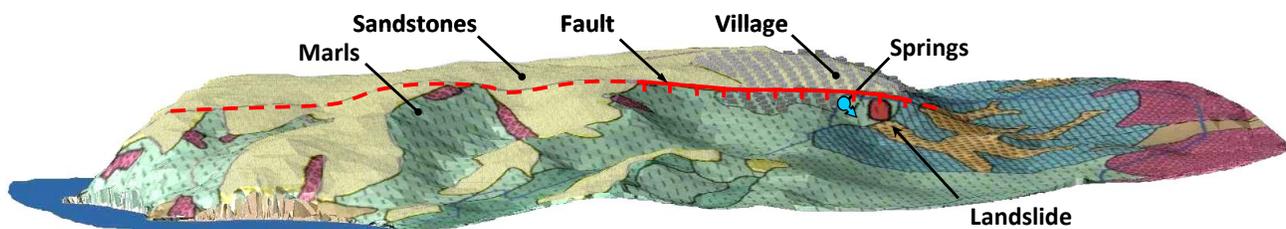
A field survey of the broader landslide area, led to the location of a number of natural springs and a few manmade wells, as well the mapping of distinct stratigraphic and tectonic features. The hydrogeologic regime was further studied by projecting the geological units presented in Figure 3 on a digital elevation model of the broader Pissouri area. Figure 9 presents the outcome of this exercise. The vertical scale of the ground relief is stretched (H/V 2:1) to better depict the interplay of surface drainage patterns and geological structure. From the figure it becomes evident that the more permeable capping sandstones of the Pissouri hilltop comprise the main aquifer of the area. A few wells sunk in the top hill area have been exploited constantly in the past by the villagers and provided the main source of water for the settlement. A study of the drainage pattern indicate that surface water flows in low gradients towards the southeastern edge of the village (Figure 10) and infiltrates the capping sandstone stratum, during the wet season, recharging the aquifer. Subsequently, groundwater seeps towards the slopes surrounding the hill and overflows at specific locations of the contact between the more permeable

Figure 9. Hydrogeologic setting of the Pissouri area. Geological units (after Stow et al., 1995) are projected on the distorted relief of the Pisourri hill (exaggerated vetical scale H/V 2:1). Location of the landslide and the springs with respect to the major hydrogeologic units are also noted.

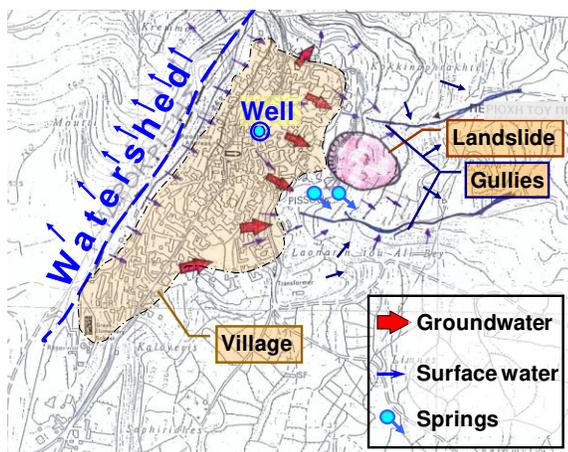
sandstones with the impermeable underlying marls, as shown schematically in Figure 10. A few seasonally discharging springs and water collecting wells have been located at the southeastern edge of the hill, near the landslide site (see Figure 11), which are exploited by local farmers for irrigation. A probable fault trending NNE-SSW, mapped by Stow et al. (1995), is running parallel to the eastern boundary of the village and dissects the sandstone layer. This fault is believed to control the steeper slopes of the Eastern side of the hill and is probably associated with the presence of the water springs down slope.

Figure 10. Surface and subsurface drainage patterns. Arrows indicate surface and subsurface water flow. Springs and wells are also noted.

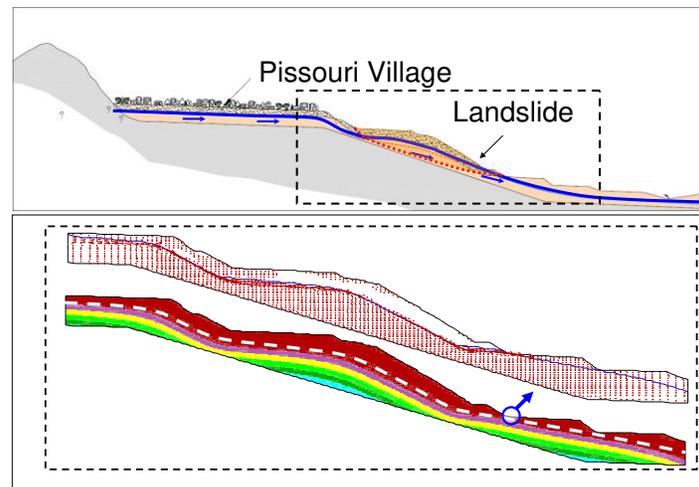
Groundwater flow and pore pressure distribution within the sliding mass was further studied, by analysing simple two dimensional numerical models, which were set up by the finite difference code FLAC. Inflow-outflow equilibrium considerations, in conjunction with the seepage analysis, performed by FLAC, provided an additional means to study and verify the water infiltration, movement and outflow pattern in the landslide area. A typical seepage model representing the eastern slope of the village, is illustrated in Figure 12. The piezometric lines have been computed on a number of transverse and longitudinal sections and were used to build the three-dimensional model presented in Figure 13. The inferred piezometric surface is found at shallow depths, in areas where vegetation growth is more intense, as observed in aerial

*Figure 12. Typical results of the seepage analysis (flow vectors and pore water pressures).*

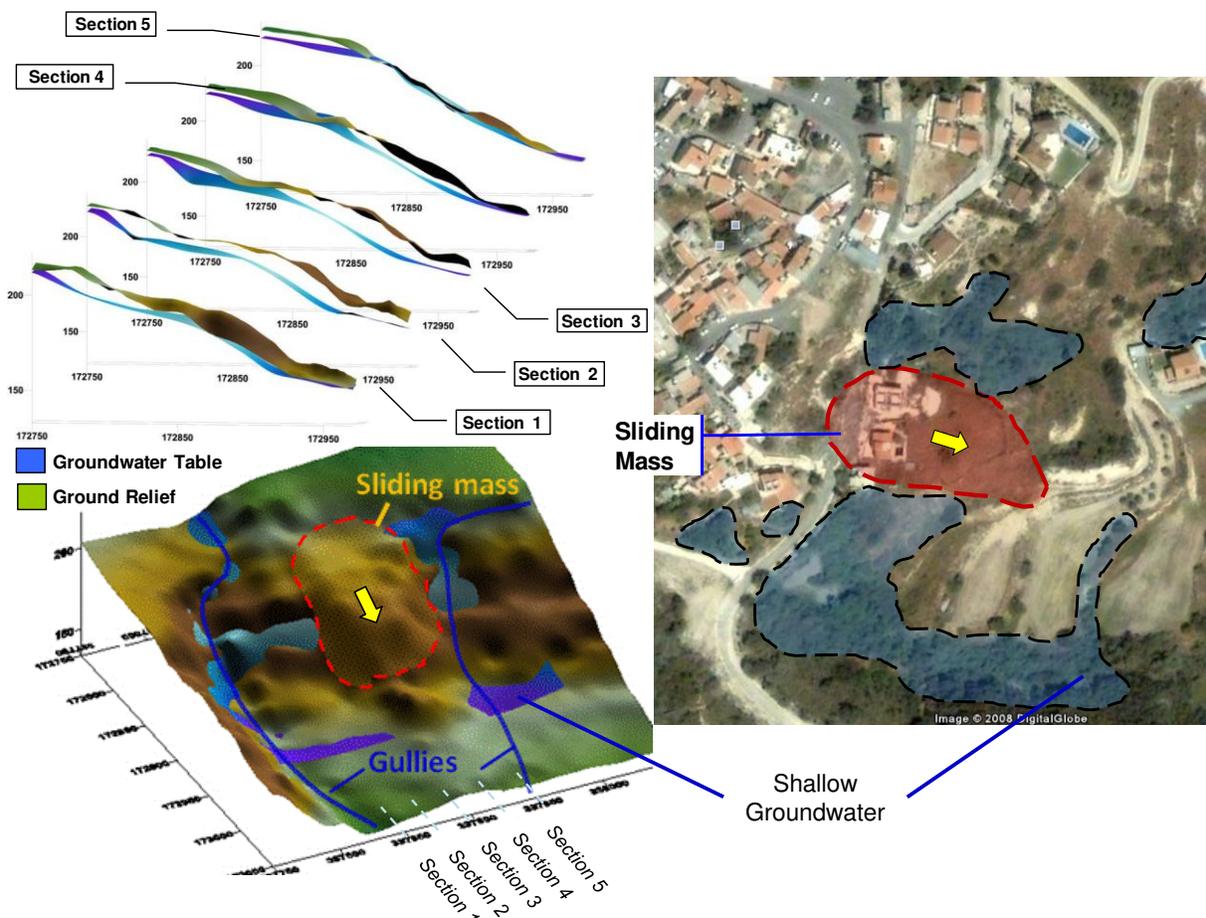
photographs, (Figure 12) and compares well with groundwater level measurements from piezometers installed in the vicinity of the landslide. The piezometric surface of Figure 13 represent the average dry season water table. During a wet season the water table within the landslide mass is expected to rise significantly and the development of a perched water table during thunderstorms should also be considered.

Figure 13. Left: A digital elevation model of the landlide area, overlain to the surface of the computed groundwater table. The groundwater table geometry is also presented as a series of sections in the upper figure.
Right: Blue areas in satelite image indicate areas where the ground water table is at shallow depth and coincide with the most densely vegetated areas.

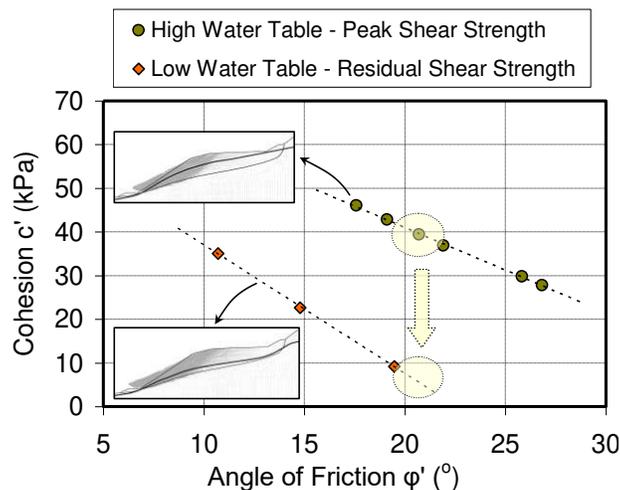
These analyses manifested the fact that an elevated water table can mobilize the weathered marl crust with operational shear strength parameters close to the peak values, as they were determined by the shear box tests performed on the soil samples. They also show that the slide remained mobile after water table lowering, (dry season) if the operational strength values of the weathered marl crust at the failure surface were close to the residual strength values, determined by the ring shear tests. It is concluded that most likely we deal with a new slide, which was brought in the verge of failure due to gradual loading of the upslope area with scree and manmade fill and the gradual progression of the weathering process. The development of high water pressures triggered an already mature slide, which continued to be active even during the dry seasons due to the drop of the shear strength values from peak to residual.

Figure 14. Back analyses results. Estimated mobilized shear strength parameters for a higher and lower water table coincide with the transition of shear strength values from peak to residual.

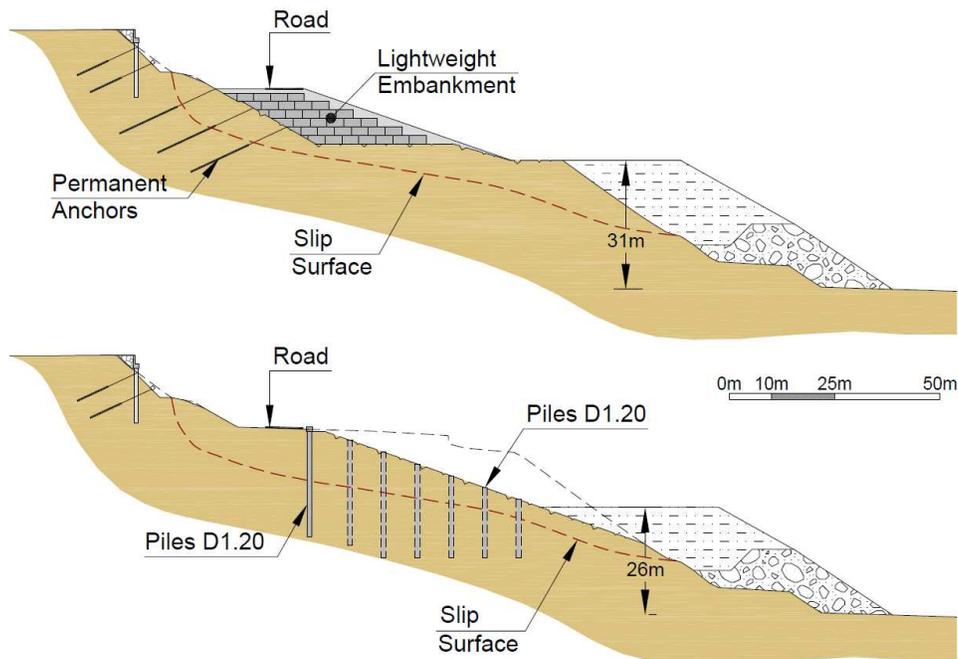
*Figure 15. Landslide remediation - Alternative design solutions.*

In order to develop a robust remediation strategy and to meet the value engineering requirements set by the district administration, alternative stabilization strategies were considered, coherent design options were developed, and subsequently evaluated in terms of economy, constructability and environmental compatibility. A wide spectrum of alternatives was investigated. An initial thought to completely abandon the site and deviate the road did not prove to be feasible. Stabilization of the slide solely by a high and massive toe stabilizing buttress proved also impracticable. Consequently the construction of a modest toe buttress and the simultaneous reduction of ground weight at the upper part of the sliding mass via ground removal and its replacement by lightweight material (EPS geofoam) was the first option developed. A second option involved the construction of a medium sized toe buttress, the trimming of the upper part of the sliding mass to remove as much of its weight as possible and the dowelling of the remaining soil mass, by means of large diameter bored concrete piles. Outline design of the two alternatives are presented in figure 15.

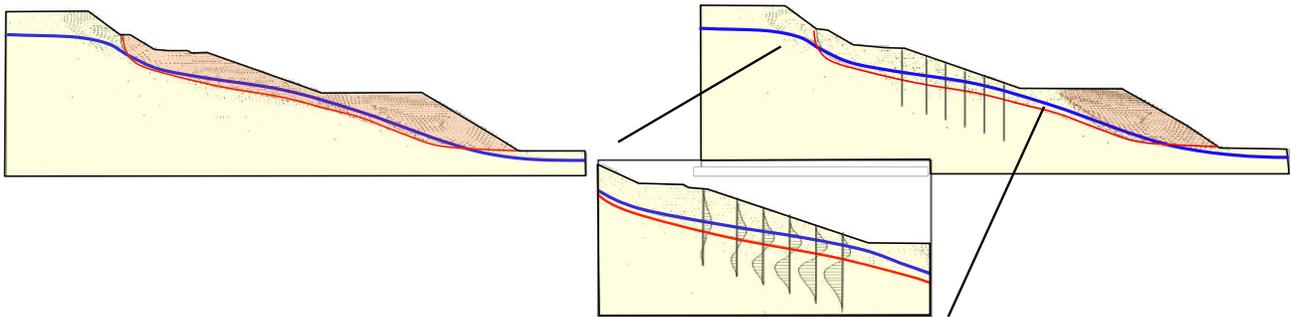
The construction of the toe buttress and the trimming of the upslope area of the landslide, lead to sufficient factors of safety (FOS=1.6) under normal conditions (low water table, static conditions), which though drop to low values with an elevated water table and very low values under seismic conditions. It was also observed that these low factors of safety are associated with mobilization of the entire sliding mass. The dowelling effect of the bored piles isolates and stabilizes the upper part of the sliding mass, while the lower part may remain more critical but still with sufficient FoS. Figure 17 depicts the critical sliding mode with and without the dowelling piles. In this case the raised water table yield a FOS = 1.6 and the seismic analysis a FOS=1.15.

Figure 17. Stability analysis of the remediated slope. Left: Without the stabilization piles the entire sliding mass mobilizes as a single body. Right: With the addition of the piles the toe buttress is more critical.
