Remediation of The Pissouri Landslide in Cyprus

Submitted: 15 May 2015; Published: 16 December 2016
Reference: Alexandris, A., Griva, I.K. and Abarioti, M. (2016). *Remediation of The Pissouri Landslide in Cyprus*. International Journal of Geoengineering Case histories, Vol.4, Issue 1, p.14-28. doi: 10.4417/IJGCH-04-01-02

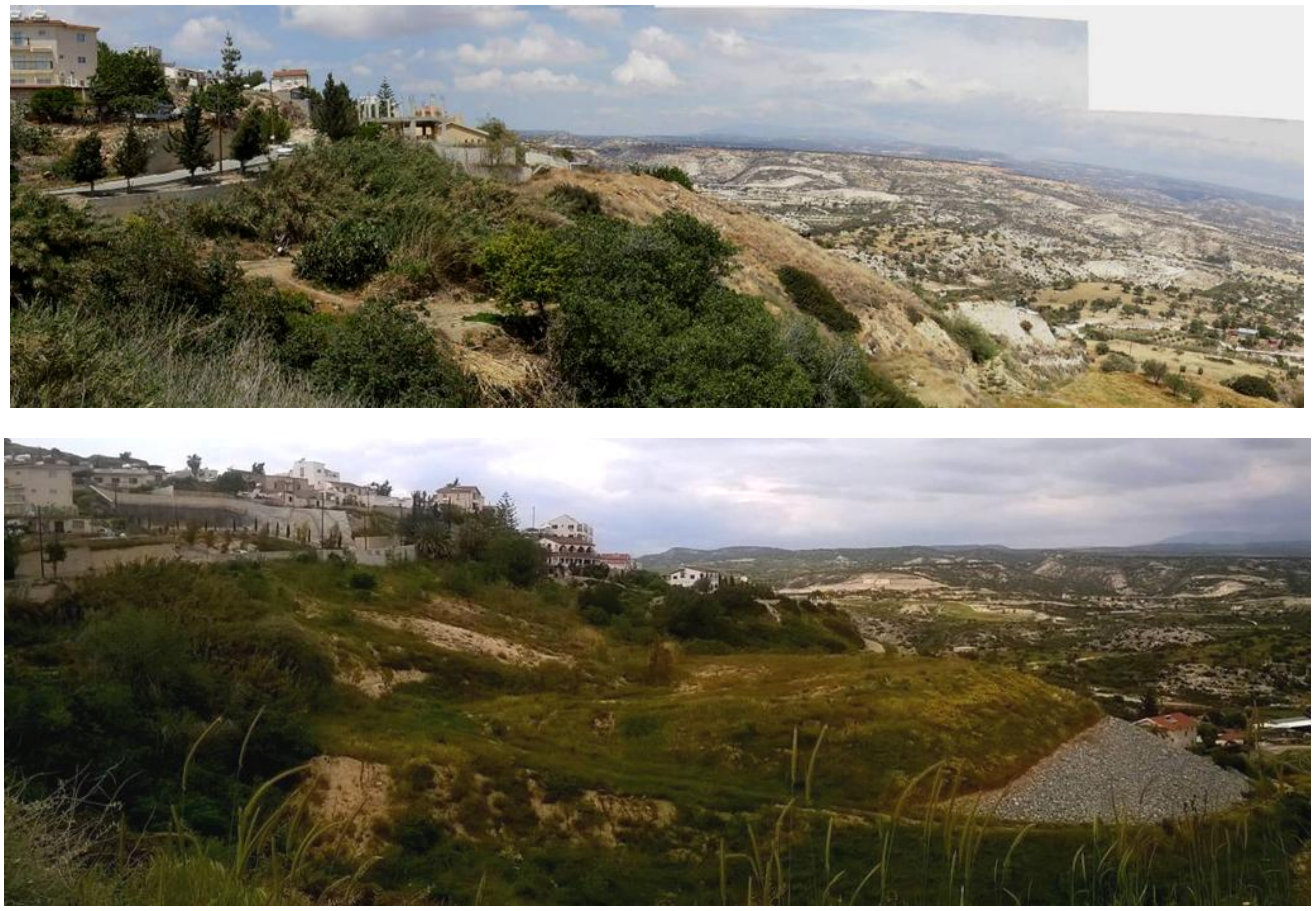
Figure 23. The landslide area before (top) and after (bottom) the stabilization works.
