A High Rock Cut Stabilization in Muscat City, Oman

Tahir M. Hayat, *Vice President, Geotechnical and Geonvironmental Engineering Division, NESPAK , Lahore, Pakistan; email: tmhayat786@yahoo.com*
Tariq J. Bhatti, *Chief Geologist, Geotechnical and Geonvironmental Engineering Division, NESPAK , Lahore, Pakistan; email: tariqjb@gmail.com*
Robert Goldsmith, *Technical Principal- Engineering Geology, Snowy Mountains Engineering Corporation (SMEC), Australia; email: Robert.Goldsmith@smec.com*

ABSTRACT: *A large road box cut was constructed in hilly terrain of Muscat city, Oman, in an area underlain by the geologically complex Sahtan and Mahil formations comprising of limestone, dolomite, sandstone and siltstone with interbedded soft calcareous mudstone. The rockmass contains a large number of small scale faults, shear zones, minor folds and solution cavities. The maximum height of the cut was 50 m with slope angle of 1V:0.25H, and intermediate benches generally 3 m wide. To control vibrations in the urban neighborhood located nearby and avoid damage to the rockmass, a very cautious and time consuming excavation approach was adopted using rock breakers. The excavation work was completed

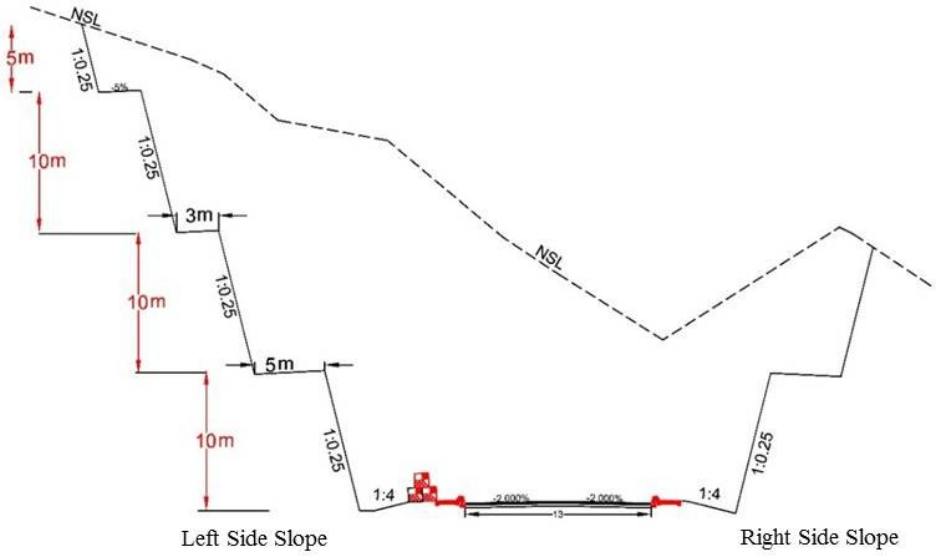
The maximum height of the rock slope in these cuts reaches 50 m with a cut slope of 1V:0.25H (76^o) and 3 m wide benches at every 10 m height interval. A typical section of box cut at RD 0+420 m is shown in Figure 2. The initial design included slope protection measures such as short length rock bolts and reinforced shotcrete.

Figure 2. Slope and roadway configuration at station RD 0+420 m in Box Cut#1.

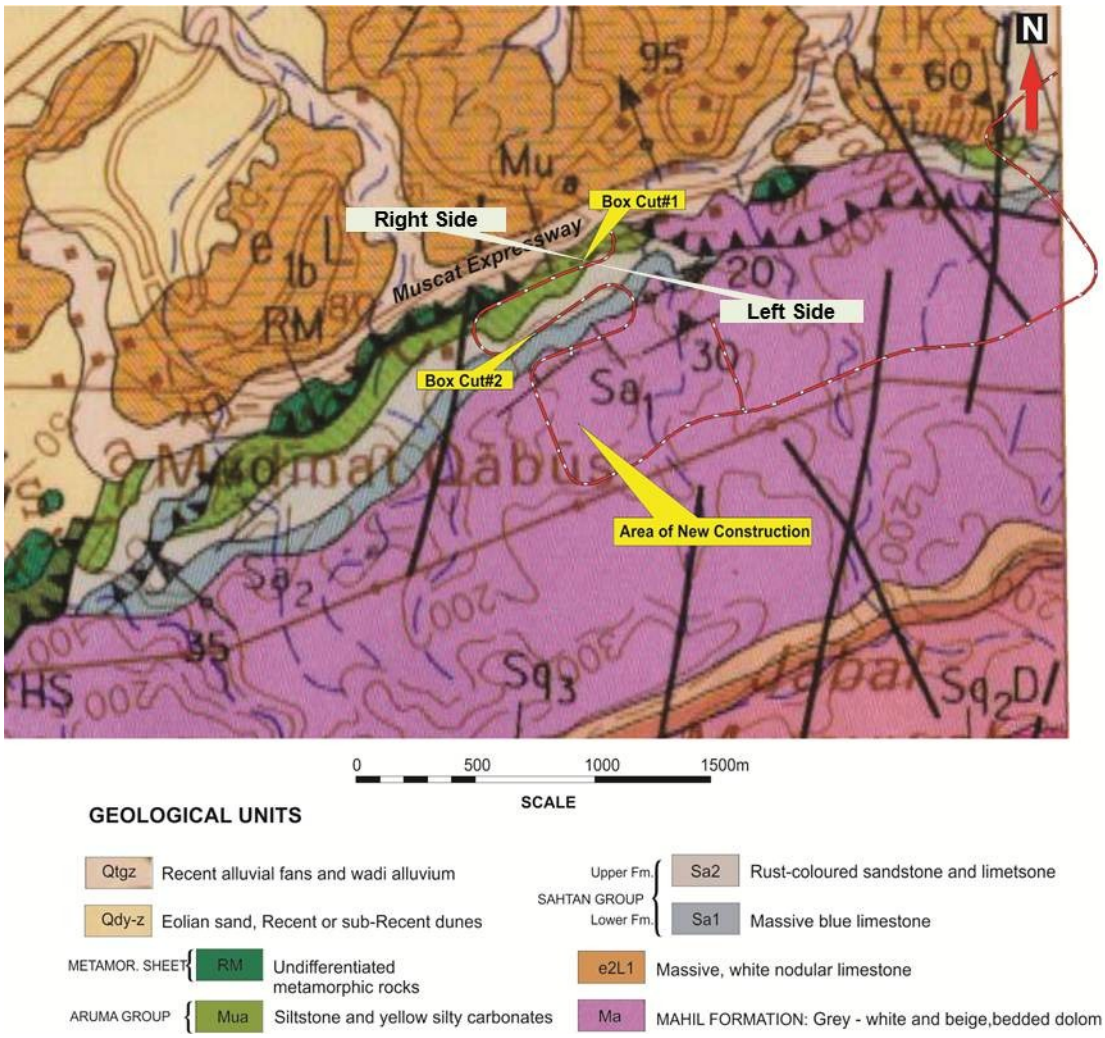
An extract of the Sib area geological sheet is shown in Figure 3. It illustrates the geology of Box Cut #1, which consists of ground making a contact between Aruma Group, and Sa2; the Upper Formation of the Sahtan Group. Box Cut #2 follows the contact between Units Sa2 and Sa1.

It is interpreted that the Lower Formation of the Sahtan Group is exposed in Box Cut #1 and the Upper Formation is exposed partly in box Cut #2. There was a discrepancy between the map and what was observed on the ground, i.e. when the built up landmarks were aligned, the geology did not match exactly and vice versa. This could be due to a shift in datum between the1986 map and the project grid. What was observed and mapped on the ground was used in design.

Figure 3. Geological map of the project area.

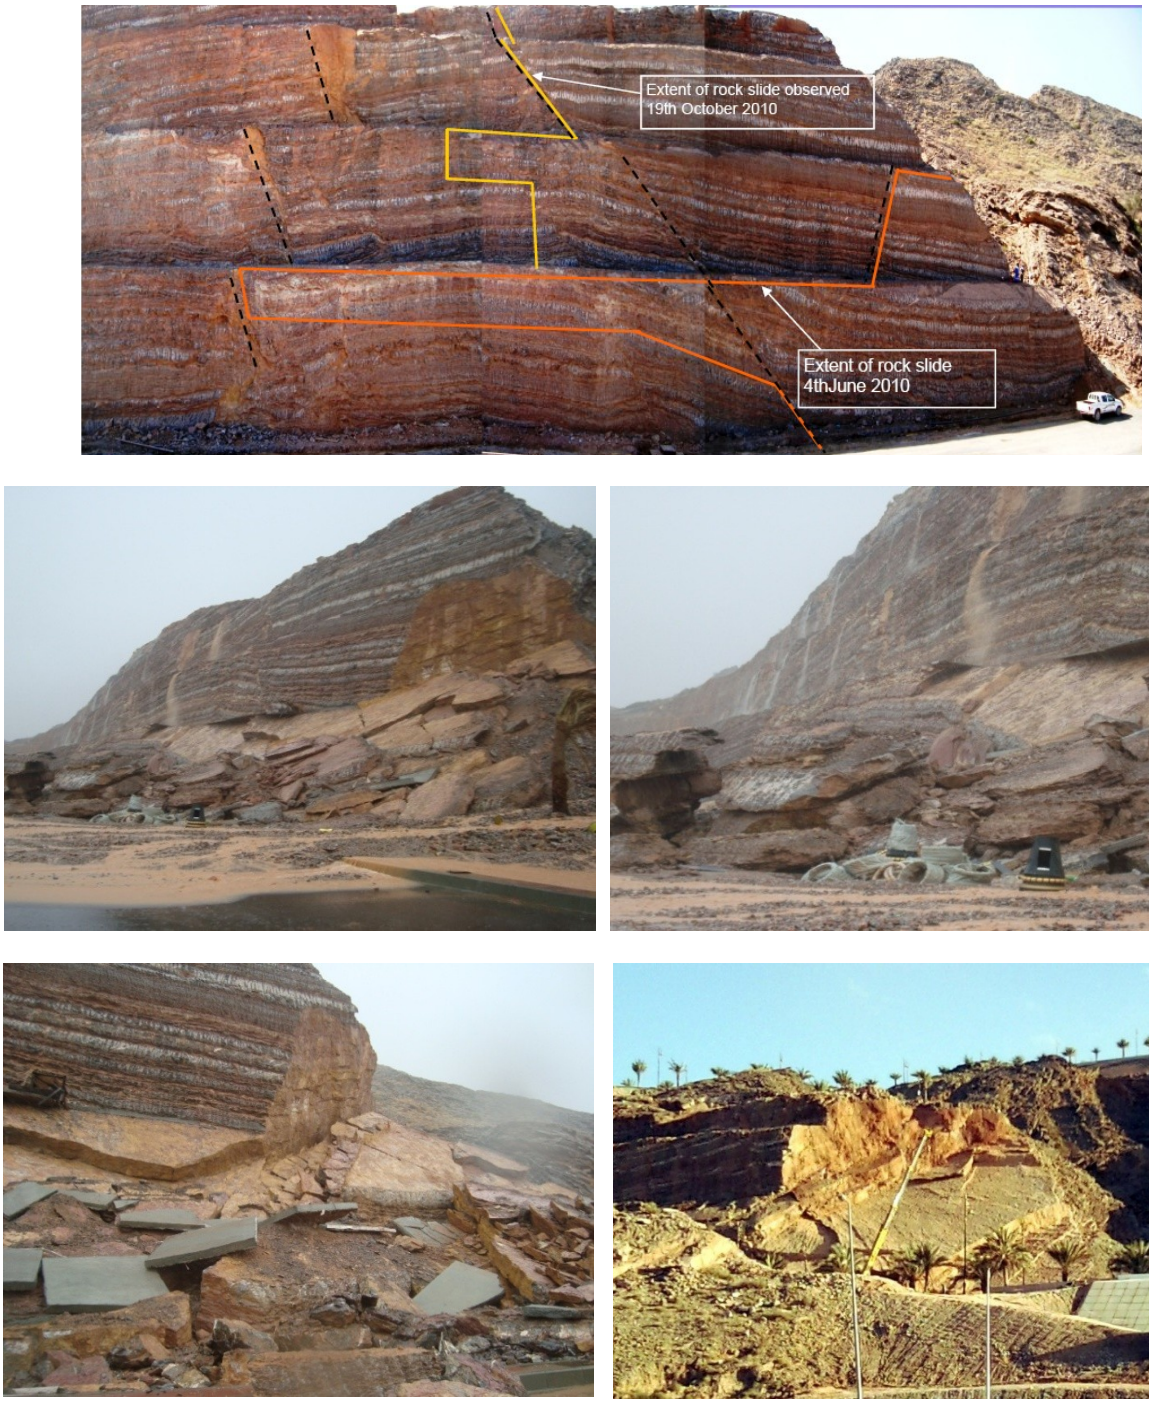
This rainfall caused a rock slide on the left side of the Box Cut # 1, from RD 0+380 m to 0+480 m. This section constituted the farthest edge of the cutting. On this side of Box Cut #1, a small wadi (valley) is located behind the slope. This was used as a channel for diverting the storm water from the catchment areas behind the slope. This wadi has steep gradient and was unlined at the time of slope failure.

Photographs taken just after the rain storm showed that the failure had occurred initially as a single event. Failure occurred along a 40^{o} dipping bed in the lowest slope, which extended to the inner edge of the first berm and a near vertical joint forming the release plane. The photographs taken at that time also showed a large amount of water transported debris coming out from the above mentioned wadi adjacent to the failed area. Water was also noticed cascading over the crest of the main rock cut.

With the passage of time, the extent of the initial failure grew in size as more and more rock mass adjacent to the initial failure area failed progressively. Within a couple of weeks of the initial event, the failure grew to the top of the 35 m high cut, extending about 20 m along the crest and reaching as far as a steep joint with a strike of about 260^{o} (N100 deg W), and dip of more than 70^{o}. The total volume of failure was estimated at 800 m^{3} (Figure 4).

From site observations, it was concluded that the failure initiated along a laminated bed of argillaceous rock layers, which had the least shearing resistance of all the rock mass at the site. The failure undermined the slopes above it and caused their failure, which progressed in the weeks ahead of the initial event.

The main triggering factor was the increase in water pressure associated with the rainfall event. The Box Cut # 1 slope at the farthest end was exposed to weather on three sides; the front cut face, the edge face and behind in the wadi (valley). It is likely that the water in the wadi overflowed and infiltrated the loose jointed and bedded rock mass. It is also likely that the small solution channels formed conduits for water that entered the formation, contributing to the failure. Although the rock mass appeared visibly stable in the area after a few weeks, there were other bedding / joints in the area that could cause further instability in the future, especially under wet conditions.

Figure 4. Top photo provides an overall view of the slope face prior to sliding and the extent of two episodes of sliding on June 4th and October 11th 2010. The lower frames, except the lower right corner view, show sliding during Cyclone Phet, while the lower right corner view shows the resulting slope face after the final collapse on October 11th 2010. The sliding along the bedding and a vertical joint, a free release plane along the overspilled wadi, is an obvious reason of sliding during cyclone Phet.

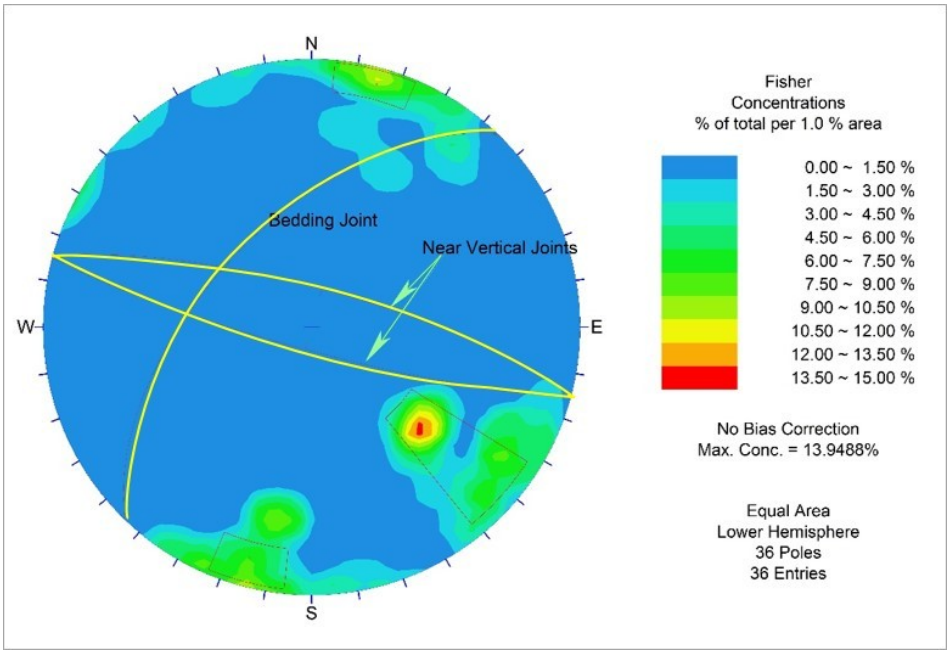
In Box Cut #1, from approximately RD 0+220 to 0+500 m, the interlayering of the beds is quite prominent and dips at 30^{o} to 45^{o} daylighting out of the face and within +/- 20^{o} of the face orientation. In addition to the bedding, there are joints and faults that are steeply dipping at 70^{o} to 90^{o} and strike NE-SW or SSW. These joints have high persistence over all cut benches to the full 40 m height. Some of these features are faulted with noticeable displacements. Figure 5 shows the pole plot of the joints and great circles drawn through the centre of poles concentration by visual examination.

Figure 5. Stereoplot of the discontinuities representing the left slope in Box Cut 1.

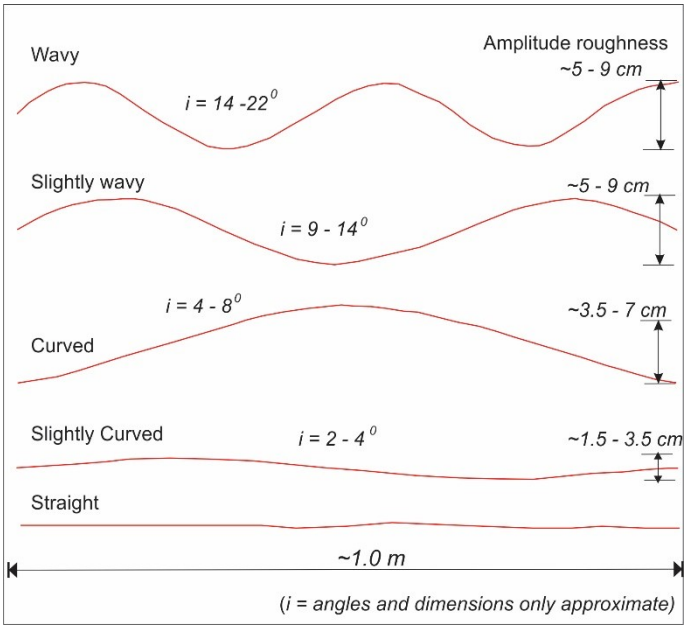
Hack et. al. (2003) reported that the large scale waviness contributed in increasing the friction angle of a discontinuity. Figure 6 shows the approximate addition to the friction angle that should be incorporated in the design for waviness of various amplitudes in the discontinuities over 1 meter length (Hack et. al. 2003). Miller (1988) reported that the waviness angle could be calculated from the observed variation in the dip of any discontinuity in the field.

Figure 6. Large scale roughness profiles.

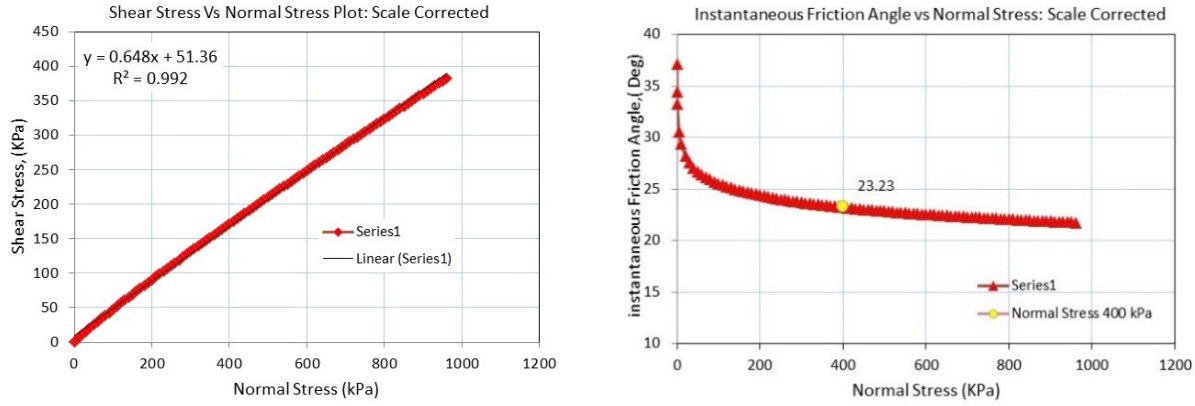
Figure 7 shows the spreadsheet results of ϕ_L at various normal stress levels for deep seated failures.

Figure 7. Friction angle at various stress levels for a deep seated sliding plane.

The average normal stress range was found to be about 400 kPa. Considering this, the corresponding friction angle (ϕ_L) was selected as 23.2° from Figure 7. In addition, based on site observations of intact rock bridges and test results, a cohesion value of 80 kPa was selected for analysis in deep seated failures. Similarly, for small scale failure, the ϕ_L value was calculated as 28° and zero cohesion was assumed in this case.

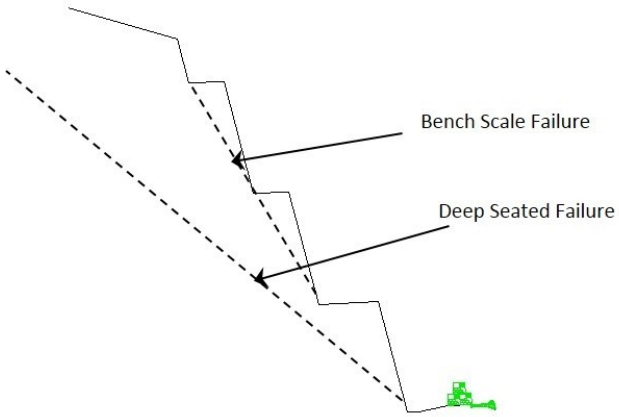
The orientation of bedding planes along various berms showed appreciable variation in the dip inclination. However, previous failures and site observations led to the conclusion that the most likely inclination of the failure plane was 40°. Also smaller scale failures involving one or two benches and larger global scale failures with deep seated planes were both possible. Based on the above, the following expected failure planes were considered in the re-assessment of slope stability:

Figure 8. Illustration of relatively small scale and multiple bench (deep) failures planes assumed in stability analysis of Left Face Slope at Km 0+400 m.

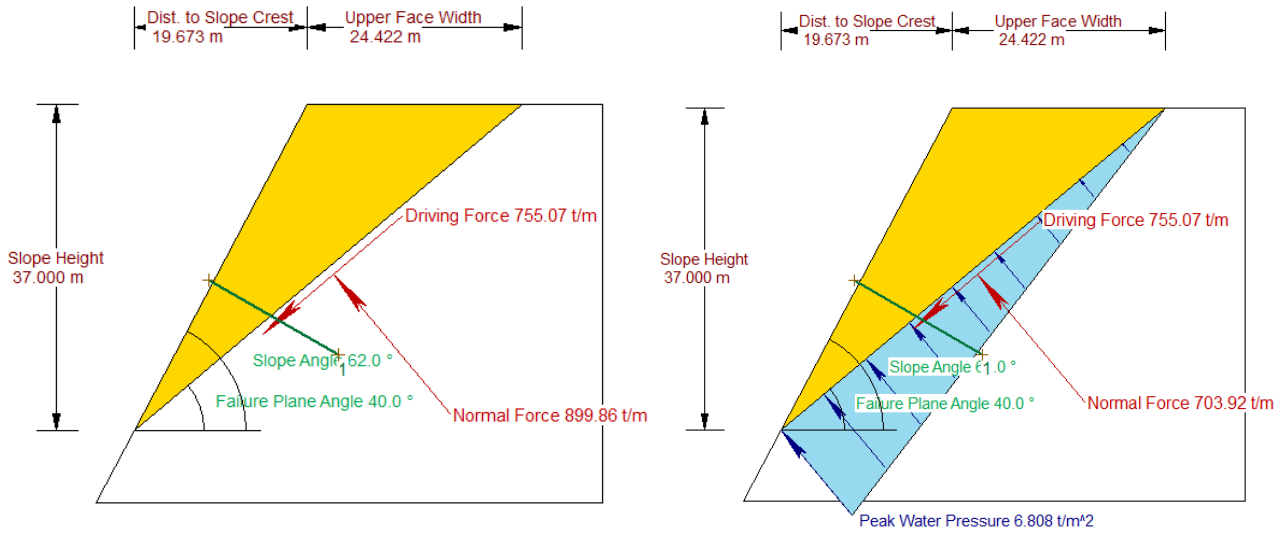
Figure 9. The driving and resisting forces against the calculated FOS 1.12 and 1.01 for dry and wet slope (15 m water head) respectively.

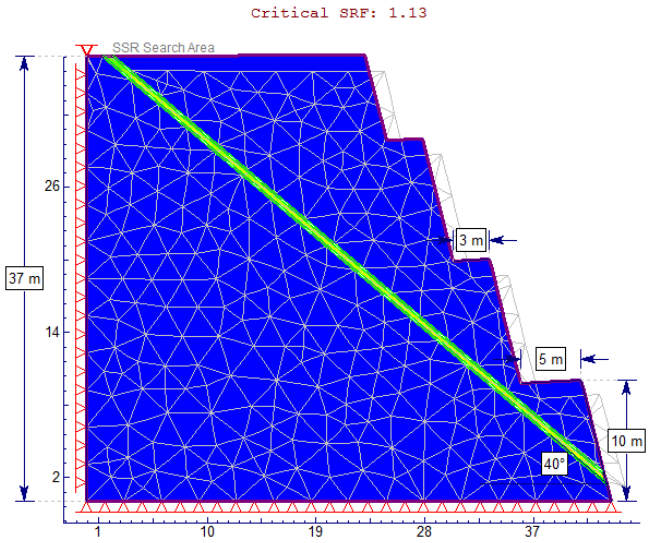
From the table above, it is can be observed that the Factors of Safety from the three approaches used are in general agreement. Figure 10 below shows the exaggerated deformed FE mesh of the upper sliding block for the SRF =1.2 (In Dry Condition) for which no FEA convergence occurred.

Figure 10. Deformed mesh for the SRF =1.2 (in dry conditions) for which no FEA convergence occurs. The maximum SRF for which the FEA satisfies the state of equilibrium is 1.13.

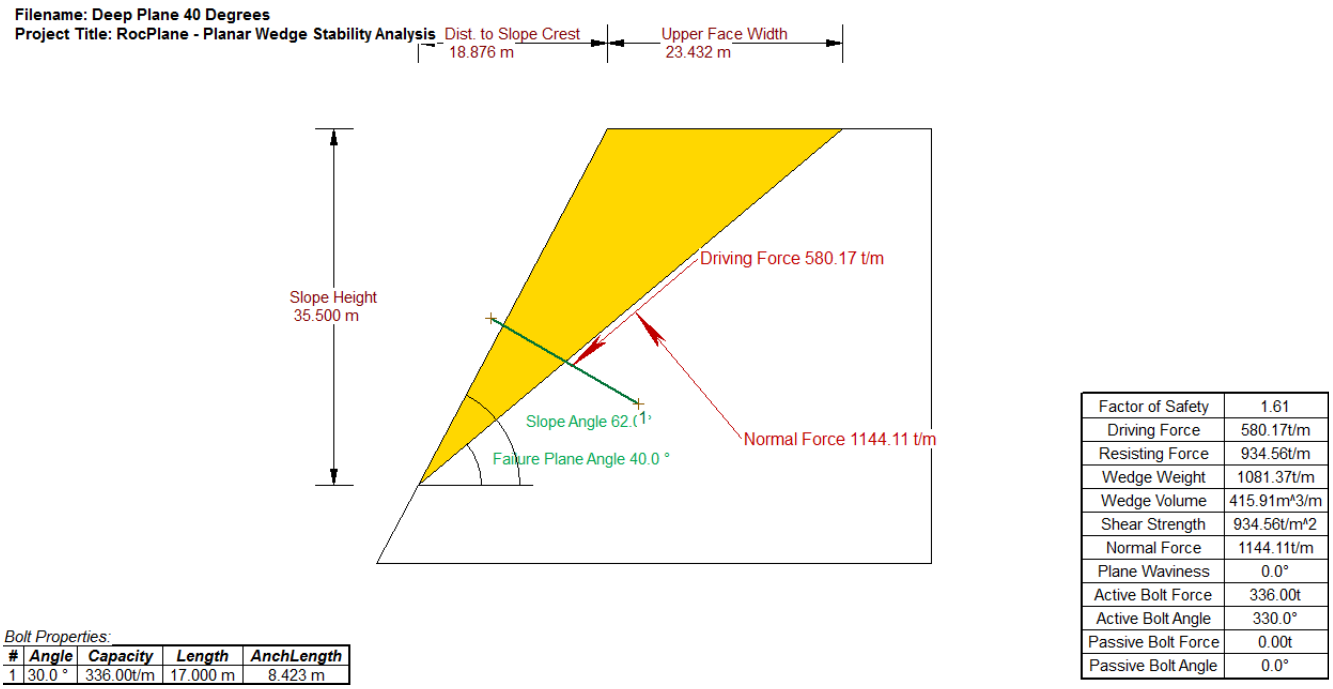
Figure 11. Factor of Safety (FOS) in dry condition with 3360 KN/m external force applied through designed cable anchors.

After several trials using different applied normal stresses on the failure plane, seven strand anchors of 1200 KN working load at 2.5 x 2.5 m grid (3400 KN/m) for a 35 m high slope were selected. The results of factor of safety using the 1200 KN anchors on the deep sliding planes are presented in Figures 11 to 14 and are summarized in Table 3.

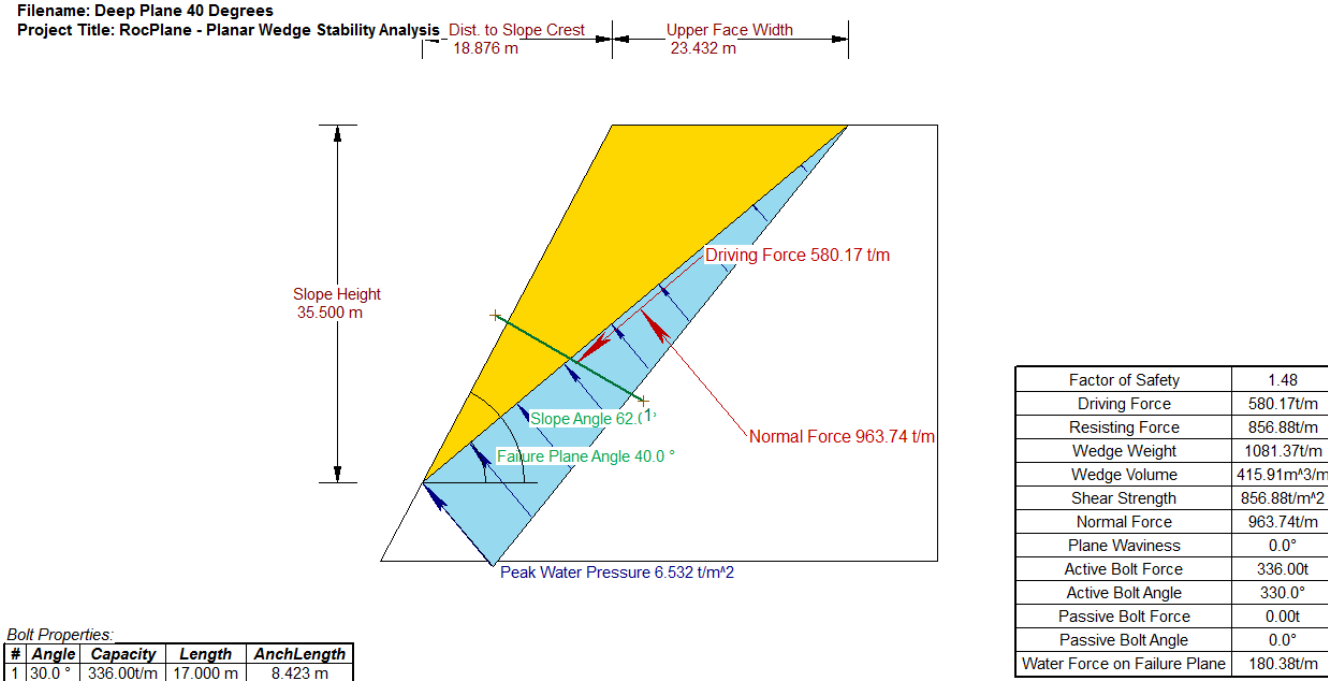
Figure 12. Factor of Safety (FOS) in wet condition under 15 m water head and 3360 KN/m external force applied through designed cable anchors.

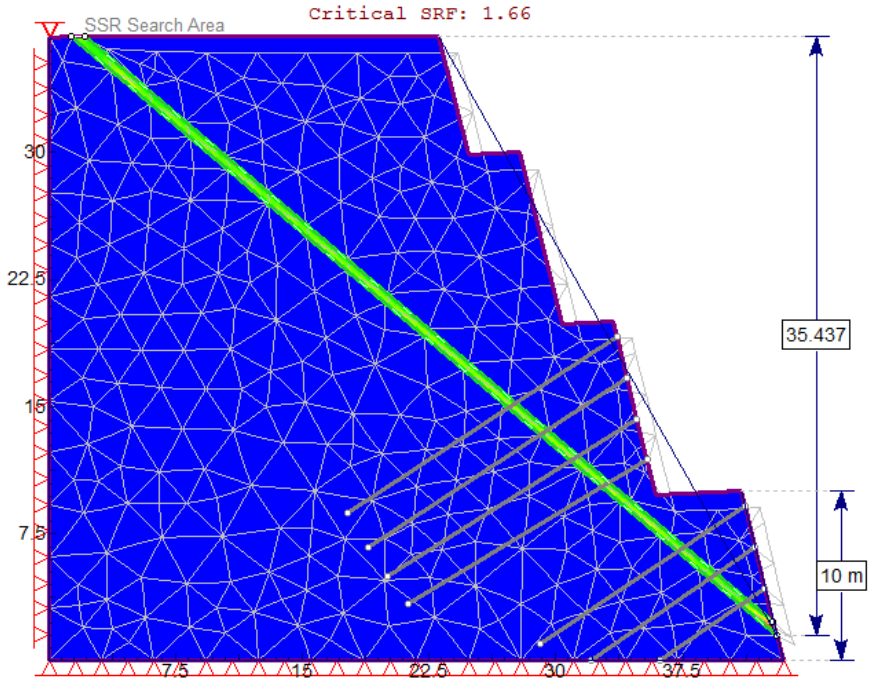
Figure 13. Deformed Mesh for the SRF =1.72 (in dry conditions) for which no FEA convergence occurred. The critical SRF for which the FEA satisfied the condition of equilibrium with 7 strand anchors of 1200 KN (2.5 x 2.5 m grid) is 1.66 as shown.

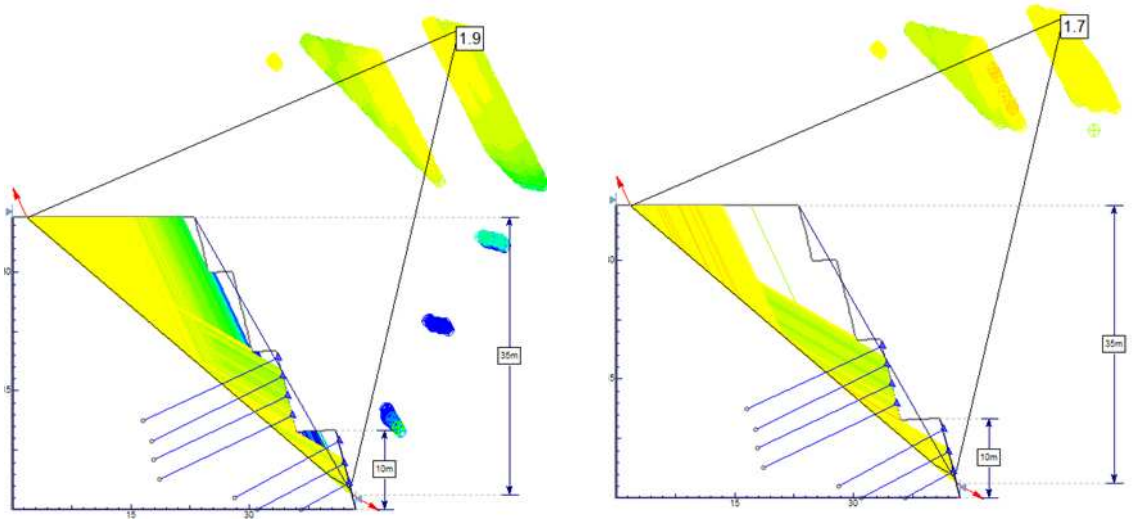
Figure 14. FOS with 7 x 1200 KN anchors in dry condition using Bishop (left) and Morgenstern-Price (right) methods.

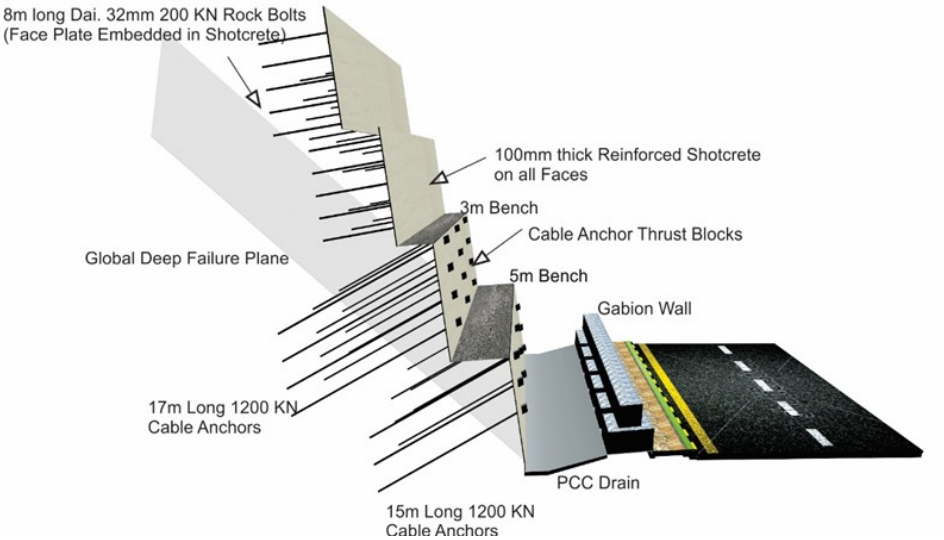
It was therefore concluded that the ends of box cut #1 were most vulnerable as at these locations large and deep seated failures were kinematically possible, whereas in the middle of these slopes, only shallower failures would be possible, the unstable wedges being confined at both ends. It was therefore decided to reinforce only the terminus of the 500 m long vulnerable slope with 1200 KN cable anchors. Other intermediate and cut faces above the cable anchored slopes were, however, reinforced with 200 KN rock bolts to control the comparatively smaller scale failures. The rock bolt heads were tensioned on steel plates resting on epoxy cement base. For long term durability, the steel plates were embedded in the shotcrete. The anchor heads of high capacity cable anchors were installed on specially constructed reinforced concrete anchor blocks. A typical arrangement of the reinforcement pattern at cut slope ends is shown in Figure 15.

Figure 15. 3D Conceptual arrangement of reinforcing elements at both the 20 m terminus of 500 m long left slope of Box Cut #1.

The arrangement of stabilization measures shown in Fig. 15 were implemented and are performing satisfactorily for the last six years.
