St. Isaac Cathedral (St. Petersburg, Russia): A Case History

ABSTRACT: *St Isaac's Cathedral in St. Petersburg was completed in 1858 after 40 years of construction; it is today the fourth largest domed Cathedral in Europe. The underlying soil is a relatively soft saturated sediment and carries this 3155 MN structure that is 100 meters high with an imprint of 92 m by 100 m. It is founded on a 7.5 m thick mat of granite and limestone blocks resting on relatively short timber piles of different lengths. The Cathedral has progressively experienced significant deformation including differential settlement causing cracks in the pillars and tilting of the porticoes. The paper summarizes the available geotechnical engineering and engineering geology aspects of the soil on which the Cathedral is built as well as classical issues such as foundation ultimate capacity and settlement analysis through simple calculations and numerical simulations. It also includes some less classical issues such as the influence of microbial activity on the behavior of the Cathedral through the changes the microbes and their activity create in the engineering properties of the soil and in the groundwater compos

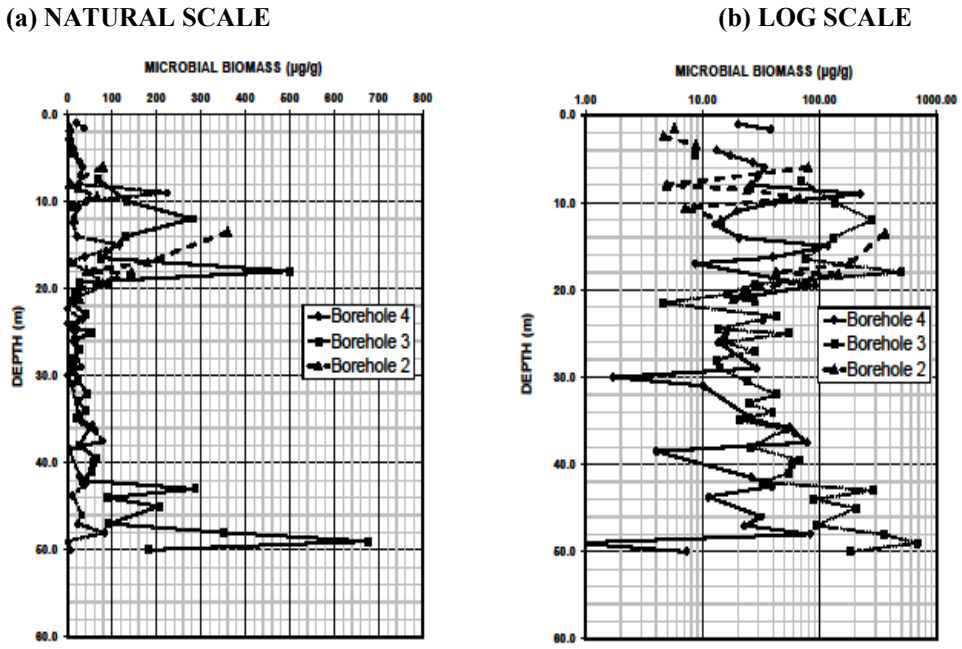
Figure 14. MM in soil vs. depth (2009 data): (a) natural scale, (b) decimal log scale.

for some St. Petersburg soils by Dashko and Shidlovskaya (2015). The microbial mass and biofilms create slippery substances which coat the particle contacts and facilitate the movement of particles with respect to each other (lower modulus of deformation and lower strength) and clog the pores (lower permeability) (Dashko et al. 2013a, 2015). Indeed, for example, hydrogen sulfide (H_2S) as a metabolic product of sulfate-reducing bacteria in anaerobic state and bivalent iron (Fe^{2+}) leads to the generation of hydrotroilite $FeS*nH_2O$ in the form of black and dark grey powder that was observed in all soil samples below the groundwater level. Fig. 14 shows the MM distribution through the soil profile. The peaks of MM at 20 m and 50 m depth correspond to the lacustrine varved clay (up to 500 micrograms per gram) and to the Vendian clay (up to almost 700 microgram per gram).
