St. Isaac Cathedral (St. Petersburg, Russia): A Case History

ABSTRACT: *St Isaac's Cathedral in St. Petersburg was completed in 1858 after 40 years of construction; it is today the fourth largest domed Cathedral in Europe. The underlying soil is a relatively soft saturated sediment and carries this 3155 MN structure that is 100 meters high with an imprint of 92 m by 100 m. It is founded on a 7.5 m thick mat of granite and limestone blocks resting on relatively short timber piles of different lengths. The Cathedral has progressively experienced significant deformation including differential settlement causing cracks in the pillars and tilting of the porticoes. The paper summarizes the available geotechnical engineering and engineering geology aspects of the soil on which the Cathedral is built as well as classical issues such as foundation ultimate capacity and settlement analysis through simple calculations and numerical simulations. It also includes some less classical issues such as the influence of microbial activity on the behavior of the Cathedral through the changes the microbes and their activity create in the engineering properties of the soil and in the groundwater compos

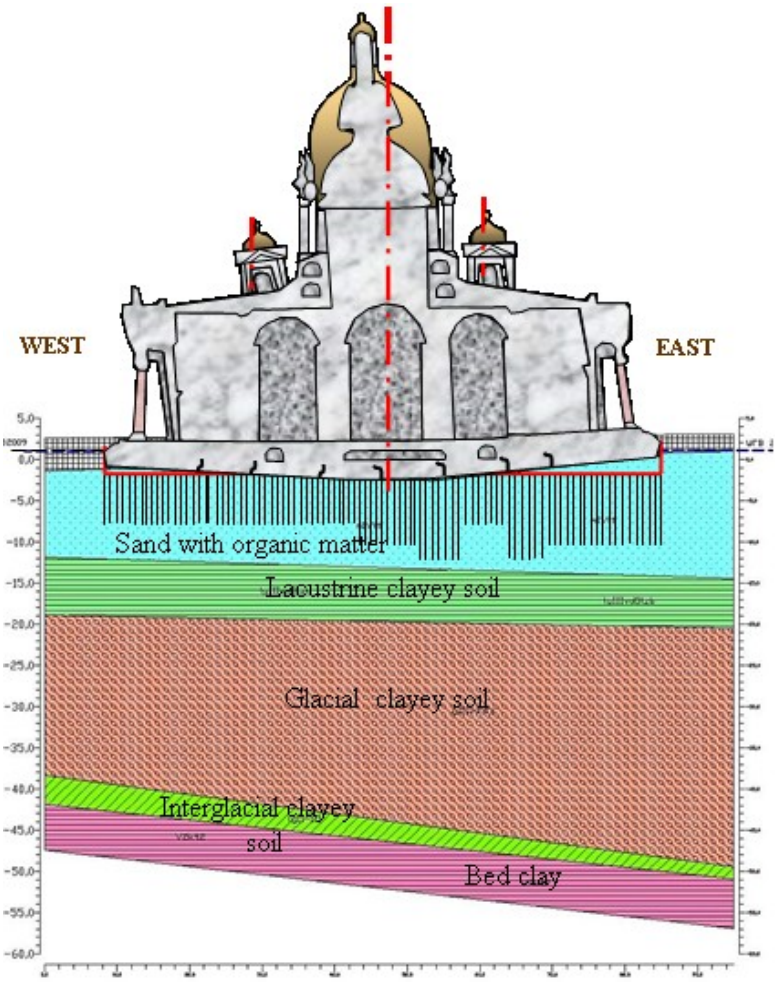
Figure 5. Soil profile of St. Isaac Cathedral.

All the results from the borings in Table 1 were used to determine the underlying stratigraphy, soil type, and soil properties. A summary stratigraphy is shown in Fig. 5. The quaternary soil deposits consist of saturated soft sandy and clayey layers down to a depth of 44.5 m or more. The Upper Vendian clay is found at a depth of 44.5 m on the southwest corner of the Cathedral while it could not be found at a depth of 50 m on the northeast corner of the Cathedral because the boring stopped at a depth of 50 m. The quaternary deposits include inter-moraine, glacial, lacustrine glacial, and lacustrine marine origin formations, overlain by fill deposits and peaty soils (Fig. 5).

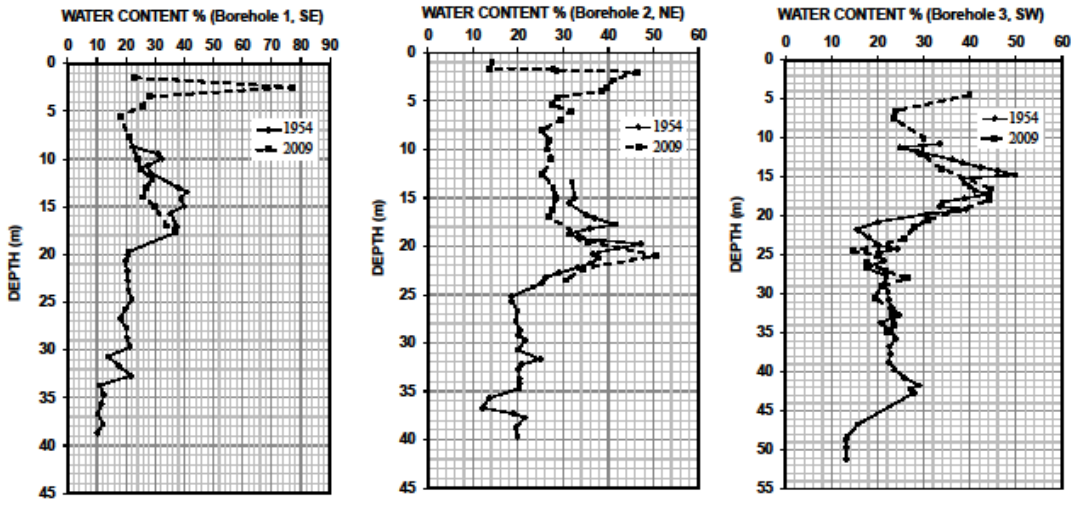
Figure 7. Variation of natural water content versus depth at different locations.

Soil properties were obtained in 1954 and 2009 and are combined in the following figures. The natural water content is presented in Fig. 7 and the plasticity index in Fig. 8. Fig. 7 indicates that there is no clear trend in the evolution of the water content with time and that the largest water contents occur in the layer of silty sand with peat at a depth about 3-5 meters and in the varved clay at the depth of 15-20 meters. Fig. 8 indicates that the varved clay at a depth of 15-20 meters exhibits the highest plasticity.

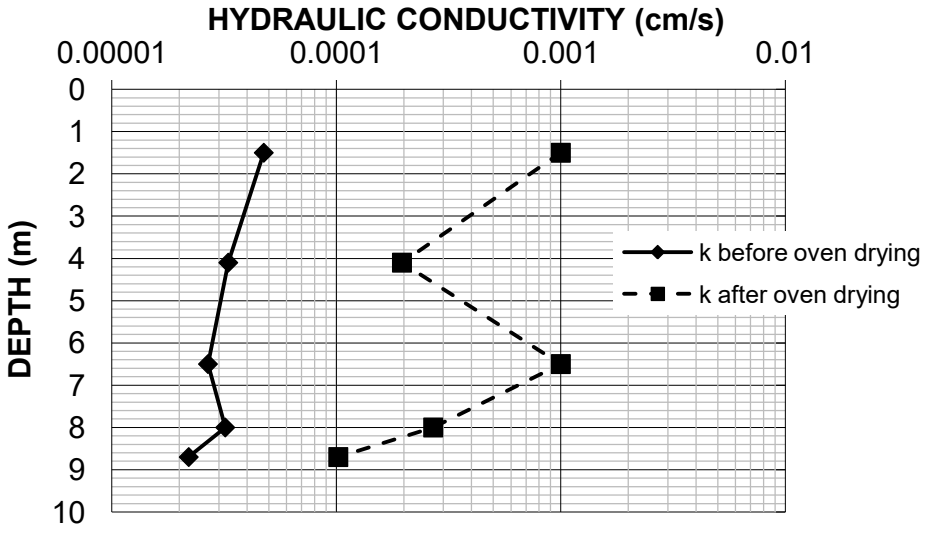
Figure 9 - Hydraulic conductivity of sand vs. depth before and after oven drying.

Falling head permeameter tests were performed in 2009 on the silty sand samples (Fig. 9) and indicated relatively low hydraulic conductivity varying from 1.1 x 10^{-5} to 6.8 x 10^{-5} cm/sec. These low values are likely due to the presence of organic matter clogging the pore space in the sand (Dashko et al. 2015, 2016). Permeability tests were also performed on the silty sand after oven drying the samples at 105 ^{0}C; the permeability of the dry silty sand increased to 1 x 10^{-3} to 1 x 10^{-4} cm/sec (Fig. 9). This likely occurred because the drying process burnt some of the organic matter thereby increasing the size of the pores.

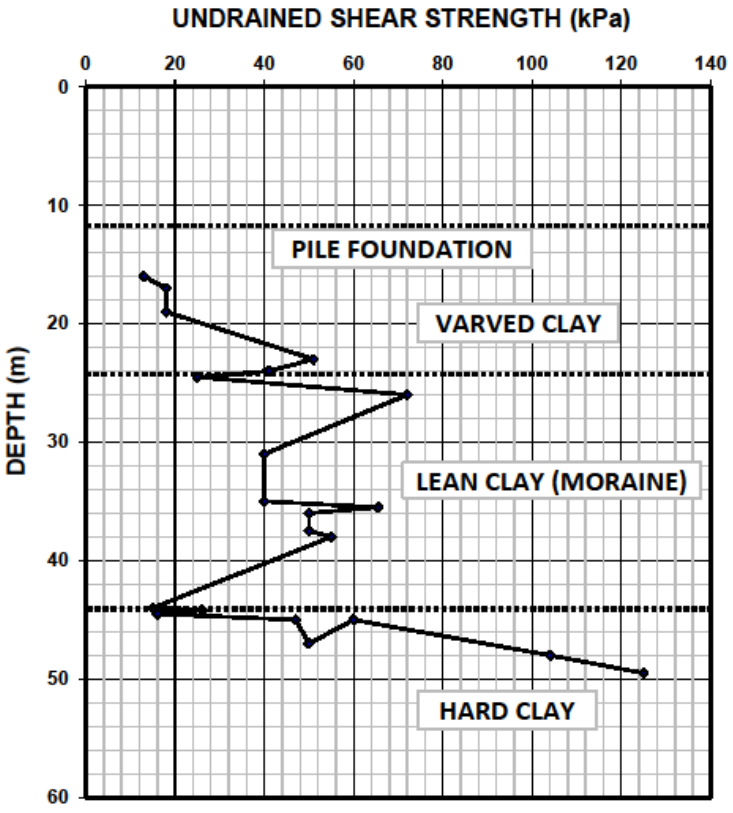
Figure 10. S_u profile versus depth.

The shear strength properties, cohesion and angle of internal friction, available from the archives of 1954 are limited to direct shear test results (Table 3). In 2009, unconsolidated undrained triaxial tests were performed. The undrained shear strength (s_u) vs. depth profile obtained from these tests is shown in Fig. 10. Figs. 11 and 12 show the deviator stress vs. normal strain for some of the tests; the samples failed mostly in general deformation mode (barrelling) rather than along a single plane of failure. As indicated by the stress strain curves, the varved lacustrine clay underlying the pile foundation is very soft with s_u values between 18 and 20 kPa. The glacial clayey soil below the varved clay is a bit stronger with values in the range of 25 to 72 kPa. The Vendian clay below that glacial soil has s_u values which vary with depth from 18 kPa at the top of the layer to 125 kPa at depth. This significant variation could be due to the micro-fissures present in the upper zone of that clay layer which weaken the global strength.

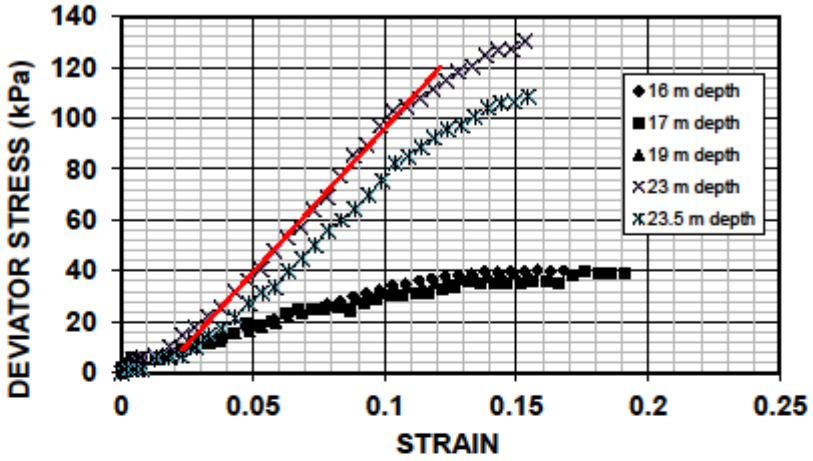
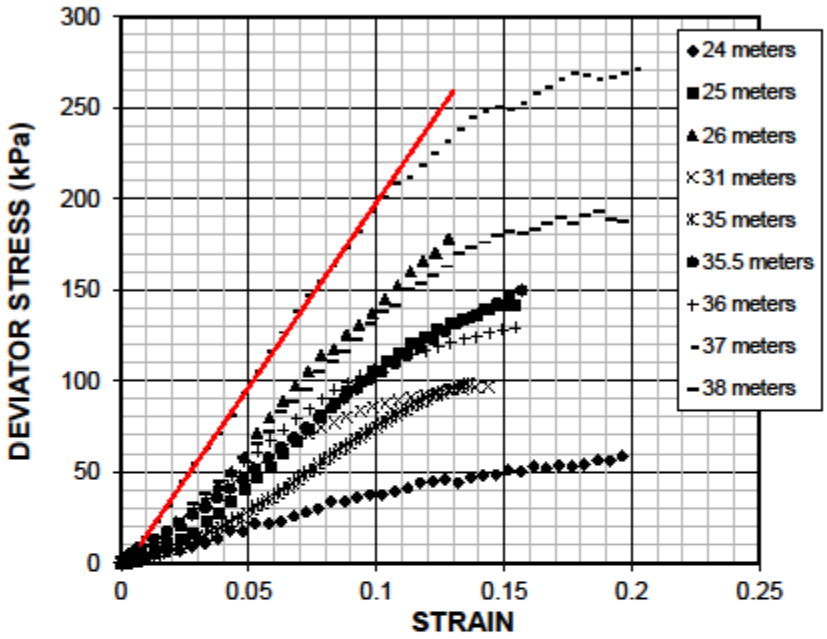
Values for the modulus of deformation of the soil were calculated from the triaxial test results. They are presented in Table 4 while Fig. 13 shows the modulus profile versus depth. The modulus E was obtained as the slope of the initial linear part of the deviator stress vs strain curve. The red lines on Fig. 11 and 12 show examples of how the linear part was selected. The modulus equation is:

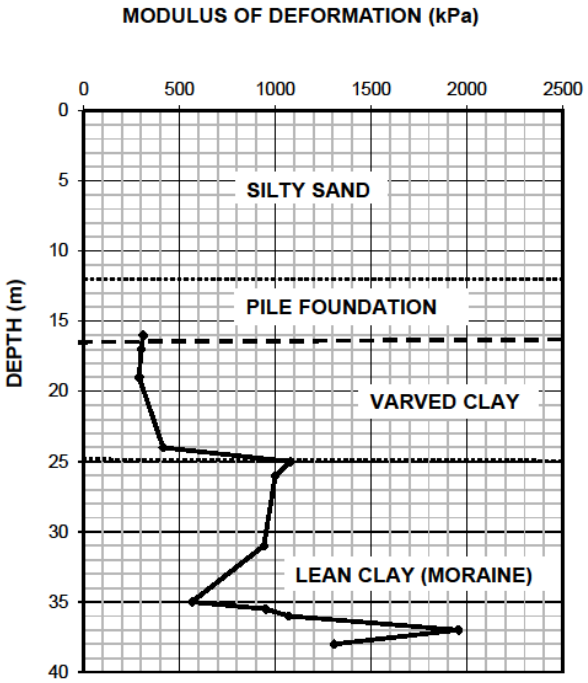
Figure 13. Undrained soil modulus versus depth.

Where σ_1 is the major principal stress, ν is Poison's ratio taken as 0.5 for undrained behaviour, σ_3 is the minor principal stress, and ε_1 is the principal normal strain. The modulus (E) reaches 5000 kPa in the top layer of lacustrine marine soil,

becomes much lower in the glacial lake clayey soil with values between 290 to 1000 kPa, and then increases slightly in the moraine from 415 to 2000 kPa. Additional soil properties are shown in Table 4.
