Uplift of an Underground Tank in Northern Malabar Region, India

ABSTRACT: *An underground reinforced concrete tank was constructed for a project in the southwest region of India. The tank was 90 m x 35 m in plan and 7.3 m deep resting on partly filled-up and partly native soil. During the peak monsoon, a sudden uplifting of the base slab by about 300 mm and subsequent failure of the foundation raft and a partition wall was observed. Laboratory testing was executed and hydrogeological survey was carried out using ground penetrating radar, seismic refraction and infiltrometer testing, and an analytical study was carried out to identify the root cause of the tank uplifting. Based on this study, it was observed that the uplifting and structural failure was essentially due to the peculiar land terrain and soil properties and the development of excess hydraulic head below the bottom of the tank. After considering different options, the rectification measures were carried out by provision of dewatering wells along the tank periphery to release the excess hydrostatic pressure and stabilize the foundation raft. The structural repair of the top of the foundation raft and partition wall was

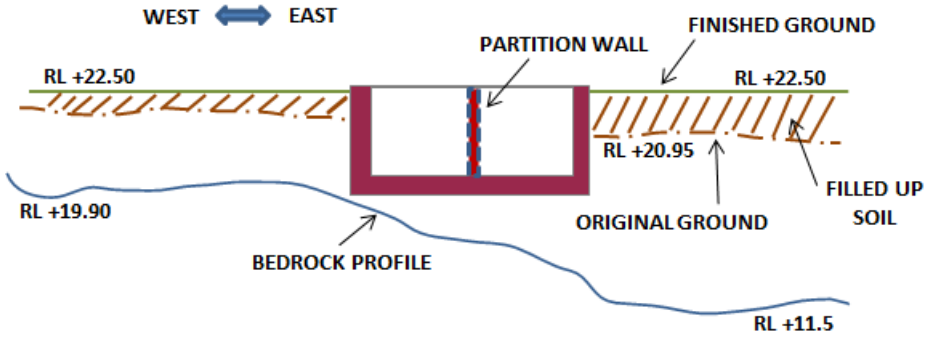
Figure 1. Topographic features near the tank.

The overall topography of the project site was sloping from west towards the east. The profile of bedrock was also dipping down from west towards the east as shown with varying reduced levels (RL) in Fig. 1 along with the relative location of the tank.

The general topography and geological features of the surrounding area indicate that the ground level elevation is increasing towards the west, further away from the tank location. The difference in elevation of the ground surface at the tank location and the surrounding areas has led to large amount of water flow from surrounding areas towards the tank during rainy season. Also as indicated in Fig. 1, the presence of the bedrock, which was dipping downward from west towards the east, has caused the water to flow from higher elevation to lower elevation i.e. from west towards the east direction along the bedrock surface.

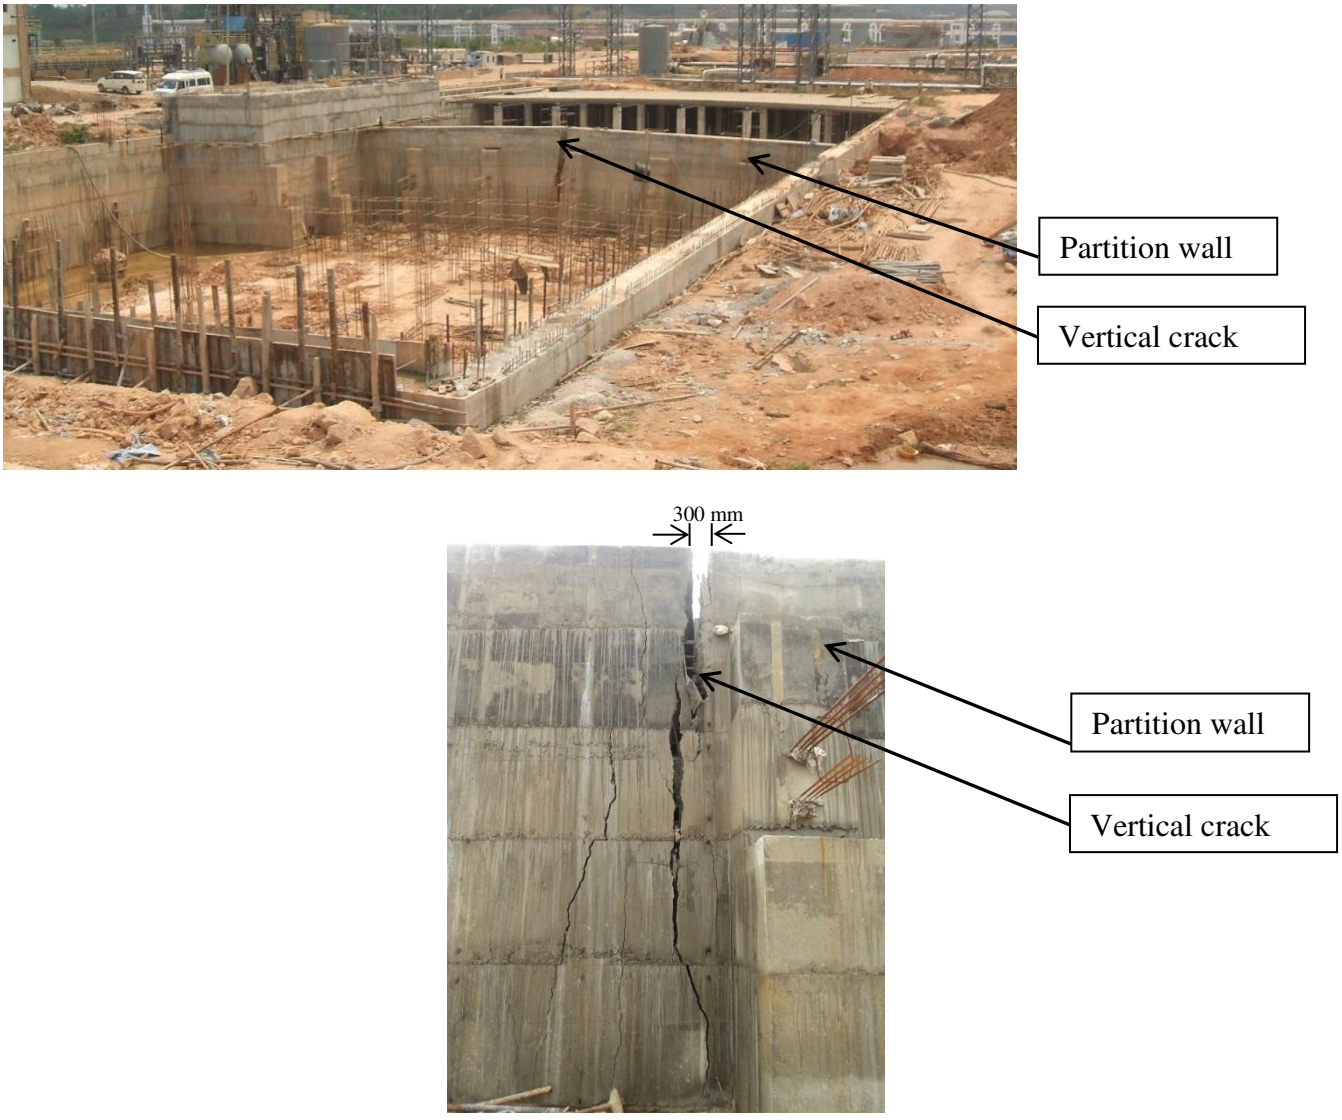
Figure 2.Uplifting and cracking of tank partition wall.

In the southern part of India, the monsoon is at its peak in the months of June & July every year. In mid-June of 2013, the foundation raft of the tank suddenly got uplifted by approximately 300 mm at the center. The review of past rainfall data revealed higher rainfall intensity in June 2013 compared to rainfall in the previous three years as shown in Table 2. During the failure of the tank, the 0.9 m thick reinforced cement concrete (RCC) partition wall inside the tank got cracked in tension at the center due to the uplifting and bending of the foundation raft. However, no uplifting was noticed at the four edges of the tank. Thus, the tank took an inverse saucer shape due to the uplifting at the center.

Fig 2 indicates the curved and cracked partition wall due to the tank uplifting. Several other cracks were observed along the height of the partition wall on either side of the middle 300 mm wide crack, with the crack width decreasing away from the center. Based on daily measurements taken on top of the partition wall after the failure, the uplifting of bottom slab and the crack width of partition wall was observed to be increasing at a rate of 30 mm per day. The cracks, which were observed on top of the foundation raft inside the tank, had maximum width of 12 mm. The seepage of groundwater inside the tank was not observed through these cracks. Thus, the depth of cracks was limited only to the top portion and not penetrating the entire thickness of the foundation raft.

As the crack width in the partition wall was increasing at a rate of 30 mm per day, it was necessary to take immediate corrective measures to stop the cracks from further widening. It was therefore suggested to drill boreholes of 200 mm diameter up to 8 m depth (as the depth of tank is 7.3 m) around the tank periphery so as to reduce the water pressure acting on the bottom of foundation raft by allowing the water under pressure to get released through these boreholes. However, due to the heavy rains, the contractor could not position the drilling equipment near the tank to drill the boreholes. Considering the practical delays in carrying out the borehole activity, another suggested option was to fill the tank with water up to approximately 5.5 m height which would generate additional weight within the tank, to counter the upward buoyant force of groundwater. Thus the accumulated water within the surrounding area was diverted inside the tank. As soon as the tank started filling with water, the settlement of the tank started taking place due to the weight of water. It took more than a month to fill the tank with water up to a height of 5.50 m after which the tank was observed to be completely settled to its original position and the crack width in the partition wall was reduced to 25 mm from 300 mm.

The structural rectification of damaged partition wall was carried out by demolishing the damaged portion, providing new reinforcement, applying epoxy bonding coating on old concrete and reconstructing the demolished portion of the wall.

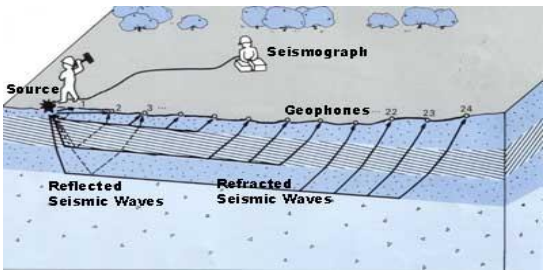
Figure 4. Typical set up for seismic refraction survey.

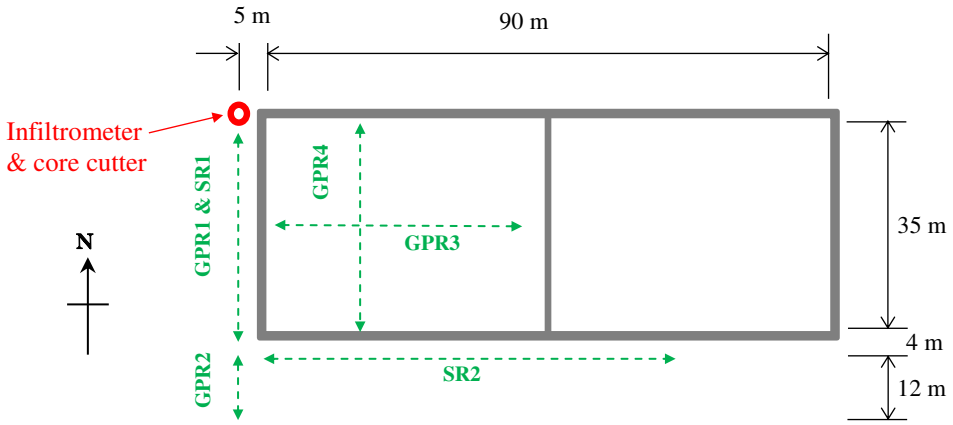
Figure 5. The schematic plan illustrating the location of GPR profiles, seismic refraction (SR) survey profiles and soil samples (see also Table 2).

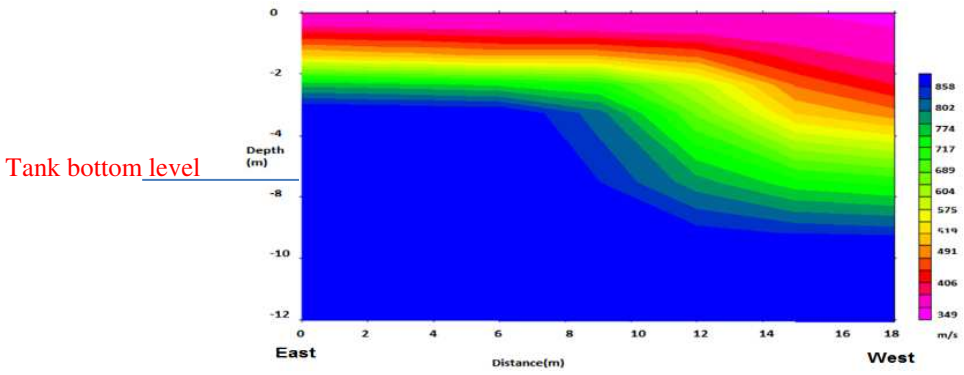
Figure 6. The soil strata profile obtained from SR2 data conducted on the south side of the tank near the closed water well (see Fig. 5 for survey location with respect to the tank).

The seismic refraction survey data was used to classify the soil using correlations between typical velocities, type of formations and the density as suggested by Bourbie et al. (1987). Based on this classification, the top layer consists of clayey soil, which is moderately compacted up to a depth of 1.5 m with P-wave velocity of 349 m/s. It is followed by a layer of clay and gravel with a thickness of 1.5 m, having a velocity range from 377 m/s to 482 m/s and a layer of sandy silt strata up to 10 m with a thickness of about 7.5 m and a seismic velocity range from 491 m/s to 858 m/s, as shown in Fig. 6.

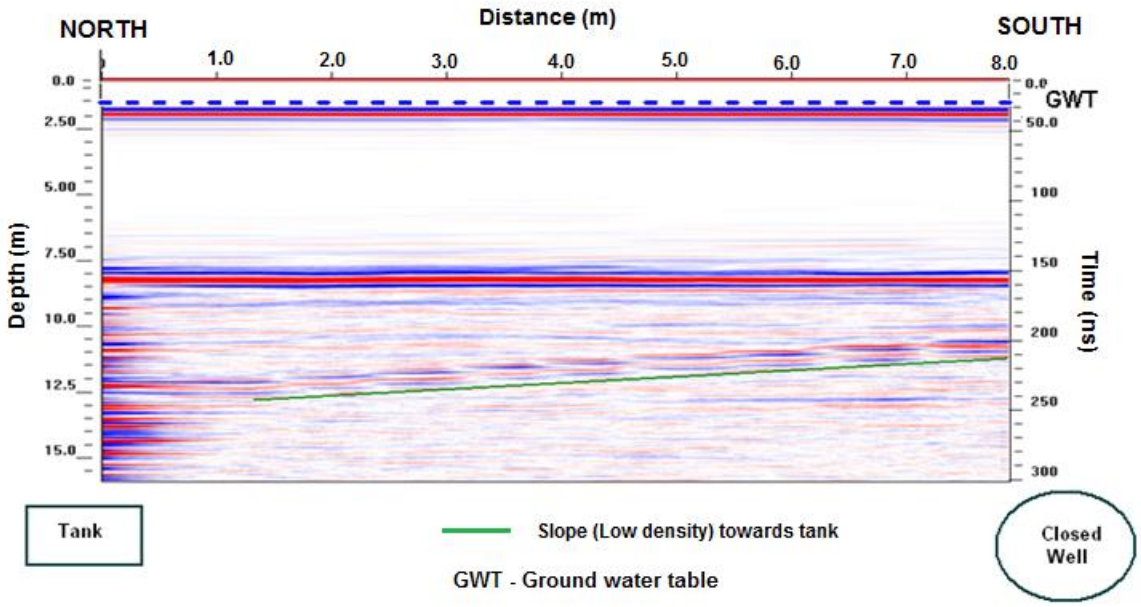
Close to the side wall of the tank, the discontinuous sloping feature towards the tank at depths of 11 m to 12.5 m below existing ground level (EGL) was observed. The observed sloping feature was identified as water channel with the direction of flow from closed water well (south direction) towards the tank (north direction) as highlighted by the green line in Fig. 7.

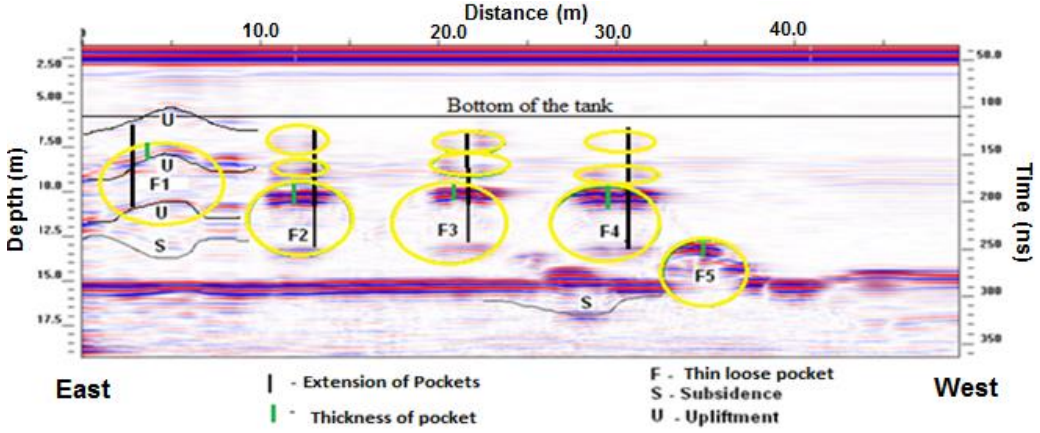
Figure 7. GPR3 profile collected using a 200 MHZ antenna inside the tank along East - West direction by placing antenna inside the floating body.

A phase inversion occurred at the concrete and void interface as indicated by a negative amplitude preceding a positive amplitude (see Fig. 8, 9 and 10). The amplitude of the GPR data is represented by red, blue and white colors. Red coloured areas represent a positive reflection and blue coloured areas represent a negative reflection while white areas represent distinct reflected areas, typically indicative of a dielectric uniformity within a given medium.

Loose pockets in the substrata were observed along the East-West direction beneath the tank bottom. The horizontal length of loose pockets below the bottom of the tank (F1 to F5) are observed to be varying between 0.5 m to 5.5 m at different locations. (see Fig. 7). The vertical thicknesses of the loose pockets are approximately 0.5 m each.

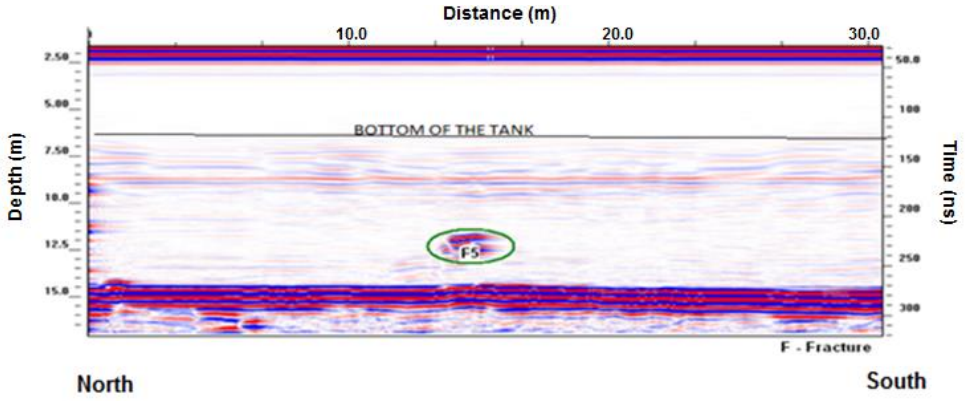
Figure 9. GPR4 profile collected using a 200 MHZ antenna inside the tank along North - South direction by placing antenna inside the floating body.

Fracture F5 is visible at the depth of 12.5 m in the profile along North-South direction (shown in Fig. 9). High amplitude reflections at 7.5 m depth are interpreted as rock formations and very high amplitude thick reflections encountered at depth of 14.5 m are interpreted as hard bedrock.

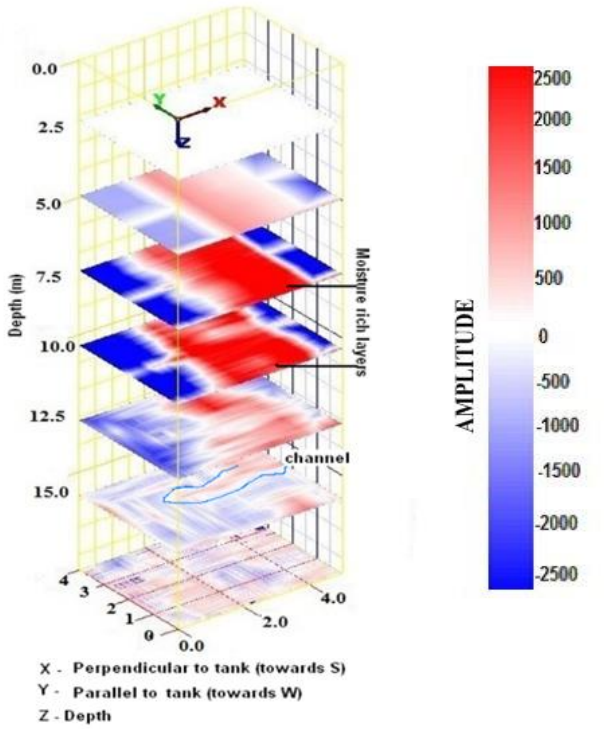
Figure 10. 3D view of the grid from GPR2 near the tank, data collected with 2 m interval at X axis and 1 m interval at Y axis. X is the direction perpendicular to the tank; Y is direction parallel to the tank and Z is the depth of penetration of the GPR2 antenna, i.e., 20 m.

3D data near the tank clearly indicates the clay rich strata at the depth of 2.5 m below ground level and the moisture is more concentrated at the depth of 7.5 m to 10 m from ground level (see Fig. 10). This visualization assisted in confirming the presence of water channels between the well and the tank.
