Electrical Resistivity at Internal Erosion Locations in Levees

INTERNATIONAL JOURNAL OF
GEOENGINEERING
CASE HISTORIES

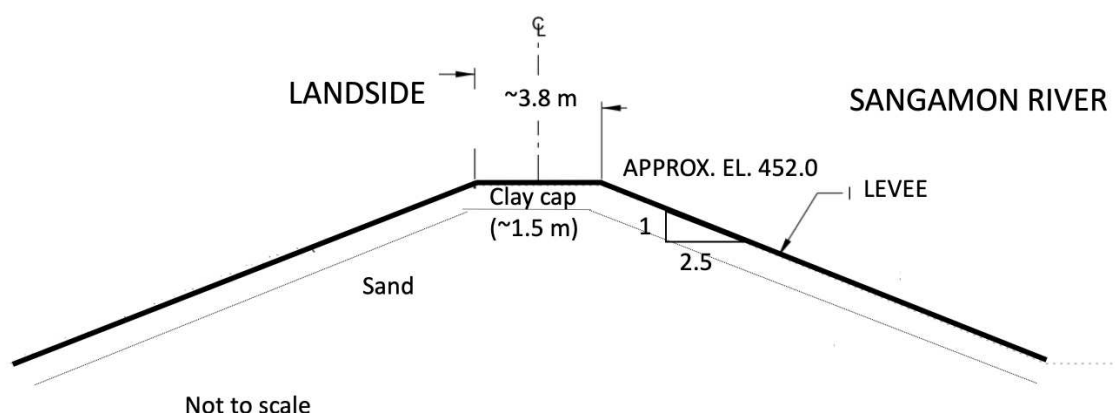
Figure 3. Hager Slough Levee pre-repair simplified cross-section.

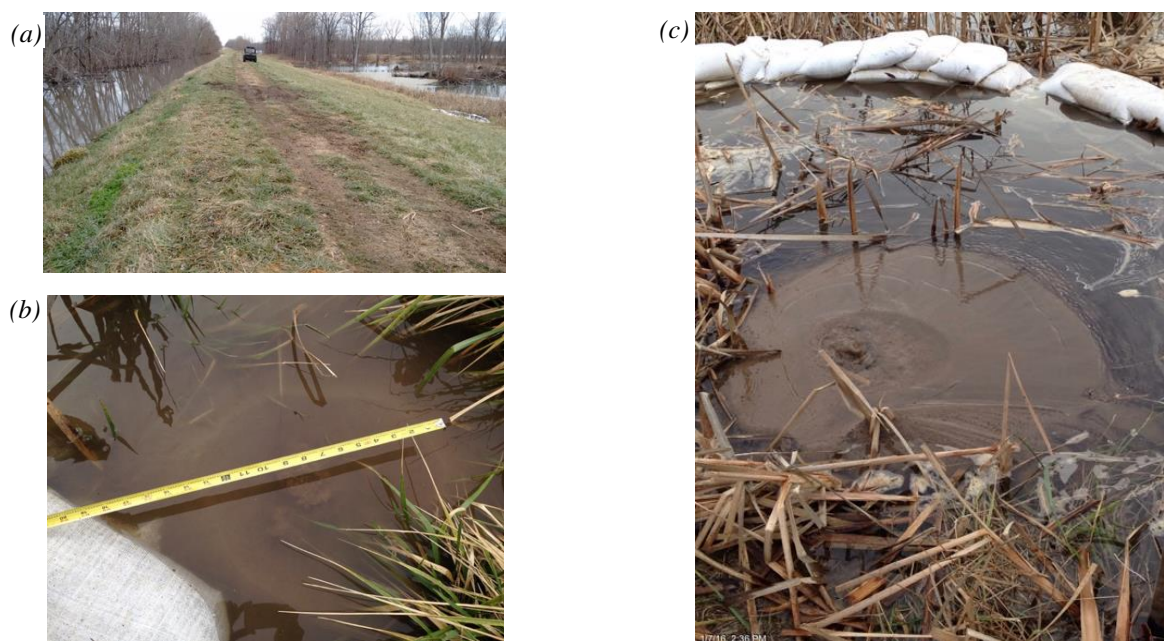
The levee district officials and the USACE engineers have observed a large number of sand boils at the Hager Slough Levee toe during flood events over the last thirty years (Bishop et al. 2015). In December of 2015, unusual winter storms related to a strong El Niño weather pattern in the Midwest sent large volumes of water into rivers and drainage areas, causing historic flooding in Illinois. As part of the flood protection systems investigation in Illinois, a team from the Geotechnical Extreme Events Reconnaissance (GEER) Association was mobilized to investigate the impacts of record and near-record flood crests and the performance of levee systems (Rutherford et al. 2016). The Hager Slough Levee was inspected and damage in multiple locations was documented on January 8, 2016. There were upwards of 15 active (carrying material) sand boils and many inactive (clear flowing water) sand boils from previous flood events which were documented during the reconnaissance. New (active at the time) sand boils generally formed adjacent to the existing boils. There were upwards of 41 sand bag rings placed by the levee district in coordination with the USACE in the 0.4 km levee stretch covered during the site visit. Many of the sand bag rings contained numerous sand boils and seeps. The sand bag rings were typically 2.43 – 3.00 m in diameter and 0.610 – 1.22 m in height (Figure 4).

Figure 4. Observed damage during December 2015 flood event: (a) crown of levee, (b) 0.33 m diameter active sand boil, (c) active sand boil (Rutherford et al. 2016).

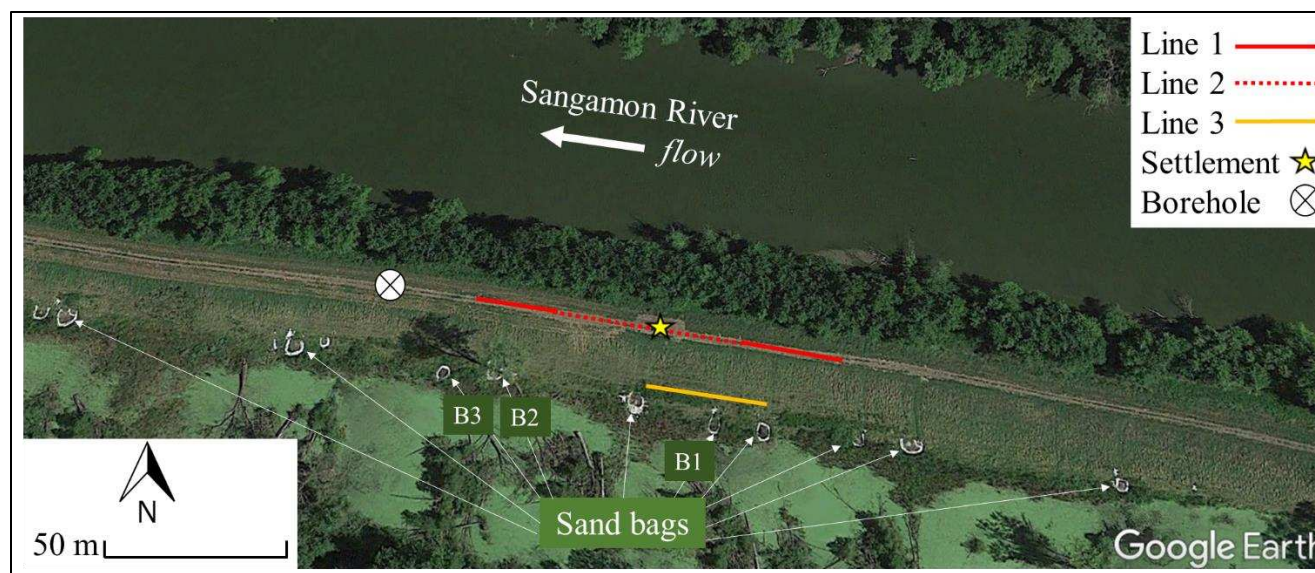
Three ERT surveys were conducted at the Hager Slough Levee. The survey locations were chosen in an area where damage was apparent (i.e., crown settling and sand bags around previous sand boils) and borehole data were available for ground truthing. The crown settlement was estimated between 0.12-0.14 m based on survey data. The three survey lines are shown in Figure 7. Two overlapping survey lines were conducted along the levee crown and one was conducted parallel to a 5 m diameter sand bag ring shown in Figure 7 at the landside toe. Stainless steel stakes were used as contacts between the 56 electrodes on the cables and the subsurface. The electrodes were spaced at 2 m, 1 m, and 0.5 m in Lines 1, 2, and 3 respectively. Lines 1 and 2 were aligned so that the visible 2 m wide depression from the crown settling was approximately in the middle of the surveys (marked with a star in Figure 7). The larger electrode spacing in Line 1 allowed for deeper measurements while the 1 m spacing in Line 2 resulted in more detailed measurements near the surface. The relative elevation at each electrode was collected with a total station, although the elevation change cannot be seen in the crown surveys (Lines 1 and 2) due to the length of the survey relative to the elevation changes. The closest borehole was approximately 73 m west of the crown settlement, where samples were collected by the USACE through the levee to 9.45 m in 2013.

Figure 7: Survey locations; white rings are remaining sand bags from January 2015 flooding (Google Earth 2015). B1, B2, and B3 indicate where grab samples were collected for the laboratory analysis.

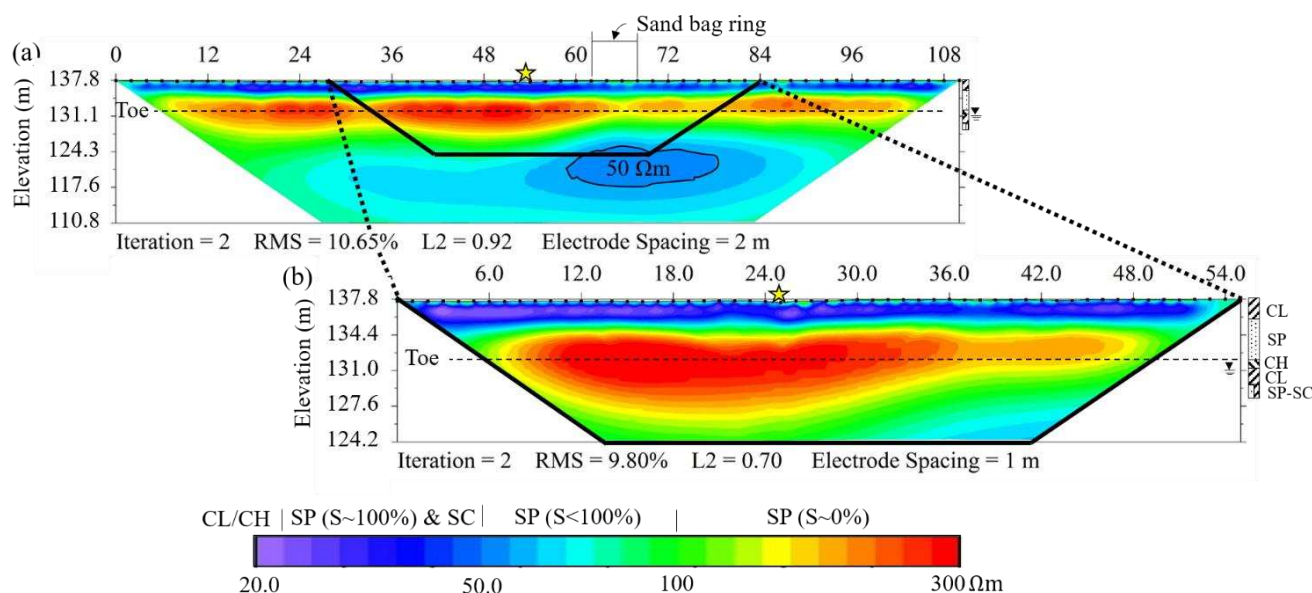
Figure 9. Crown surveys: (a) Line 1 with 2 m electrode spacing; (b) Line 2 with 1 m electrode spacing.

Line 2 (Figure 9(b)) was conducted at half the electrode spacing of Line 1. The outermost 14 electrodes on both sides of the central point in Line 1 were removed and installed between the remaining 28 electrodes. The alignment of Figure 9(b) within Figure 9(a) is shown with a black trapezoid on Figure 9(a). The larger electrode spacing in Figure 9(a) increased the penetration depth of the survey; however, near surface resolution was lost as a trade-off. Therefore, the lower resistivity band is more apparent in Figure 9(b) than in Figure 9(a), varying from 20 – 25 Ωm. A band of higher resistivity (200 – 300 Ωm) is again noted beneath the low resistivity layer along the surface. In Figure 9(b), the depth of this higher resistivity layer varies from El. 134.4 m to El. 129.4 m. There is a bowl shape of the higher resistivity layer in Figure 9(b), with the maximum curvature approximately 3 electrode spacings from the depression in the crown of the levee. The small pocket of lower resistivity (60 Ωm in Figure 9(b)) is observed in the lower right side of the inversion, though the depth of penetration of this signal did not allow the entire region to be captured. Although the borehole data were approximately 99 m from this survey,

the data are shown along with the measured groundwater table in Figure 9(b). The soil stratigraphy aligns well with the geophysical measurements in the upper 5 m of the levee from 36 to 48 m along the profile.

There are relatively thin layers between the higher and lower resistivity zone discussed in both surveys. These should not be interpreted as additional soil layers, but rather as smoothing effects. ERT surveys collect bulk measurements with depth, and a trade-off of the mathematically stable Occam style smooth inversion smears at sharp boundaries, preventing the defining of sharp layer interfaces with depth. This smearing effect is especially noted in Figure 9(a) where the resistivity in the upper 2 m appears to be higher and less uniform than in Figure 9(b), where higher resolution data were collected near the surface. The smearing effect is still noted between the two layers in Figure 9(b), though it is minimized.

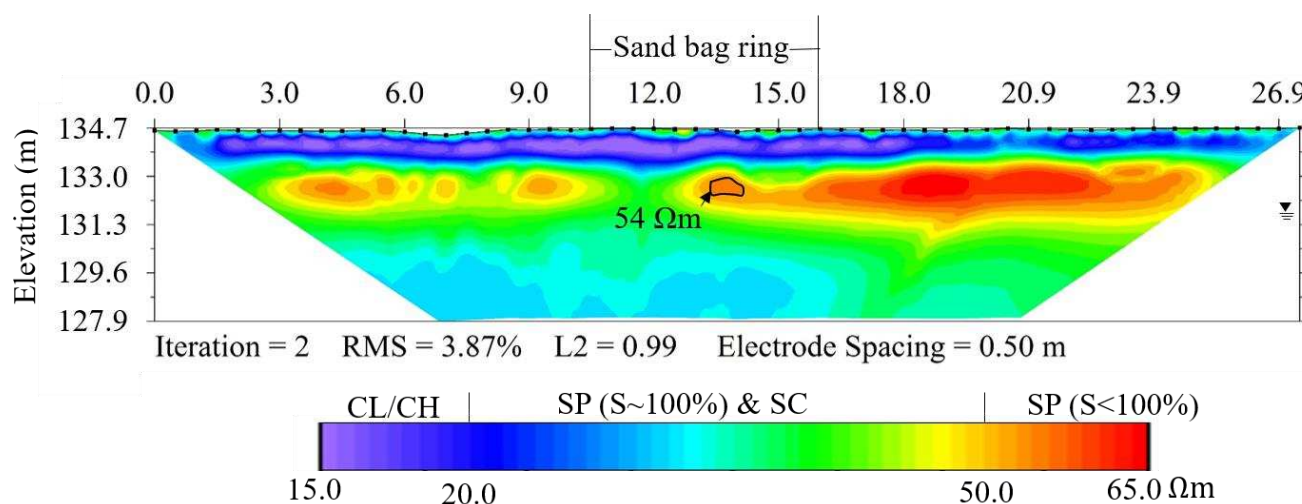
Line 3 (shown in Figure 10) was conducted approximately 3 m above the levee toe on the land side of the levee. The survey in Figure 10 was approximately 5.1 m from the center of the sand bag ring labeled in Figure 9(a). No nearby borehole data were available; the depth to the groundwater table based on the boring from the crown of the levee, however, is shown on the right side of the inversion. The uppermost layer to El. 133.9 m was low resistivity, from 15 – 20 Ωm, similar to the upper layer in Figure 9(b). There is a layer from El. 133.7 m to El. 132.7 m that has resistivity values between 30 and 75 Ωm. The bottom layer is less than 30 Ωm and likely corresponds to the approximate groundwater table as shown. Note that relative resistivity color scheme was changed in Figure 10 to improve visualization of the inversion.

Figure 10. Line 3, survey near the landside toe that was 5.1 m uphill of sand bag ring.

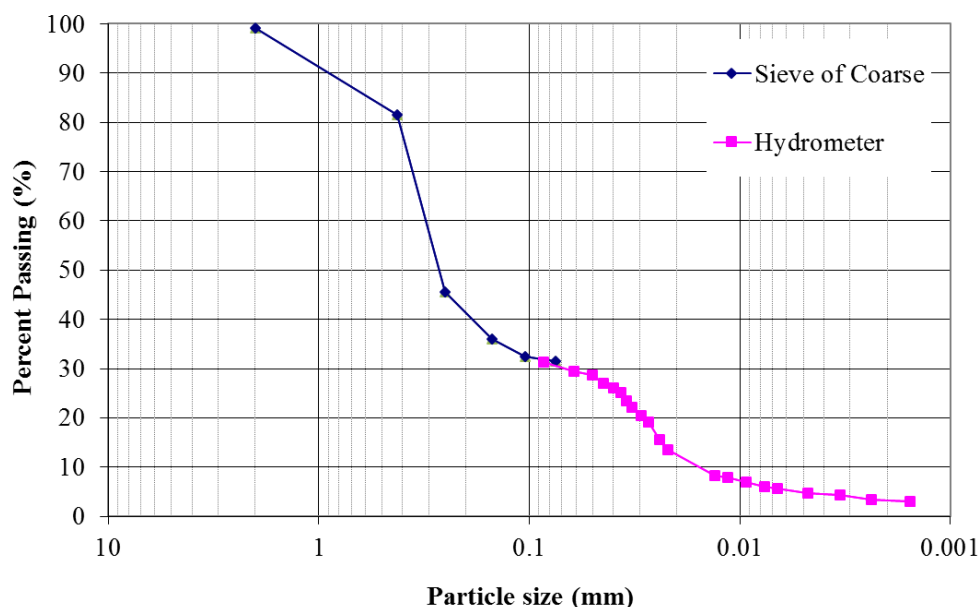
Sample B1 classified as a silty sand (SM) based on the USCS classification (ASTM D2487 2011); however, there was no SM identified in the soil borings by the USACE. Determination of the percent fines by washing (ASTM D1140 2017), particle size analysis of the coarse fraction by sieve (ASTM D6913 2017), and particle size analysis of the fine-grained fraction by hydrometer (ASTM D7928 2017) were conducted to determine whether this soil was a mixture of the sand fill and clay levee material shown in the boring log or a foundation soil located deeper than what was captured in the USACE boring. Figure 11 shows the particle size distribution curve for sample B1. The soil contained approximately 68% sand particles and 32% fine-grained particles passing the No. 200 sieve, of which approximately 3.5% were clay sized particles (i.e., < 0.002 mm). This soil was comprised of approximately 28% silt sized particles. The large fraction of silt size particles and the fact that a silty soil was not identified on the boring log suggested that the soil came from locations deeper than what was captured by the available boring. The low percentage clay fraction obtained also indicated that this soil was a different soil altogether and was not a mixture of the sand and clay soils resulting in a SM classification. The liquid limit and plastic limit of sample B1 were determined to both be 19 (following ASTM D4218 2017), resulting in a non-plastic designation for the fines.

Figure 11. Particle size distribution for sample B1 retrieved from Sand Boil 1.

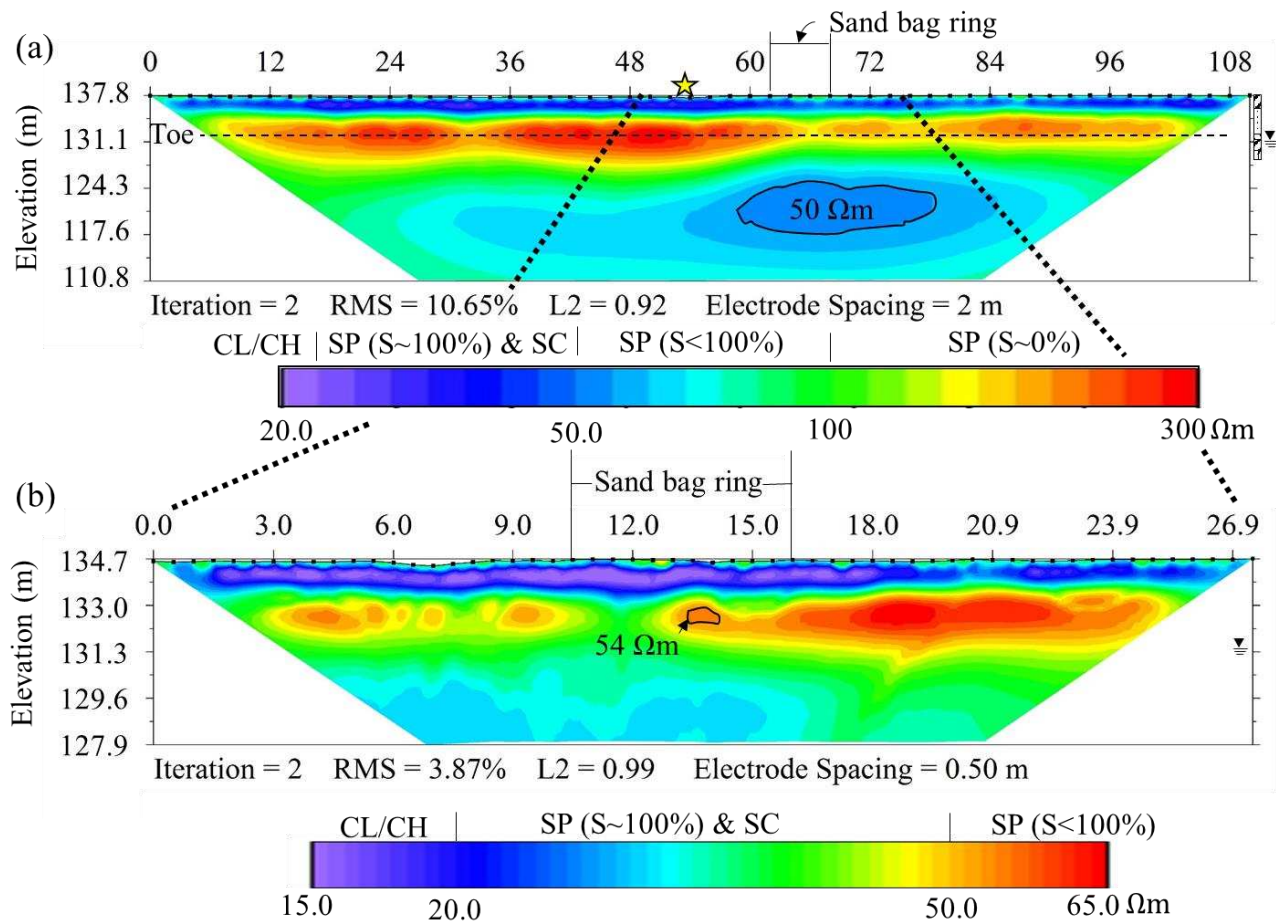
Figure 12. Alignment between Line 1 at the levee crown and Line 3 near the levee toe.

The uppermost clay layer is apparent in both surveys, although it is clearer in Figure 12(b) where the electrode spacing is smaller and the near surface resolution greater. The electrical resistivity of clayey soils (CL/CH) is typically between 1 - 20 Ωm (Everett, 2013). As shown in Figure 3, the levee was constructed of sand with a clay cap. Therefore, a zone of higher resistivity was anticipated beneath the clay layer. The sandy material (electrical resistivity between 150 - 300 Ωm) was noted in Line 1 and aligned with the nearby borehole data; however, it was not present in Line 3. Note from Figure 12 that the approximate interface between the levee and foundation materials was at El. 133.5 m, therefore minimal sand was expected at Line 3. Line 3 allowed for a more focused interpretation of the anomalous zone of 50 Ωm that aligned with the sand bag ring in Line 1. Zones of relatively higher resistivity between 50 - 65 Ωm were identified in Line 3, including one discrete zone that was centered along the alignment of the ring of sand bags at the toe of the levee. Figure 12(a) also includes a zone of lower resistivity (approximately 50 Ωm) that aligns with the ring of sand bags and extends to the edge of Line 3. The

remaining material beneath the toe of levee in Figure 12(a) is between 70 - 100 Ωm and likely a partially saturated coarse-grained material based on the location of the groundwater table from the USACE data.

By combining the laboratory and field electrical resistivity with the approximate areas of seepage based on the sand bags at the site, it was likely that these zones of 50-60 Ωm in Line 1 and Line 3 represent the zones in which the seepage and material transport occurred, carrying these soils under the levee and to the sand boils at the levee toe. In Line 1, the seepage channel appears to spread between the 58 and 76 m markers, but again resolution is lost with depth. Line 3 aligns with the Line 1 damage, showing higher resistivity from approximately 13 to 26 m. More discrete zones where material may have been moved under the levee and to the sand boils are seen in Line 3. The regions of the seepage channels in Line 3 are much closer to the surface than in Line 1 because they are closer to the sand boil "exit" and the material is working its way to the surface. The change in electrical resistivity within these potential seepage channels relative to the undisturbed soils may be due to a combination of many factors. The seepage force displacing the particles will likely alter the soil porosity as particles are displaced. The pore fluids within this seepage channel may be different than the native pore fluid, changing the ionic composition of the pore water. The seepage may have caused the removal of finer particles, or the removal of surface conductance of the fine particles. Unfortunately, the cause of the change in electrical resistivity relative to the native soil could not be identified because no samples could be collected from the identified anomalies beneath the levee at the time of the ERT survey. Therefore, the primary limitation of this study was that these interpretations of the seepage channels were based on laboratory and field resistivity measurements alone. Subsequent ground truthing where the surveys were conducted is the only way to definitively support this interpretation.

Following the field investigation and surveys presented in this study, the USACE completed rehabilitation work to mitigate the seepage issues on the Hager Slough Levee. A 960.4 m sand seepage berm was constructed on the landside toe of the levee and a turtle mitigation berm was constructed on the riverside toe of the levee in July 2017. The berms were constructed using approximately 60,000 m^3 of sand dredged from the adjacent Sangamon River channel.
