Forensic Analysis of Levee Failures: The Breitenhagen Case

ABSTRACT: *Forensic analysis of past failures is valuable to improve our understanding of levee behavior. In this article a new systematic approach of forensic analysis for levee failures is proposed and applied to the Breitenhagen levee breach that occurred along the river Saale in Germany in 2013. The purpose of this study is to identify the cause of the breach based on the proposed approach, even though limited data is available. Based on the information prior, during and after the breach of the levee, a slope stability model is developed for the entire event. First, results from this model are obtained based on the expected values of the uncertain parameters and the best estimates of the situation. Uncertainty of the model is included in the calculation subsequently by defining possible failure scenarios. The most likely failure scenarios are derived from the data and included into the model so that it is possible to eliminate or validate all possible causes by means of a sensitivity calculation. It is concluded that the levee breach is likely caused by locally weak soil conditions, unexpected high water pressures due

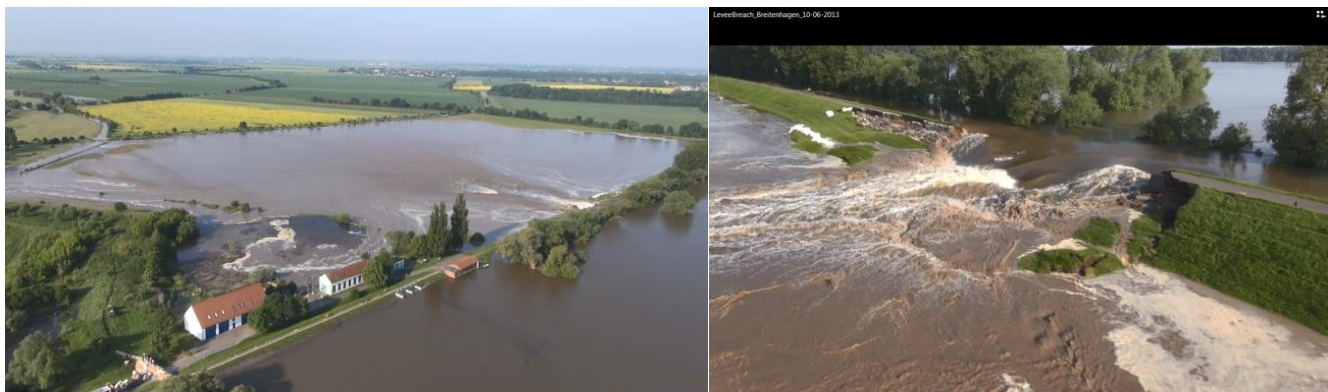
During the floods of the Saale River in June 2013, the east embankment breached near Breitenhagen (Saxony-Anhalt, Germany) (Figure 1 and Figure 2) (Grubert, 2013). The breach of the levee caused a lot of economic damage that was financially covered by the state of Saxony-Anhalt (Drews, 2017). The failure appears to be the result of slope instability due to the long lasting high water level in both the Elbe and the Saale (Drews, 2017; Grubert, 2013). Historical documents indicate that the levee was built in the second half of the 19th century (Sixdorf, 2016). The overview photo shows a grassy levee with a paved road on top of the levee which can be used by heavyweight traffic (Figure 2). Trees grow along the length of the levee in the floodplain of the Saale. The overview photo also shows a pond near the location of the breach at the river side of the levee (Figure 2).

Figure 1 Left: Overview photo of the landside while the flooding evolves, Right: Overview photo of the breach on June 10[th] 2013 (Weichel, 2013).

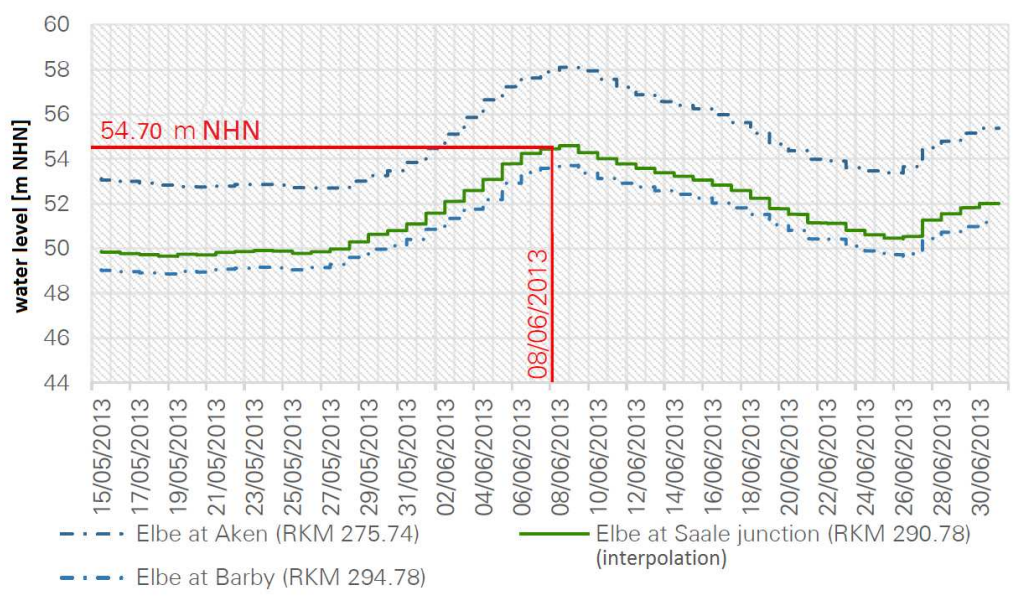
Figure 3. Graphs with water levels over time of the Elbe and Saale near Aken and Barby. Water level at Elbe and Saale junction, RKM 290.8, is NHN+54.7 m (Drews, 2017; Grubert, 2013)

In the summer of 2013 both the Elbe and the Saale river experienced high water levels due to heavy rainfall upstream. The peaks of the high water levels met each other at the intersection of the Saale and the Elbe near Breitenhagen. The actual water height was not measured at the location of the breach, but the water levels were measured at the nearest upstream and downstream measurement station and the levels at Breitenhagen were interpolated (Figure 3) (Drews, 2017). The elevation of the (water) level is expressed as a standard reference level called the NormalHohenNull (NHN) which is approximately equal to mean sea level. The breach occurred just at the moment that the water levels in both rivers reached their peak on June 8th, 2013. It appeared that the water levels of 2013 were the highest water levels ever measured in both the Saale and the Elbe (Drews, 2017). Both water levels have a return period of 100 to 200 years (Drews, 2017; Elbe, 2014).

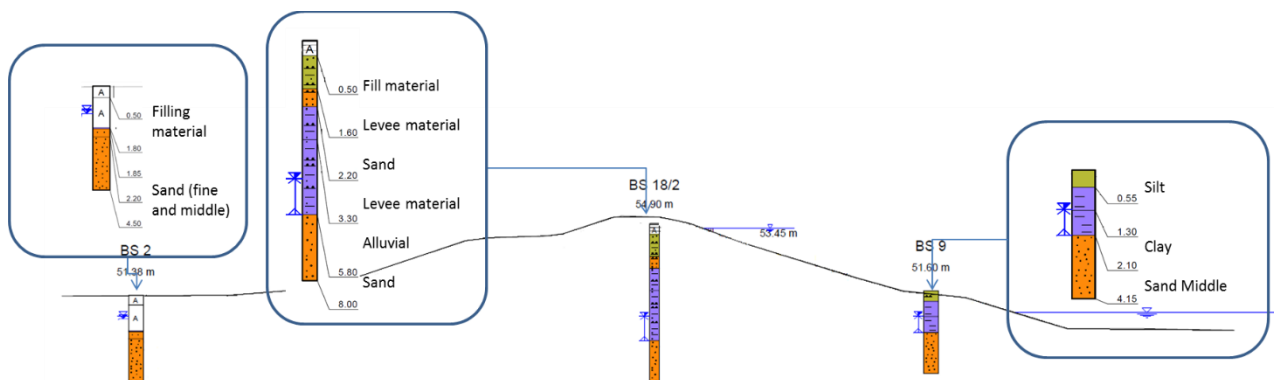
Figure 4 Cross-section of the levee (right is riverside) near the location of the breach (length marker +590 m), with the water levels, groundwater levels and the results of the borings (titled BS2, BS18/2, BS9 taken about 10 m in distance of the start of the breach (Grubert, 2013). The borings were taken both before and after the breach of 2013.

The cross-section generally consists of two layers (Figure 4 and Table 2) (Grubert, 2013). The top layer of the levee consists of largely homogeneous cohesive material (clay-like). A few inclusions of locally mixed-grained soils are identified. The bottom layer consists of a sand layer that can be found throughout the cross-section at an approximate elevation of NHN+49.5 m about 5.5 m deep from the surface (Table 2). This layer likely functions as an aquifer. The identified soil types are characterised by the typical characteristic parameters listed in Table 3 (Grubert, 2013; Schneider & Albert, 2014).

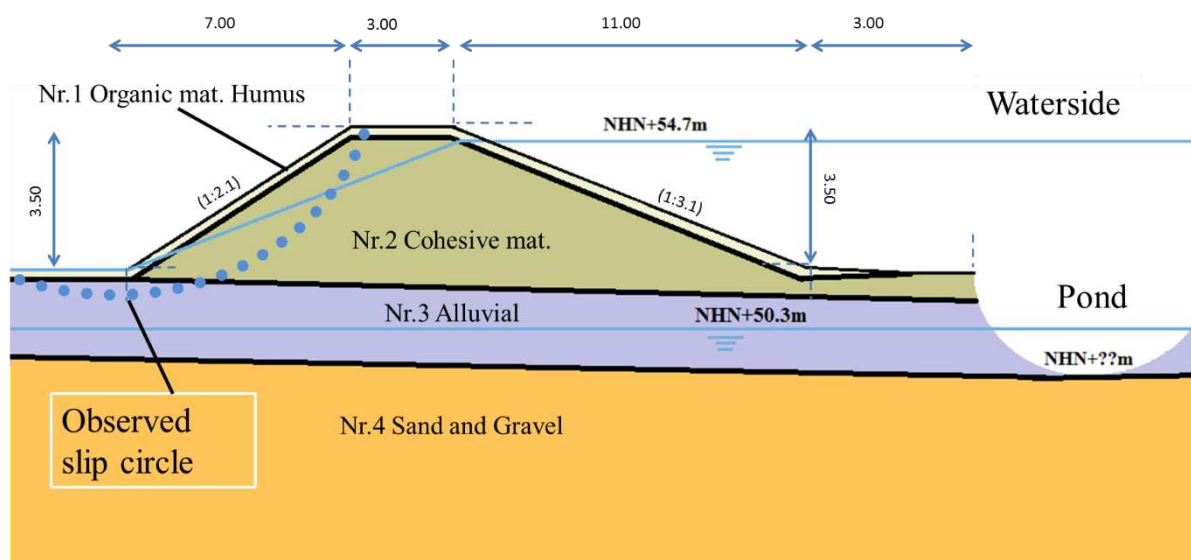
The dimensions of the cross-section of the levee are mapped at the location of the breach (Figure 5). The measurements show that the levee is about 3.50 m high with a crest width of 3.00 m. The landside slope is 1:2.1 and the waterside slope is 1:3.1. The distance between the waterside toe and the pond is about 3.00 m.

Figure 5. Dimensions of the Breitenhagen levee including simplified soil layering flood level and assumed aquifer level (pre-failure, left side is landside, right is the waterside). The 2013 high water level is NHN+54.7 m, the measured groundwater level is NHN+50.3 m. The soil modelling is based on the forensic engineering report (Grubert, 2013), incorporated with maximum occurred flood level, and soil types (Grubert, 2013).

The data collected prior to the breach provide an indication of the condition of the levee prior to the breach. The overview photo shows a pond in front of the levee possibly caused by an earlier breach (Figure 2). This indicates the possibility of a direct connection between the outside water level and the aquifer below the levee. The photos show a row of trees at the riverside toe of the levee which might influence the conductivity of the levee due to the intrusion of the roots inside the levee, or might indicate the presence of a more conductive layer inside the levee (Figure 2). The slope of the levee is very steep (about 1:2.1 vertical to horizontal) with a gradient that exceeds the friction angle of most soil types. The slope at the landside is prone to instability (Figure 5).

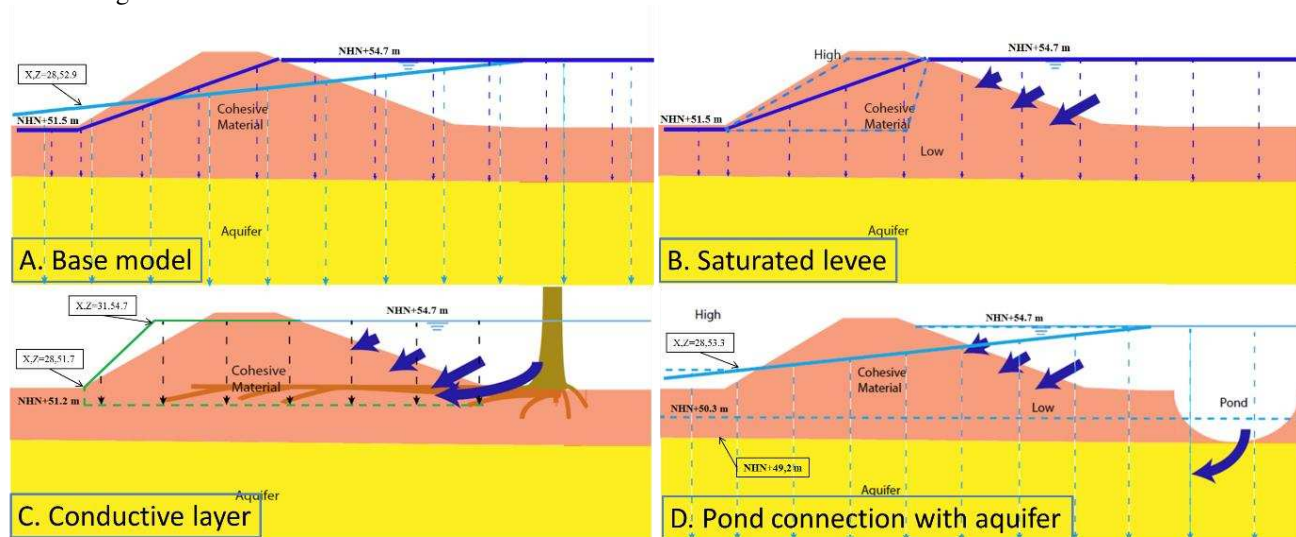
Figure 10. View of the four possible scenarios derived from the data analysis. ScenarioA: Best estimate of phreatic line inside the levee (solid dark blue) and best estimate hydraulic head in the aquifer (solid light blue), called "Base model". The river head (NHN+54.7m) and localy heightened polder head (NHN+51.5m). Scenario B: Infiltration of water through the levee slope which is called "Saturated levee" (dashed light blue lines); Scenario C: Infiltration through a conductive layer related to the tree roots which is called "Conductive layer, indicated by the tree roots" (situated at NHN+51.2m)(the hydraulic head in green is the head at the location of the roots, the phreatic line is the same as the Base model. Inside the levee, water pressures in the levee are interpolated between the phreatic line and the green line); and Scenario D: Infiltration through the connection between the outside water level and the aquifer which is called "Pond connection with aquifer" (polder head of NHN+51.5m) with an upper and lower head (dashed light blue lines);.

In the scenario of the "Saturated levee" (scenario B), the only phenomenon that is taken into account is the development of the phreatic line in the levee body (Figure 10). The development of the phreatic line in the levee itself is caused by the infiltration of the high water wave from the river in the levee body. Due to the low permeability of the cohesive material, the infiltration of the water in the levee is a relatively slow process. The intrusion length of the high water wave is limited by the width of the levee. The extreme low and high boundary of the phreatic line are based on standard phreatic models to represent infiltration (upper extreme boundary) and transient (lower extreme boundary) flow are suggested by literature (TAW, 2004). The models incorporate the influence of the dominant factors that influence the phreatic lines, i.e. infiltration and groundwater flow in order to simulate the transient flow and the different possiblities of steady state flow.

In the scenario of the "Conductive soil" (scenario C.), the roots inside the levee indicate a more conductive layer due to a relatively large permeability (Figure 10). Therefore, the intrusion length of the water wave is increased in this layer. This causes a local increase in water pressure. Moreover, the velocity of the high water pressure wave in the conductive layer is relatively fast compared to the levee body. In this area, the water potential equals the outside water level. At the inside toe of the levee, the potential inside the rooted area is limited by the covering soil. The analysis of Scenario C. is executed as a direct relation to Scenario B. to show its influence on the upper, mean and lower bound of the phreatic line. The water pressure inside the levee is interpolated between the phreatic line and the hydraulic head inside the conductive soil layer.

In the scenario of the "Pond connection with aquifer" (scenario D), the pond in front of the levee might introduce a connection between the aquifer layer and the outside water level (Figure 10). This causes a local increase in water pressure in the aquifer compared to the water pressure corresponding to the phreatic line. Because of a relatively large leakage length of the outside water level, the water pressures inside the aquifer might cause a shear strength reduction at the landside. The weight of the blanket layer limits the hydraulic head in the aquifer. The water pressure inside the levee and the blanket layer is interpolated between the phreatic line and the (limited) hydraulic head at the interface between sand and clay.

The analysis of the "Saturated levee" uses 3 different scenarios of water pressures to incorporate the uncertainty in transient flow and the contributors in the phreatic line (rain, groundwater, high water wave, etc.) e.g. convex, straight and concave (Figure 10). The analyses with the straight phreatic line is similar to the base model that is introduced as the base case (Figure 9). The analysis of the "Conductive layer (indicated by roots)" is executed as a direct relation to the saturation of the levee as described earlier.

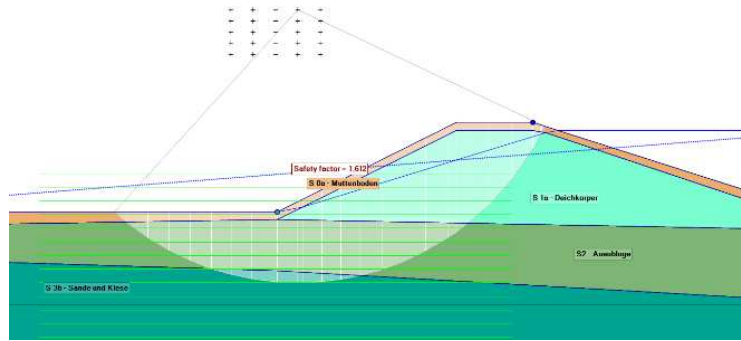
The "base model" (scenario A) represents the best estimate scenario with the expected values of input parameters. The "base model" functions as the basis of the sensitivity analyses (Figure 9). The LEM calculation is executed using the Bishop method and drained soil behavior. The Bishop method is used as best-estimate since this method reflects the circular observed slip circle relatively well. The results of the simulation of the best estimated situation show a FoS=1.61 [-], which is considered stable (FoS>1.0). The shape of the slip circle shows realistic similarities with the actual slip circle (Figure 11). However the slip circle starts at the riverside of the top of the levee, instead of the landside. Also the slip circle intersects the sand layer, which is not considered realistic.

Figure 11 View of the LEM calculation using Bishop stability model with drained soil behavior (FoS=1.61).

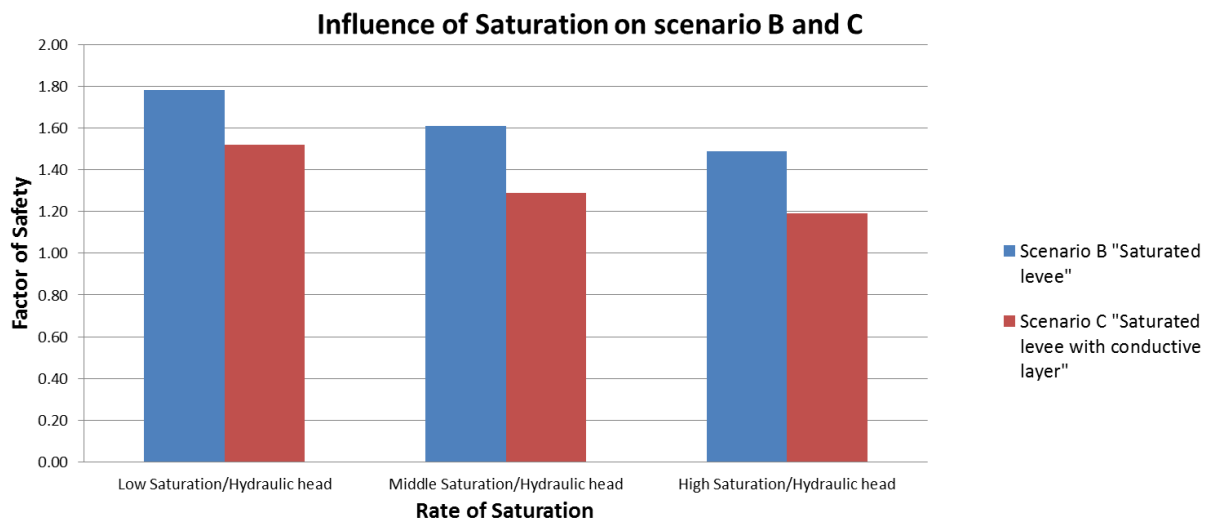
Figure 12. Blue: Influence of the saturation of the levee on the FoS. Red: Influence of the saturation when the local high water pressures in the conductive layer are introduced.

The FoS is negatively correlated with increase in water pressures, because the effective stresses are reduced, which in turn causes the shear strength to decrease. Due to the rising phreatic line, the range of FoS is in between 1.78 and 1.49 (Figure 12). The analysis of the increased potential head in the conductive layer around the tree roots results in FoS of 1.52, 1.29 and

1.19. The lowest factor of safety is found for the highly saturated cross-section in combination with the conductive layer. All models, yield safe values for the FoS.

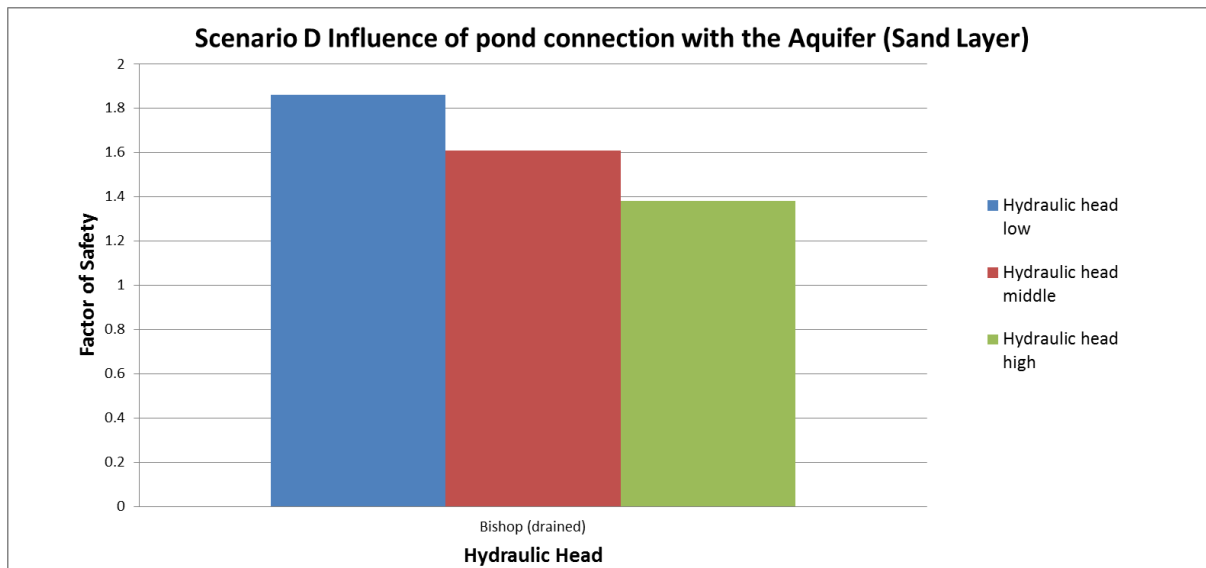
Figure 13. Influence of the rise of the hydraulic head in the aquifer with three different levels in hydraulic head in scenarios D.

Due to the rise of the hydraulic head in the aquifer, the range of the FoS overall is between 1.86 and 1.38. The shape of the slip circle shows realistic similarities with the actual slip circle. However the slip circle still intersects the levee crest instead of starting from the landside of the levee.

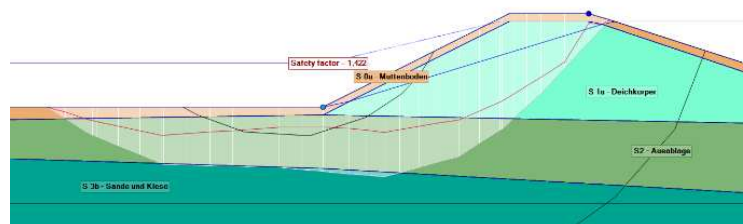
Introducing undrained soil behavior for the clay, scenario D, results in FoS between 1.66 and 1.28. The slip circle of the actual failure (Figure 6) and the calculated slip circle (for example with the use of Bishop with undrained soil behavior and Spencer with drained soil behavior) differ in geometry. The slip circle of the Spencer method seems to show more realistic geometry of slip circle than the Uplift Van method and Bishop's method in case of low effective soil pressures at the interface between sand and clay (Figure 14).

Figure 14 View of scenario D: "Pond connection with aquifer" output. The high hydraulic head is included and the Spencer model is used (with drained soil behavior) which results in FoS=1.42.

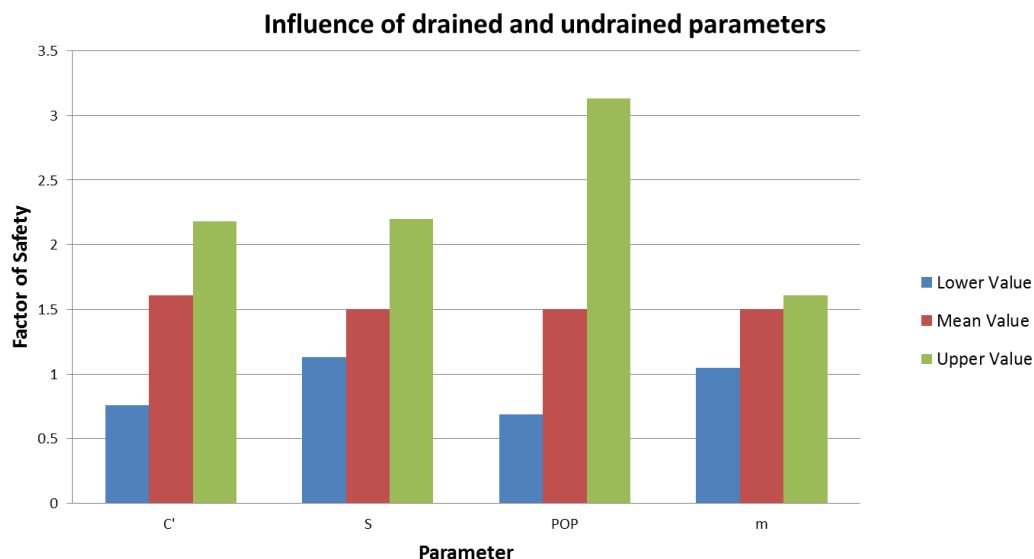
Figure 15. Results of the sensitivity analysis of drained parameter cohesion and undrained parameters.

Varying the cohesion, which is the dominant parameter of the drained soil model, the FoS covers a range between 0.76 and 2.18 (Figure 15). The undrained shear strength has a high variability, due to the uncertainty of the previous stress history and related overconsolidation state (the POP, pre-overburden presure, was used to describe this uncertainty). The results of the calculations greatly reflect this uncertainty in the calculated FoS ranging from 3.13 and 0.69. The parameters S and m, used to model undrained shear strength, result in large variation in FoS, but do not result in values below 1, which would represent failure of the levee. The calculation using the low cohesion values and the Bishop model show similarities with the actual slip circle and do not reach the sand layer underneath the cohesive layers (Figure 16).

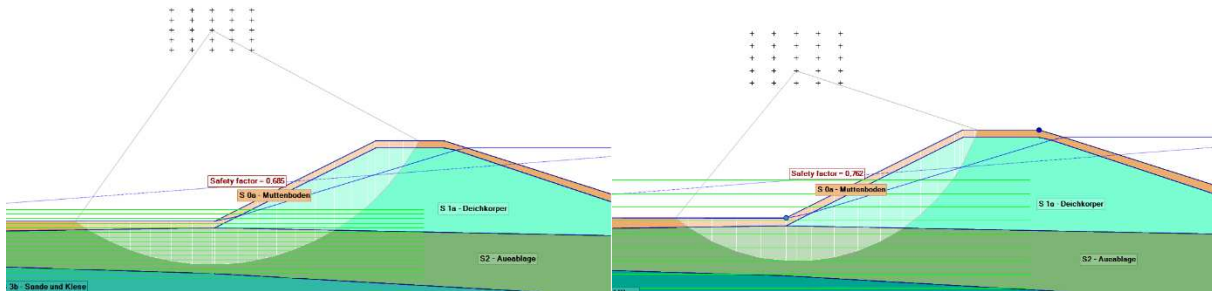
Figure 16 Left: View of scenario A. "Base model" using the Bishop slip circle and low values of POP resulting in FoS=0.69 (undrained soil behavior). Right: Scenario A. "Base model" using the Bishop model and low values of cohesion resulting in FoS= 0.76 (drained soil behavior).

The additional calculation run with a combination of low values of cohesion with high water pressures in the aquifer results in a FoS of 0.55, using Bishop's LEM. The resulting slip circle seems shallow compared to the actual observed failure surface.

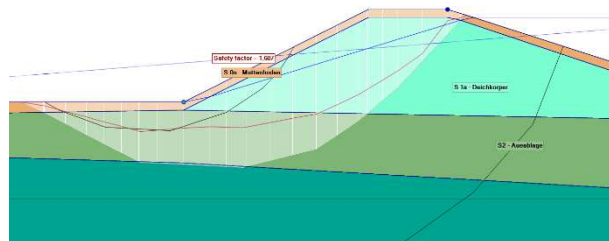
Three different LEM are used in the assessment on the levee strength, i.e., Bishop, Uplift Van and Spencer (Figure 9 level 4) in the D-Geo Stability software (Deltares, 2016). All three LEMs are applied to the "base model". The sensitivity analysis is used to establish the influence of different LEM. The FoS determined with the help of the Bishop, Uplift Van and Spencer model covers a range between 1.55 and 1.61. All models result in approximately the same slip circle (Figure 11, Figure 17). The Spencer method shows the most realistic geometry of the slip cirlce (i.e., the slip circle doesn't intersect the sand layer).

Figure 17 View of scenario A. "Base model" using the Spencer method presenting the calculated critical slip circle (FoS=1.61).
