Geotechnical Effects of Hurricane Harvey in the Houston, Beaumont, and Port Arthur Areas

ABSTRACT: *The Geotechnical Extreme Events Reconnaissance (GEER) Association deployed multiple teams of engineers from academia and practicing firms to the coast of Texas in late August and early September 2017 following Hurricane Harvey. This report summarizes the observations and data from the GEER team that focused primarily on the inland effects of Hurricane Harvey in the Houston area with some observations in the Port Arthur / Beaumont area east of Houston. Rain, not storm surge or wind, caused the observed damage in Houston, Beaumont, and Port Arthur by overwhelming stormwater management facilities and creating high flows and flooding in and near area waterways. The major Houston-area flood structures, Addicks and Barker Dams, performed well from a geotechnical perspective. Observed damages included shallow slides along levees, severe erosion along riverways, isolated road and culvert erosion and uplift, and area-wide flood effects in low and poorly drained neighborhoods.*

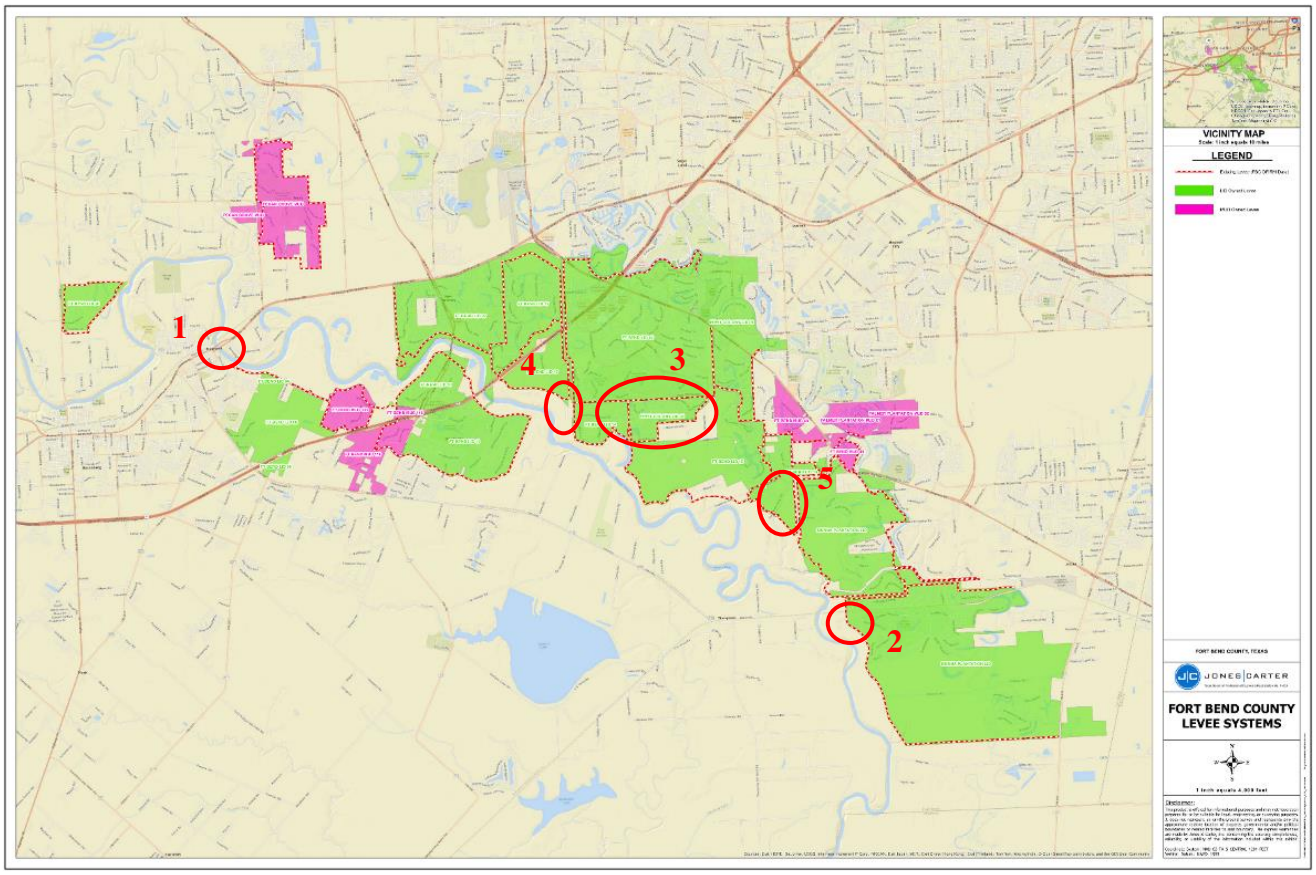
Figure 13. Fort Bend County Levee Systems. See following list for names of labelled systems. Existing levees are shown as red-dashed lines, LIDS in green, and MUDs in purple (from Jones|Carter), 1 – Richmond, Texas, USGS gauge on the Brazos River, 2 – Sienna Plantation Levee Improvement District levee surficial slough, 3 – First Colony LID 2, 4 – Ditch H, 5 – Flat Bank Diversion Channel

Overall, we understand that the Brazos River LID levees performed well, with no major failures, breaches, or overtopping. One incident of a surficial slide on the protected slope of a Sienna Plantation LID levee was reported and photographed by others as shown in Fig. 14 (see Location 2 on Fig. 13). The GEER team visited the First Colony LID 2 (see Location 3 on Fig. 13) and two of the drainage ditches that serve the LIDs (see Locations 4 and 5 on Fig. 13). Despite the good levee performance, flooding occurred within several LIDs due to the issues with storm water removal from the protected side behind the levees to the river side. Some LIDs were even completely cut off due to water surrounding the entirety of the LID.

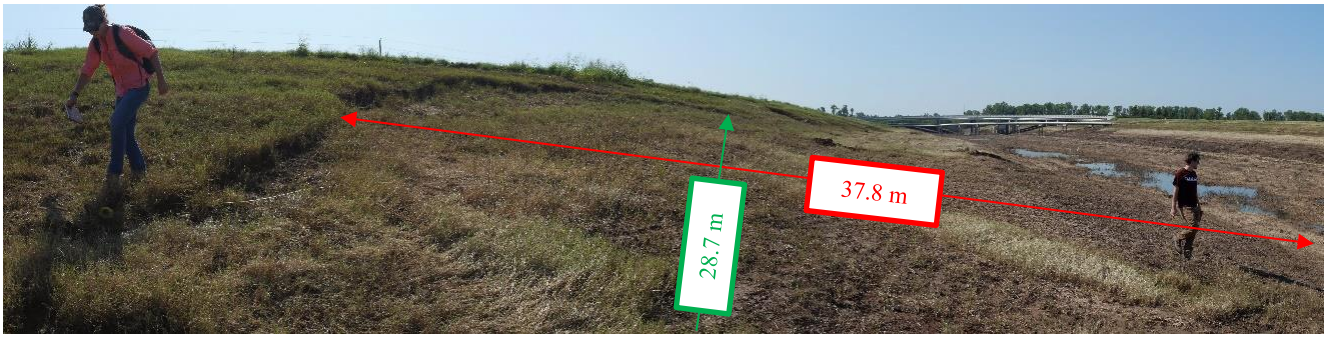
The team observed several slope failures or sloughs along the slopes of Ditch H and numerous feral hog burrows. The east side slopes had some scarps that ranged in height from 15 to 99 cm (6 to 39 inches). Figs. 18 and 19 show two of the sloughs. The slope failures were likely due to softening of the clay soils by the flooding and the subsequent increases in stress on the slope due to drawdown of the flood water. Leakage from either an intact or ruptured CMP could have also contributed to one of the slope failures. The team also observed an erosion gulley below a drainage outfall on the University Avenue bridge (Fig. 20), which could have been prevented with hardened material protection (e.g., riprap, concrete blocks) below the outfall.

Figure 18. Ditch H levee, dimensioned slope failure (September 10, 2017, 29.55797°N, 95.63792°W).

Figure 19. Sour hole at ruptured drainage pipe on Ditch H levee (September 10, 2017, 29.55759°N, 95.63768°W).

Figure 20. Erosion on Ditch H levee under the University Blvd Bridge due to flow impact from bridge drainage outfall (red arrow, September 10, 2017, 29.55902° N, 95.63744° W).

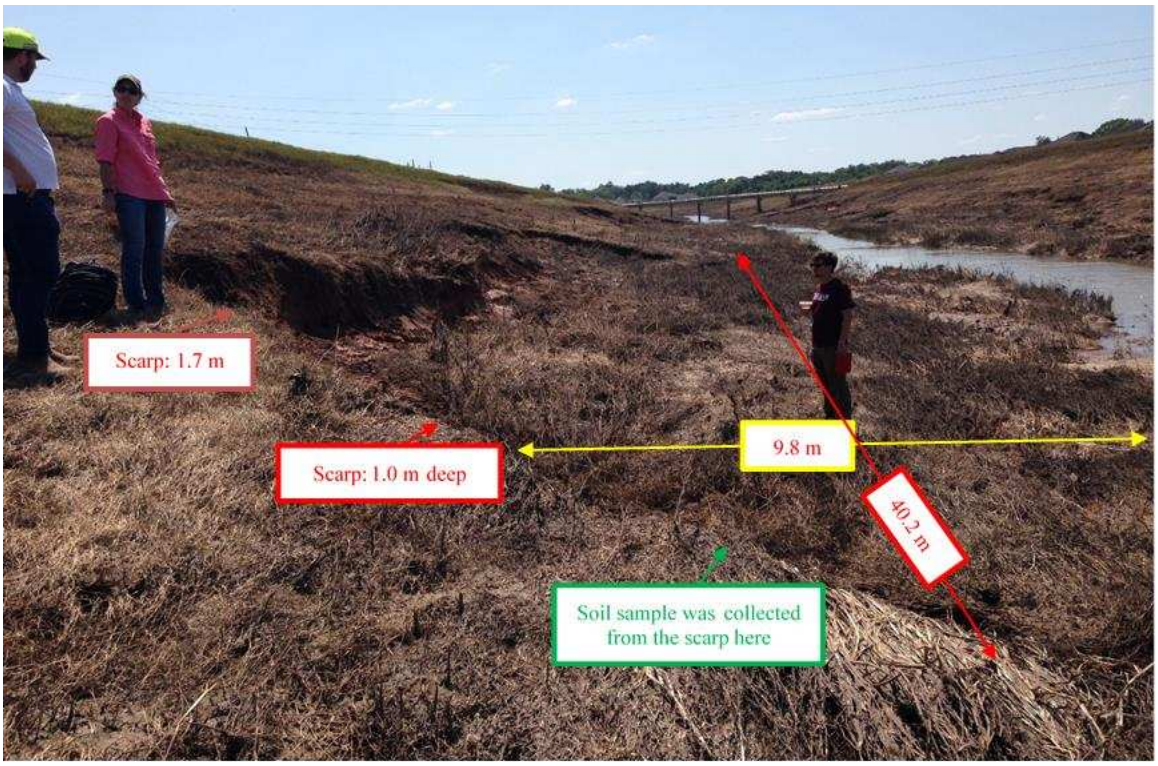
The team observed numerous slope failures along the Flat Bank Diversion Channel (see Fig. 13 for location) between 29.53103° N, 95.56200° W and 29.52572° N, 95.56201° W. Fig. 21 shows the dimensions of one large slide where the team collected a soil sample that was subsequently classified at the Kansas State University laboratory as low plasticity clay (CL) with a 21.3% moisture content. The team noted a drainage CMP outfall on an intact portion of the slope adjacent to this slide and another slide to the south. Figure 22 shows another embankment slough that extended into the base channel.

Figure 21. Slope failure north of damaged drainage pipe on the east side of ditch (September 10, 2017, 29.52647°N 95.56194°W),

Figure 22. Earth slumping on the west side embankment (September 10, 2017, 29.53103° N, 95.56200° W).

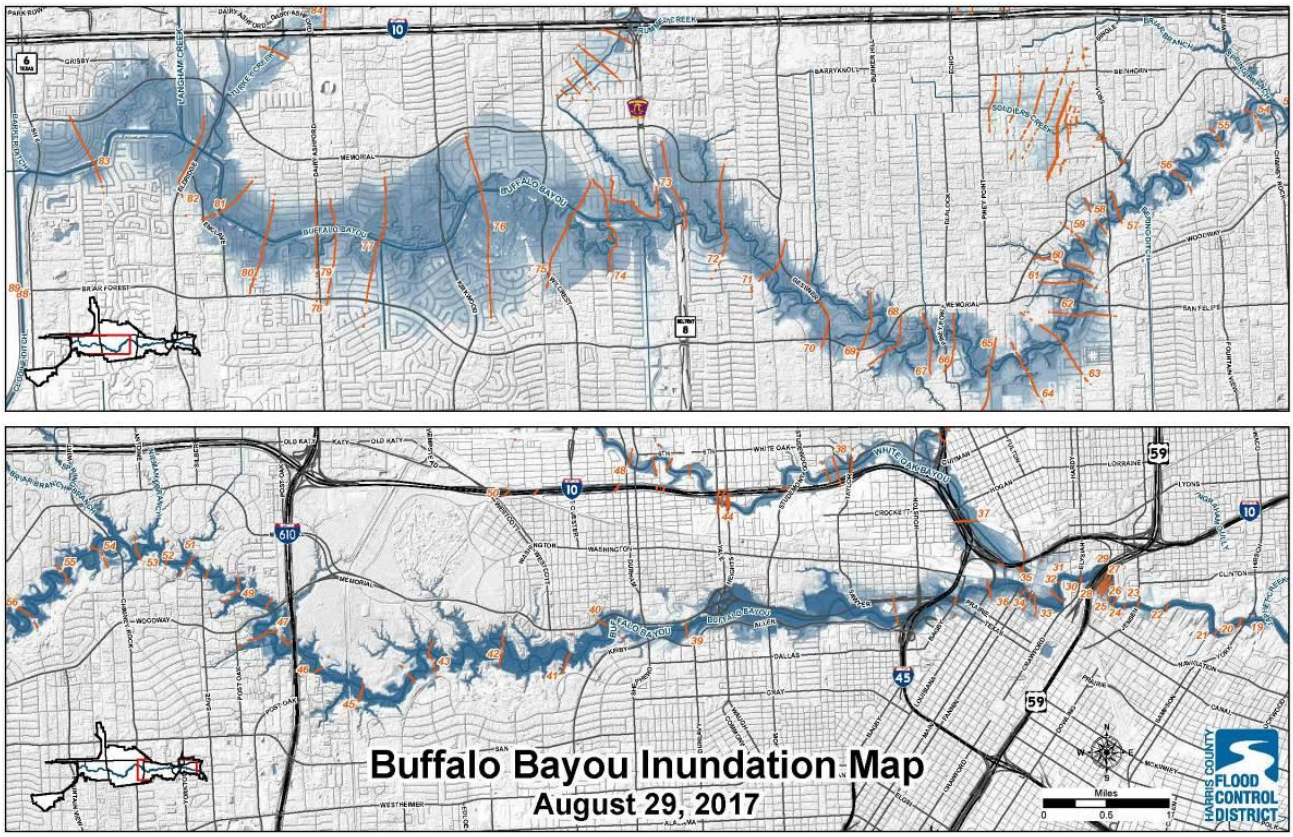
Figure 23. Buffalo Bayou inundation map (courtesy of Harris County Flood District).

Upon arrival of the GEER team at sites along Buffalo Bayou on September 9, 2017, the observed flows in the bayou were about 210 m^3/s (7,300 cfs) at the USGS Addicks gauge. Flooding of residential areas had been largely reduced by September 9, though much of the former parks and trails along the bayou were still inundated with water. Signs of the previous flooding could be seen with river debris noted on bridge girder and railings (see Fig. 24). No critical geotechnical failures were noted along the observed portions of Buffalo Bayou, but scour areas and a slope failure were observed (see Figs. 25 and 26).

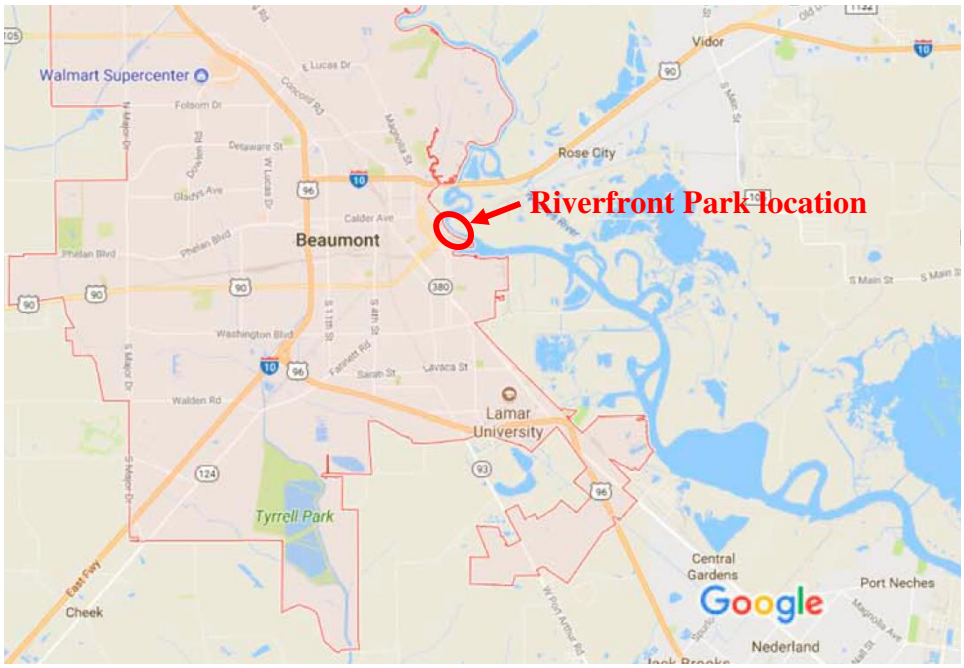
In Beaumont, the team observed significant erosion scour along the Neches River in the downtown area. Riverfront Park, behind City Hall and located on an outside bend of the river, was severely affected with the loss of shoreline and undercutting of many park features. Fig. 1 shows the location of Beaumont within the study area. Fig. 27 shows the location of Riverfront Park along the Neches River. Fig. 28 shows aerial / satellite images from Google Earth of Riverfront Park taken before the Harvey flooding (January 2015) and during the Harvey flooding (September 2015), respectively.

Figure 27. Riverfront Park location (Google Maps for source map).

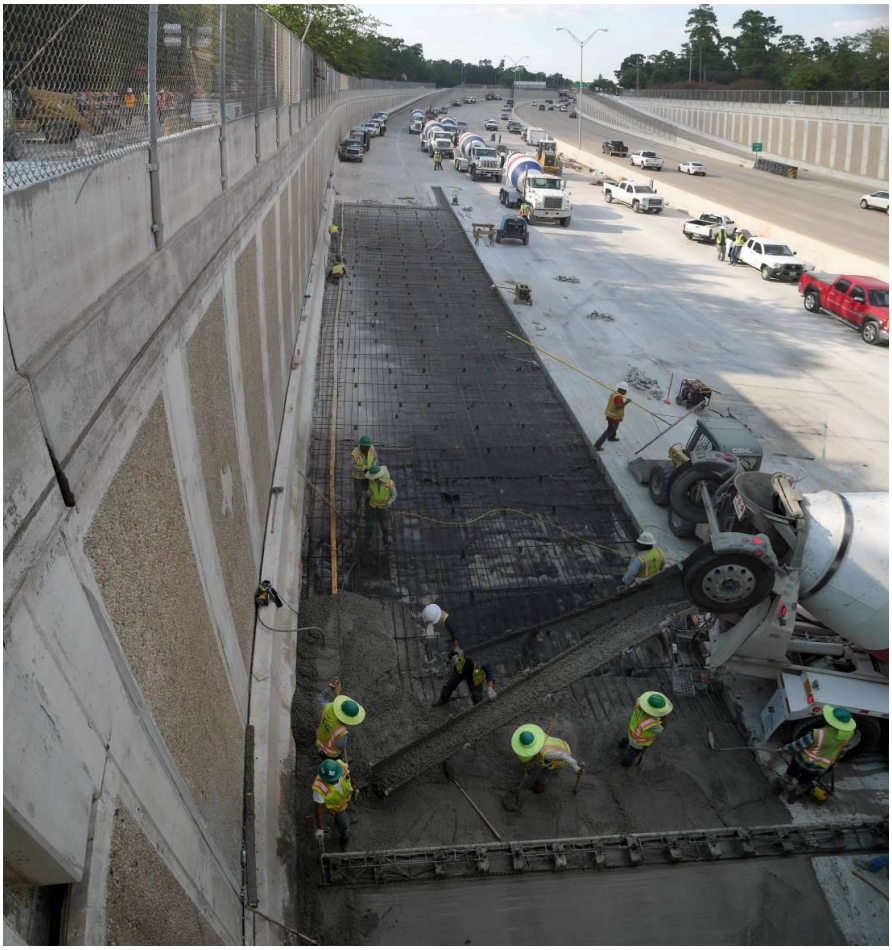
The roadway damage consisted of an uplifted road slab (or slabs) on Beltway 8 and a washout of the adjacent access road, West Sam Houston Parkway N, which is supported about 6.7 m (22 ft) above the parkway by a cantilevered retaining wall consisting of precast panels, which are supported by H-pile reinforced concrete piers. It appears that flood water from the area west of the parkway flooded the access road, drained down behind the retaining wall, and uplifted the Beltway 8 slabs. These flows then washed out soil behind the wall and under the access road and adjacent sidewalk, leaving a 5 m- (17 ft) deep hole. Fig. 32 photographs show the state of the damaged roadway during and after the flooding event. Fig. 33 shows repair work conducted on the uplifted slabs.

Figure 33. Road pavement repair in progress on Beltway 8 (September 10, 2017, 29.76736° N, 95.56208° W).

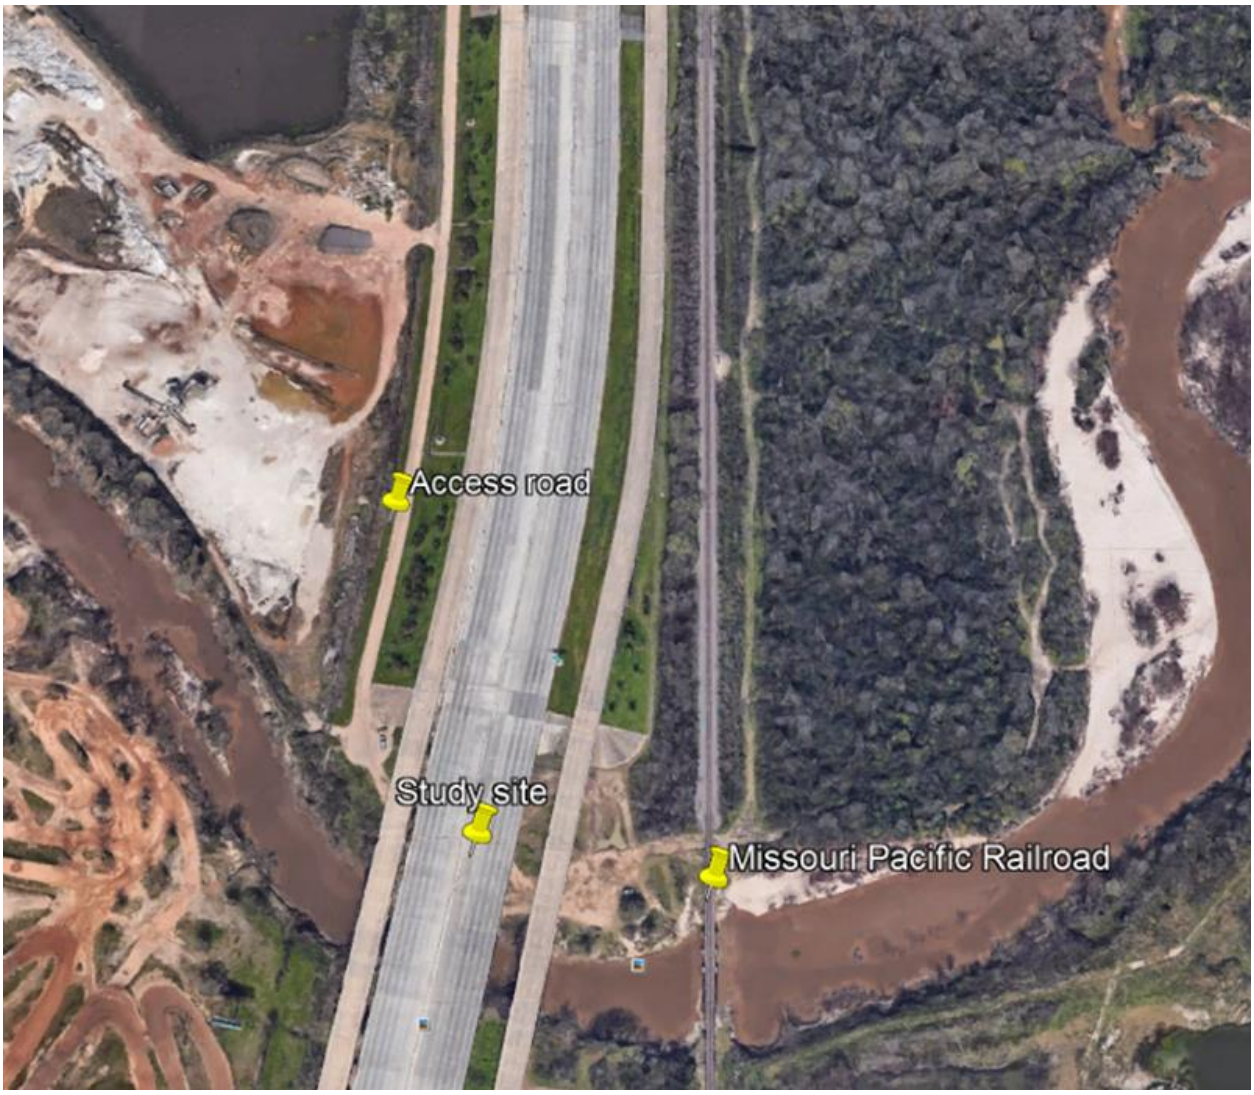
The GEER team visited the bridge foundations and supports of Interstate 45 (I-45) and the Missouri Pacific Railroad over the West Fork San Jacinto River south of Conroe, Texas, approximately 16 km (10 mi) downstream of the Lake Conroe Dam on September 11, 2017 (see Fig. 1 for location, Fig. 34 for aerial). The USGS river gauge 08068000 on the West Fork San Jacinto River, downstream of the Lake Conroe Dam, measured maximum water levels of approximately 38.7 m (127 ft) on August 29, which the USGS correlates with 3,230 m^3/s (114,000 cfs) (statistic daily mean 13.5 m^3/s [477 cfs] prior to regulation by Lake Conroe).

Figure 34. San Jacinto River Area observation locations (Google Earth image for April 2017, 30.24599° N, 95.45722° W).

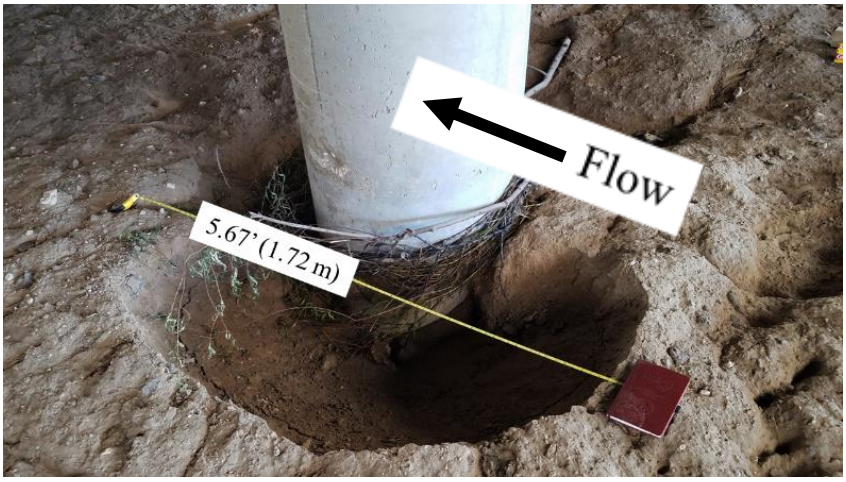
As expected, bridge columns with no erosion control had variable amounts of accumulated debris (see Fig. 35) and scour (see Figs. 36 & 37). No measurable scour was observed around columns with erosion control (see Fig. 38), which included riprap and polymeric reinforcement. Fig. 40 shows the bank of the San Jacinto River from the north side, facing south. The riprap along the banks likely reduced the erosion of the fine, sandy soil. Fig. 41 shows an observed 2.4-m- (8-ft-) diameter scour hole in the sandy bank material. Despite the observed scour, no geotechnical or structural failures were observed on the I-45 Bridge over the San Jacinto River.

Figure 36. Bridge column scour (September 11, 2017, Time 10:06 CDT, 30.24688° N, 95.45796° W).

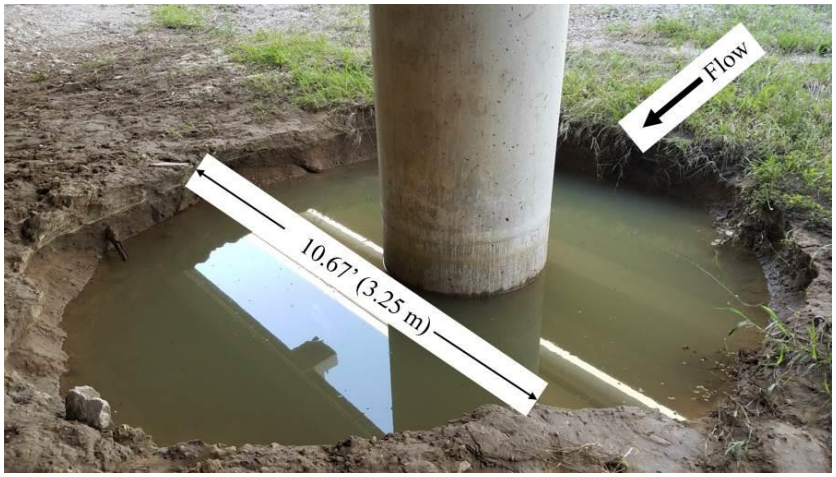
Figure 37. Scour hole on column closer to river. The hole was 3.7 m (12.3 ft) long in the flow direction and 3.25 m (10.67 ft) perpendicular to flow. The depth of the scour hole was 0.8 m (2.75 ft) from the existing ground (September 11, 2017, Time 10:23 CDT, 30.25071° N, 95.45703° W).
