Geotechnical Extreme Event Site Reconnaissance in Puerto Rico After The Passage of Hurricane Maria

Francisco Silva-Tulla, *Consulting Civil Engineer, GeoEngineering and Environment, Lexington, Massachusetts, U.S.A.; email: silva@alum.mit.edu*
Miguel A. Pando, *Associate Professor, Department of Civil, Architectural, and Environmental Engineering, Drexel University, Philadelphia, PA, 19104, U.S.A.; email: miguel.a.pando@drexel.edu*

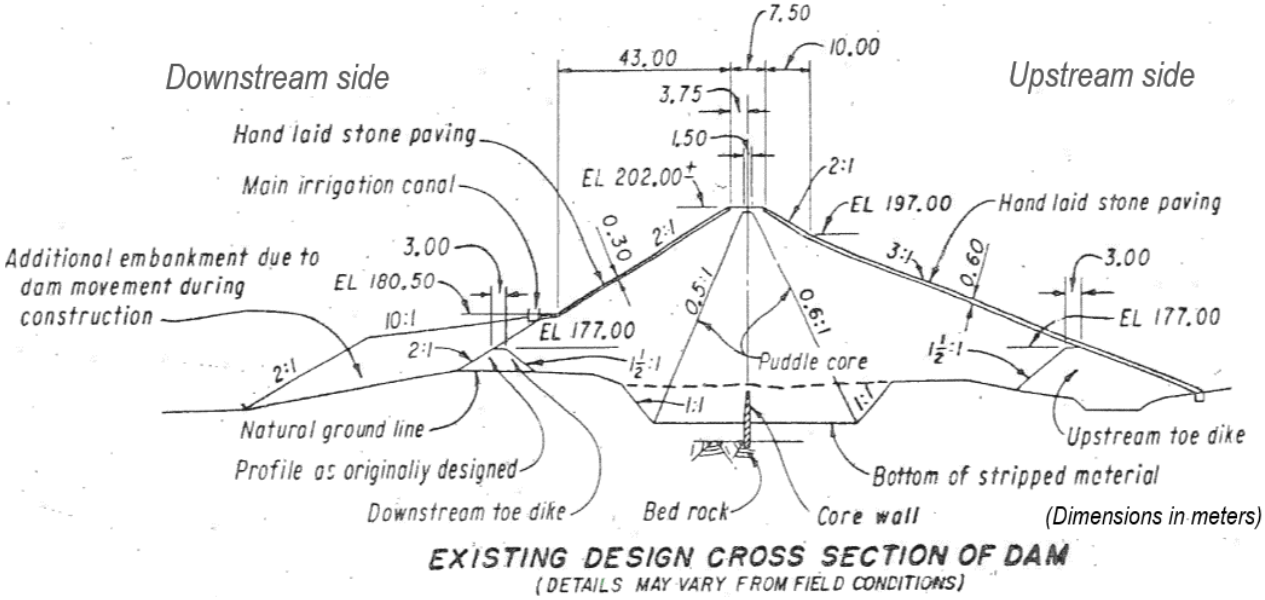
Figure 9. Cross-section of Guajataca Dam from the 1920s (date of drawing is unknown; USBR, 2002).

Figure 9 shows the cross section of Guajataca Dam, as reported by USBR (2002). Available records suggest that a large part of the dam consists of hydraulic fill, but its internal geometry and composition remain unclear. For example, the center of the dam is reported as a "puddle core", but the USBR (2002) report suggests that the hydraulic fill process left the coarsest fill materials near the dam faces and the finest in the core area. The same report indicates that fill placement was changed to "dry" roller compaction in 1927 to address field observations of dam instability. Instability during the initial construction of the dam was reported in February 1927 as cracks, slippage, and other signs of movement, including bulging and settlement of the cofferdams. Reportedly, many locations showed movements on both the dam and the downstream natural ground; maximum movements included a 0.96 m (3.2 ft) downstream horizontal displacement and 1.44 m (4.7 ft) of vertical settlement.

Figure 9 shows the remedial berm constructed on the downstream side of the dam early in 1927 after the reservoir was drained, implemented to stabilize the ongoing sliding in the downstream direction. USBR (2002) also indicates that stabilization measures included the installation of numerous drain holes and replacing the fill placement technique to "dry" roller compaction. As construction of the dam proceeded, new movements of up to 35 cm (14 in) were reported on the upstream face and a heel was installed (location unknown). The USBR (2002) report indicates that in November 1927, as the dam was nearing completion, movements reported as "creep-type" were still observed. To enhance stability, fill was placed at the toe of the dam. The USBR (2002) report indicates that crest movements were measured during the years following the original dam's completion. Movement varied from about 35 cm/yr (13.2 in/yr) between 1927 and 1929 to about 1 cm/yr (0.4 in/yr) between 1942 and 1951. In 1954, about 2,000 m^3 of fill were added to the crest area to restore its original elevation.

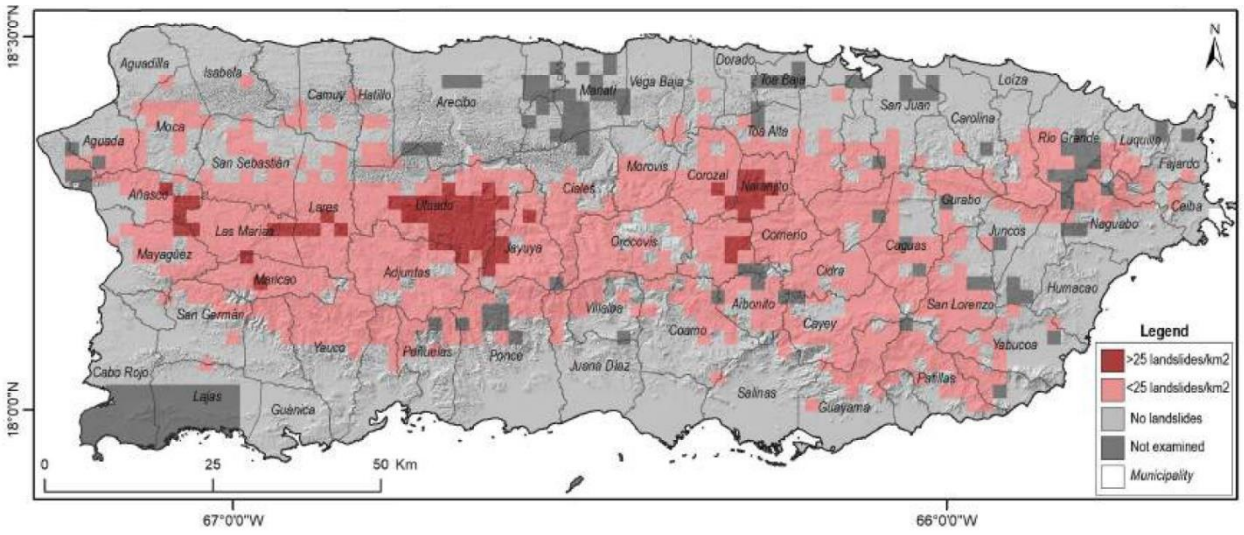
Figure 13. USGS map showing concentration of landslides attributed to Hurricane Maria (Bessette-Kirton et al., 2019).

A rapid identification of landslide density across the island was performed by the USGS (Bessette-Kirton et al., 2017 and 2019) by examining post-hurricane satellite and aerial images (Figure 13). The map was generated analyzing FEMA and DigitalGlobe images collected between September 26 and October 8 in order to estimate the number of landslides inside 2 km x 2 km square cells. The authors warn of limitations of the study related to poor visibility associated with clouds, vegetation, and/or shadows. Further, the authors assumed that the majority of landslides detected were triggered by rainfall from Hurricane Maria, but the effects of antecedent rainfall from Hurricane Irma (September 6, 2017) and heavy rainfall reported in the days after Hurricane Maria may have also triggered landslides.

Despite these constraints, this map is useful in helping to identify the most critical areas of the island affected by landslides, and in aiding response and recovery efforts. The map in Figure 14 shows results of an ongoing investigation at UPRM by Hughes and Morales-Vélez (2017), in which more than 40,000 debris flow landslide sites have been identified across PR. Based on results from these two studies, the municipalities most severely impacted by landslides were Añasco, Mayagüez, Las Marías, Maricao, Lares, Utuado, Adjuntas, Jayuya, Ciales, and Orocovis. Three deaths were attributed directly to one of the landslides in the town of Utuado.

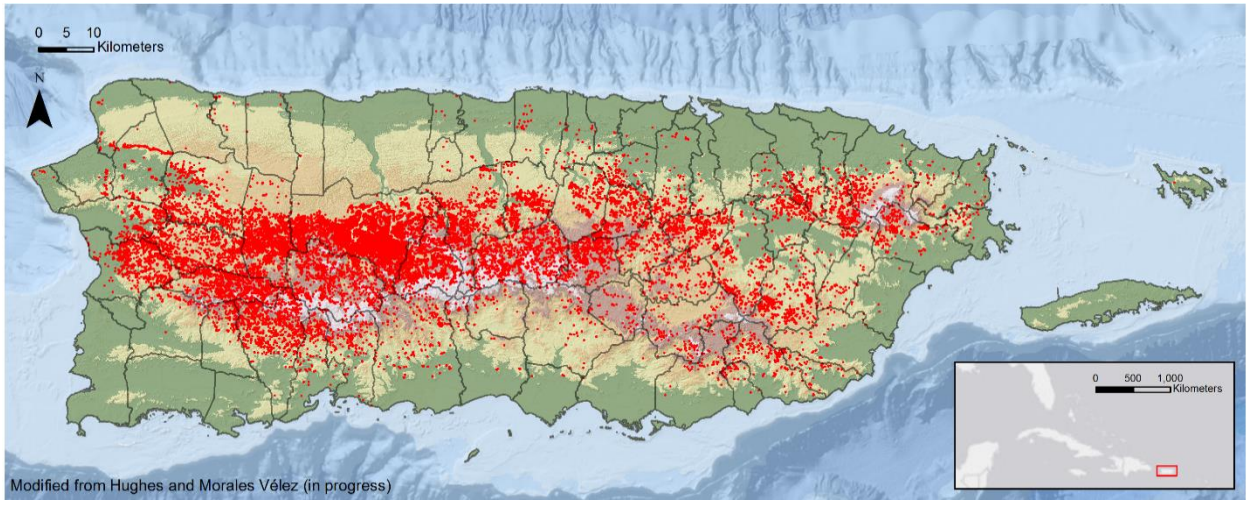
Figure 14. More than 40,000 debris flow sites (shown as red dots) identified across PR by Hughes & Morales-Vélez (2017).

The majority of the slides shown in Figure 14 consisted of shallow debris flows. Figure 16 shows a site, visited by the GEER team, which was affected by some debris flows; this site is located along Puerto Rico State Road 4131 (PR-4131) near the Rio Blanco River in the municipality of Lares. The largest debris flow shown destroyed three homes along the lower road alignment (Silva-Tulla et al., 2018). Luckily, the inhabitants of those homes were not present at the time of the landslide. The debris flow initiated just above the highest road cut on a switchback along PR-4131. The upper area is the primary zone of volume loss, while the lower portion of the road was only covered by debris. The hillslope material slid directly into the river below, which carried much of the small- to medium-sized sediment downstream. Figure 17 shows aerial imagery of the landslide before and after Hurricane Maria.

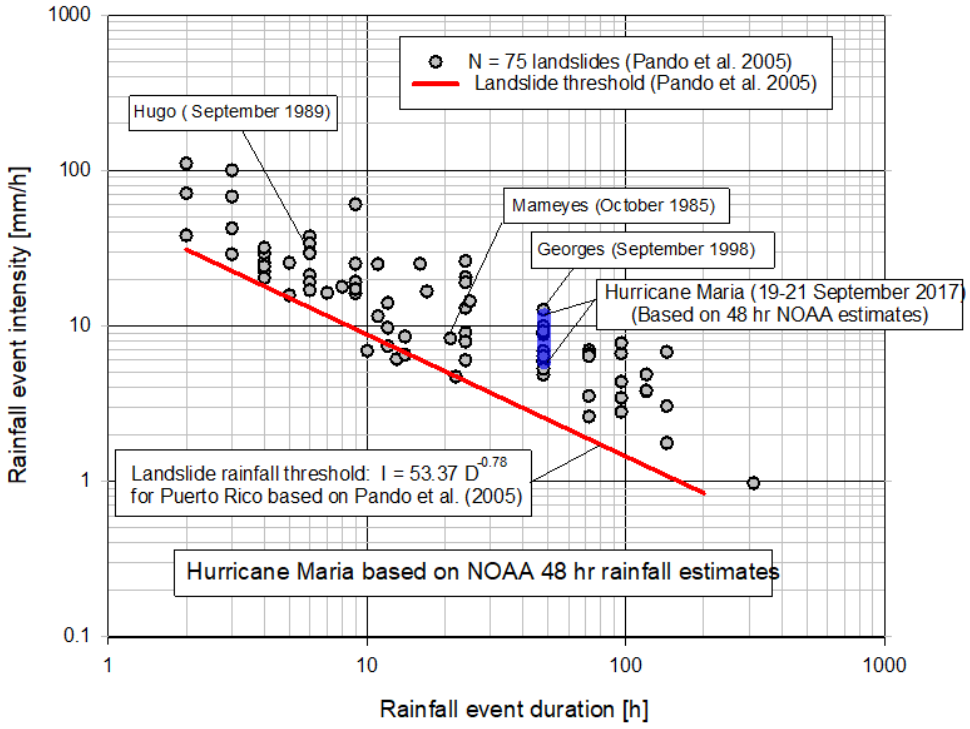
Figure 15. Estimated Hurricane Maria rainfall (blue line) and the Pando et al. (2005) rainfall-induced landslide threshold.

The passing of Hurricane Maria destroyed most rainfall gauges. However, rainfall estimates by NOAA and the National Weather Service for the period of 8:00 AM on September 19 to 8:00 AM on September 21 indicate rainfall ranging between 279 to 559 mm (11 to 22 in) for the municipalities most affected by landslides. For this 48-hour period, the average rainfall intensity would range approximately from about 5.8 to 11.6 mm/hr. Figure 15 shows this estimated range of rainfall intensity for Hurricane Maria, considering a 48-hour duration, together with a preliminary regional landslide rainfall threshold for Puerto Rico by Pando et al. (2005). The estimated rainfall intensity and duration for Hurricane Maria falls above this generalized regional landslide rainfall threshold, consistent with the many documented landslides recorded.

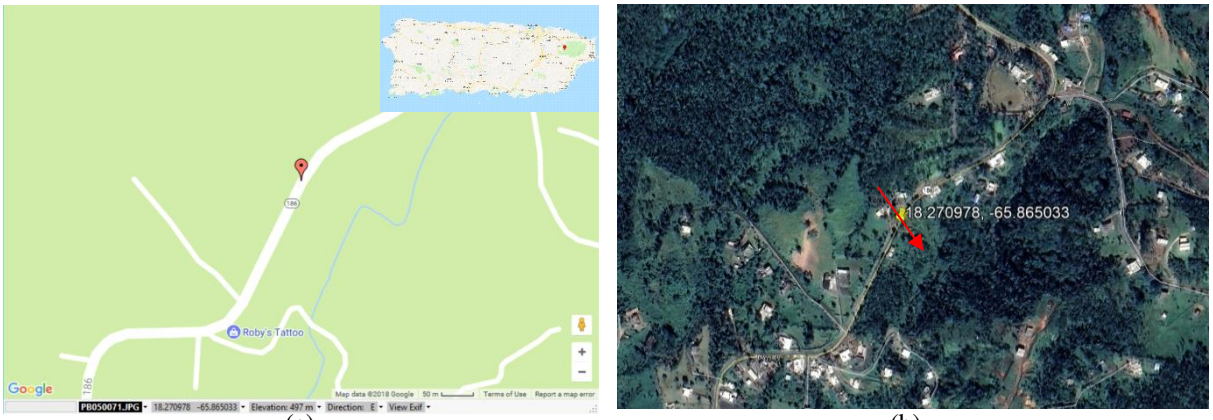
Figure 23. Road failure affecting PR-186 (GEER mission Site 7; Silva-Tulla et al., 2018).

Figure 23(a) shows the location of a road failure on the northeast side of the island near the west boundary of the El Yunque National Rain Forest, along road PR-186. The failure affected the full width of PR-186 and the entrance driveway of a residence on the west side of the road (upslope side). The arrow shown in Figure 23(b) points toward the slope failure direction (southeast). Figure 23(c) shows the upper portion of the failure that resulted in a complete cut-off of PR-186. Figure 23(c)

shows a portion of the concrete pavement driveway of a residence to the left of the image (residence not shown); the final position of the piece of concrete driveway is shown inside the red oval. Additional exemplifying photos are shown in Figures 23 (d), (e), and (f). The arrows in Figure 23(f) point toward the slope failure direction (southeast).
