Hurricane Irma: Consequences of Intense Rainfall and Storm Surge from a Tropical Storm in North and Central Florida

KEYWORDS: reconnaissance, hurricane, sinkhole, karst, erosion, scour, beach, dam, infrastructure

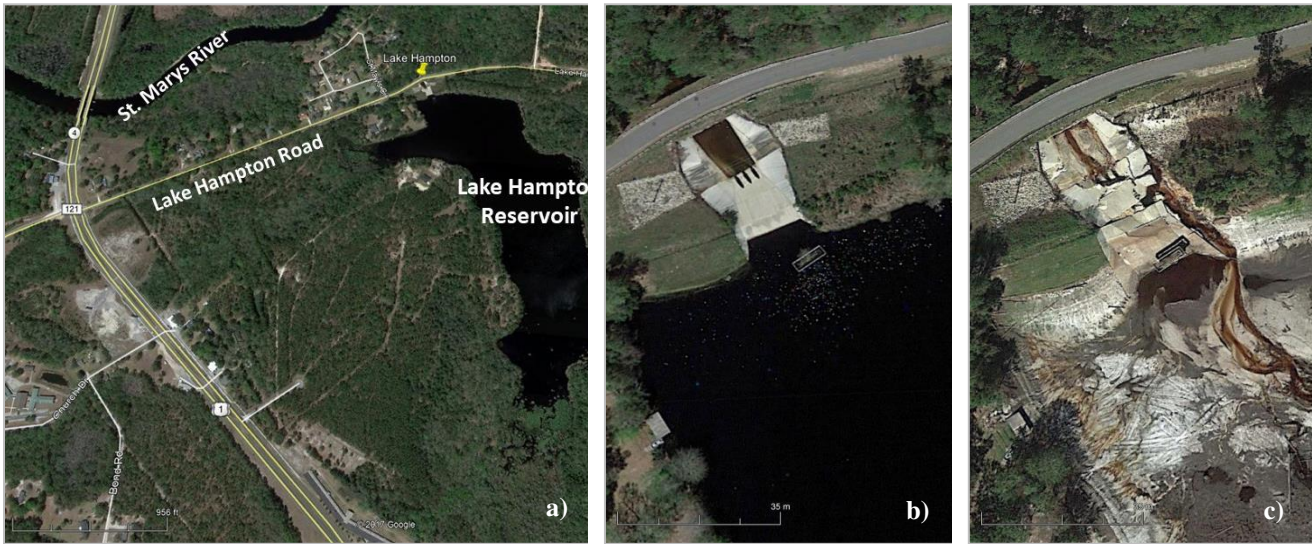
where a concrete structure with four 2.1 m (6.9 ft) diameter concrete pipes passed water from the spillway pool into the downstream tributary (Hudyma et al., 2017). Figure 14 shows aerial images of the dam prior to and after the dam's failure.

Figure 14. (a) Lake Hampton Dam reconnaissance site location with aerial photos of the dam (b) before (March 2017), and (c) after (October 2017) the failure (Google Earth 2018).

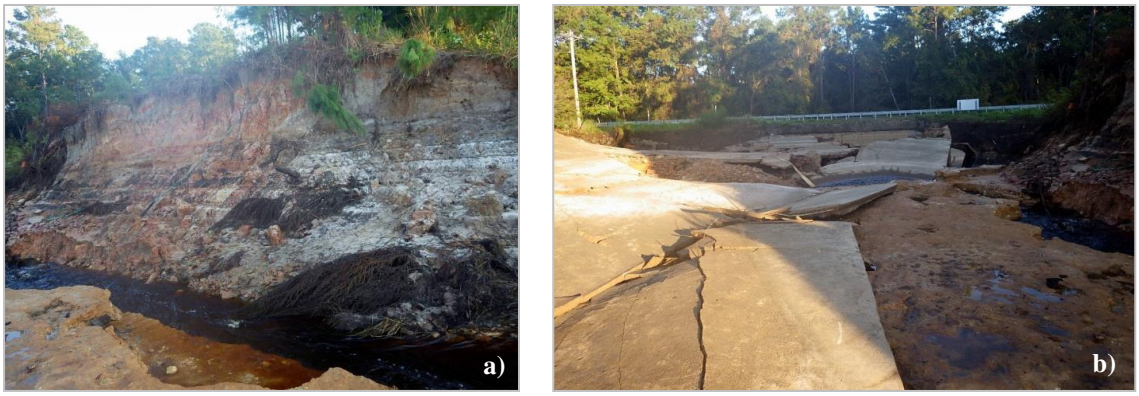
Figure 16: Erosion of the eastern natural embankment and dam soils showing: (a) eastern embankment and post failure outlet stream, and (b) eastern dam and embankment erosion south of Lake Hampton Road at 30°46'33.89"N latitude and 81°58'15.47"W longitude.

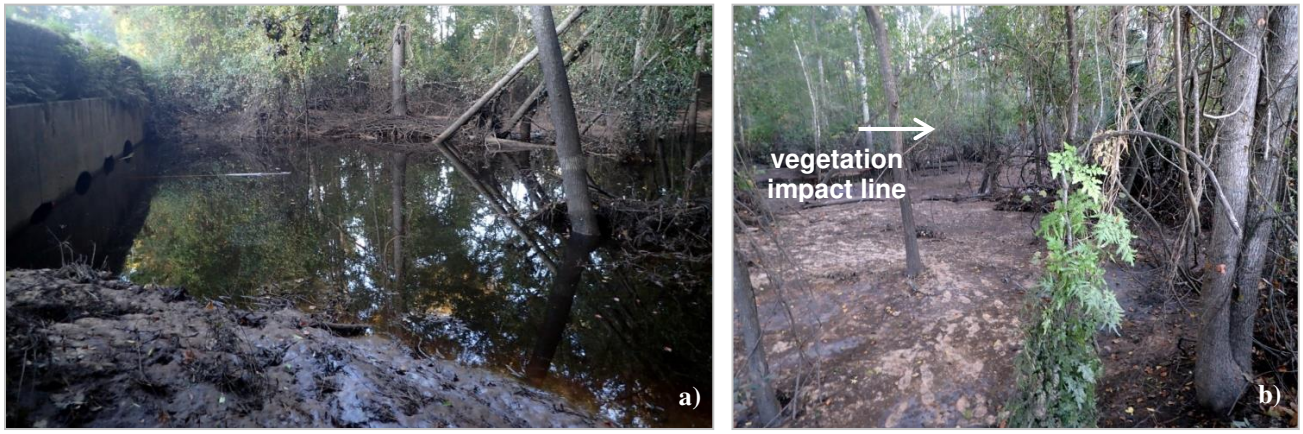
Figure 18: Downstream view of the road crossing at Pigeon Creek near 30°46'45.19"N latitude and 81°58'24.6"W longitude after the failure, illustrating: (a) the dam outlet under Hampton Road with four small diameter openings in a concrete culvert, stacked concrete sack wall stabilizing the roadway, and evidence of high water levels; and, (b) evidence of high water levels, sediment buildup, and debris within the floodplain.

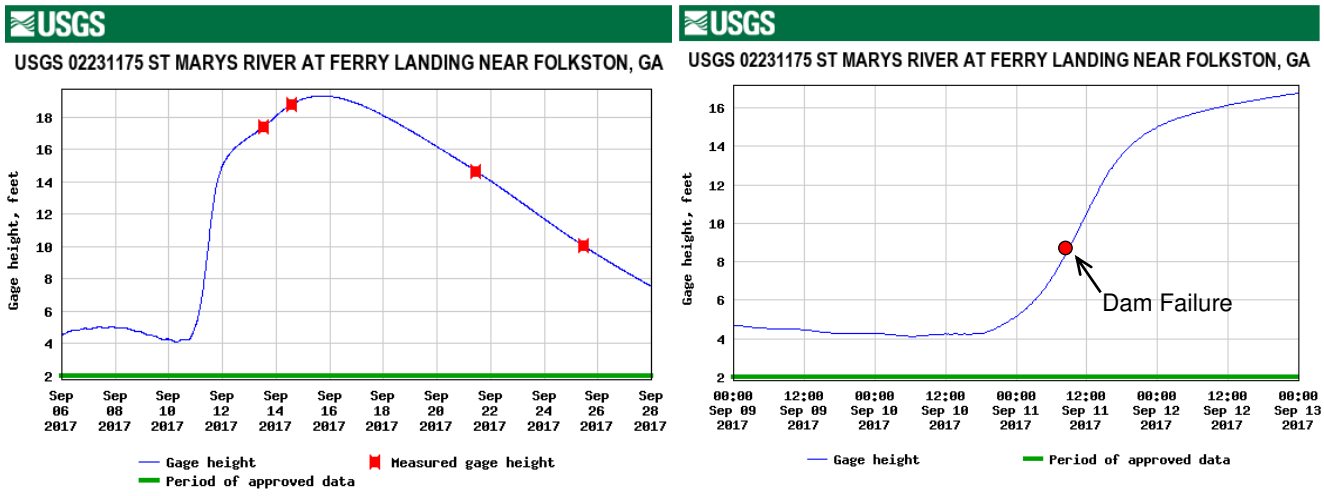
Cangialosi et al. (2018) report that record flooding occurred at Lake Hampton, with rainfall between 0.18 m to 0.25 m (0.6 to 0.8 ft) (Figure 2) and storm surge water levels between 1.2 m to 1.6 m (3.9 ft to 5.2 ft) above MHHW in the St. Johns River. The St. Marys River outlet to the Atlantic Ocean is approximately 35 km (21.7 mi) north of the St. Johns River outlet (Figure 3); thus, storm surge likely propagated similarly upstream in the St. Marys River. Figure 19 illustrates water level height in the St. Marys River approximately 9 km (5. 6 mi) upstream from the Pigeon Creek outlet. Water level initially increased significantly from approximately 1.3 m (4 ft) to 4.5 m (15 ft) during Hurricane Irma and continued to increase for several days thereafter. The initial rapid initial water level increase is likely from a combination of overland flow in the watershed, back up of water into the tributaries of the St. Johns River due to the flooding, and storm surge water level increases described in Cangialosi et al. (2018). The subsequent slower increase is from water entering the St. Marys River from overland flow and groundwater following infiltration.

Figure 19: St. Marys River hydrograph elevations in NAVD 88 *at the USGS 02231175 St. Marys River gage at Ferry Landing near Folkston, Georgia, prior to and after Hurricane Irma (USGS 2018).*

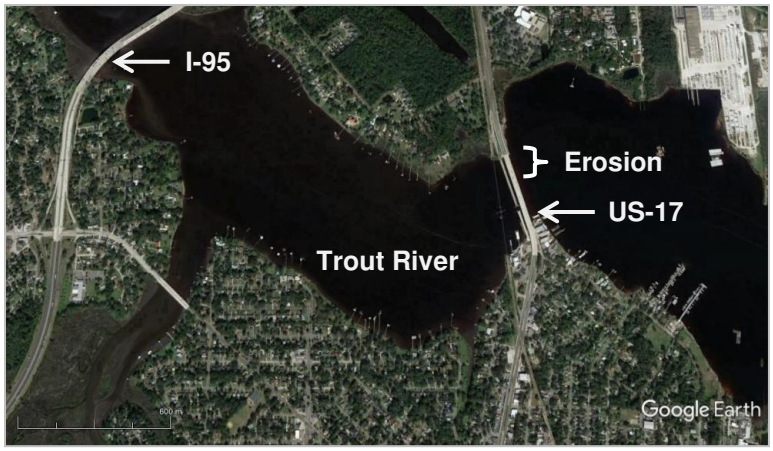
Figure 20: Location of the US 17 bridge over the Trout River in Jacksonville, Florida (Google Earth 2018).

The US-17 bridge (structure number 720011, Figure 20) over the Trout River in Jacksonville, Duval Country, Florida, was built in 1958 and has four lanes that convey approximately 12,000 vehicles per day (City-Data, 2018). The Trout River is a tributary of the St. Johns River and thus tidally influenced. The soil embankment supporting the roadway sits atop a concrete support wall that is approximately 1 m to 2 m (3.2 to 6.6 ft) above the Trout River water level, depending on the tide. The soil embankment is stabilized along the front and sides by a concrete facing and supported at the furthest extent of the concrete where it meets the grassy embankment by a stacked concrete-sack wall. Utilities are installed in the embankment 1.5 m (4.9 ft) below the finished grade, and include sewer pipes, access structures, and electrical conduit.
