Post-2017 Hurricane Season Assessment of Civil Infrastructure Impacts on Beach and Near-Beach Environments

ABSTRACT: *This paper presents an overview of observations and preliminary measurements of coastal infrastructure in the aftermath of Hurricanes Harvey and Irma in 2017. Two teams mobilized by the Geotechnical Extreme Events Reconnaissance (GEER) Association were sent to document perishable data along the Texas coastline (Port Aransas, Holiday Beach, East Matagorda Peninsula, and Follets Island) and Florida Keys (Simonton Beach, Sombrero Beach, and Coco Plum Beach). Significant damage from sediment overwash and road undercutting was observed at beach access paths and roads that transect dune fields. It was also observed that beach access points weaken the line of coastal defense provided by dunes, vegetation, and structures. The lessons learned from these field reconnaissance missions indicate that longshore non-uniformity in the dune system should be well-documented. Measurements of the geometry of beach access pathways and dunes, including the height, width, length, and vegetation coverage, should be collected prior to recovery of the system post-storm.*

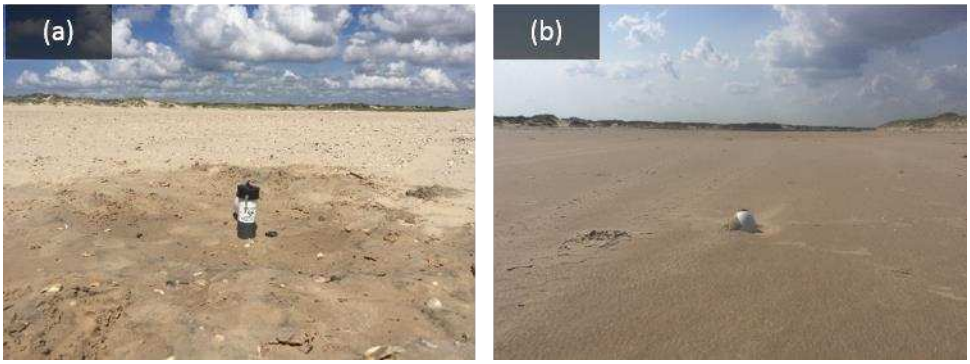
The infilled storm cut through East Matagorda Peninsula hydraulically connects GoM and bay surface waters only during elevated storm water levels. During Hurricane Harvey, the maximum water surface elevation at the backshore (GoM side of the cut) was 1.8 m above Mean Sea Level (MSL) and 1.0 m above MSL at the back-barrier location (bay side of the cut) as measured by rapid response field measurement units containing pressure transducers. The dunes at this site were not overtopped. Surface hydraulic connection through the cut lasted for approximately six hours. During this time, up to 0.50 m (1.6 ft) of GoM sediment was deposited in the backshore (back-barrier) region of the cut as a result of onshore-directed transport of sediment eroded from the shoreface by hurricane wave action. Figure 7 shows before and after photos of the backshore area on the GoM side of the cut, clearly indicating the accretion that occurred at this location. The cut serves as a roadway to access the back-barrier areas and is an example of what can happen to shore-perpendicular gaps in the dune line during hurricane impact.

Figure 7. (a) Pre-storm (collected August 23, 2017) and (b) post-storm observations (collected August 30, 2017) of the backshore area fronting the East Matagorda cut where 0.5 m of sediment accretion was observed (location 28°36'43.57"N, 95°56'24.88"W).

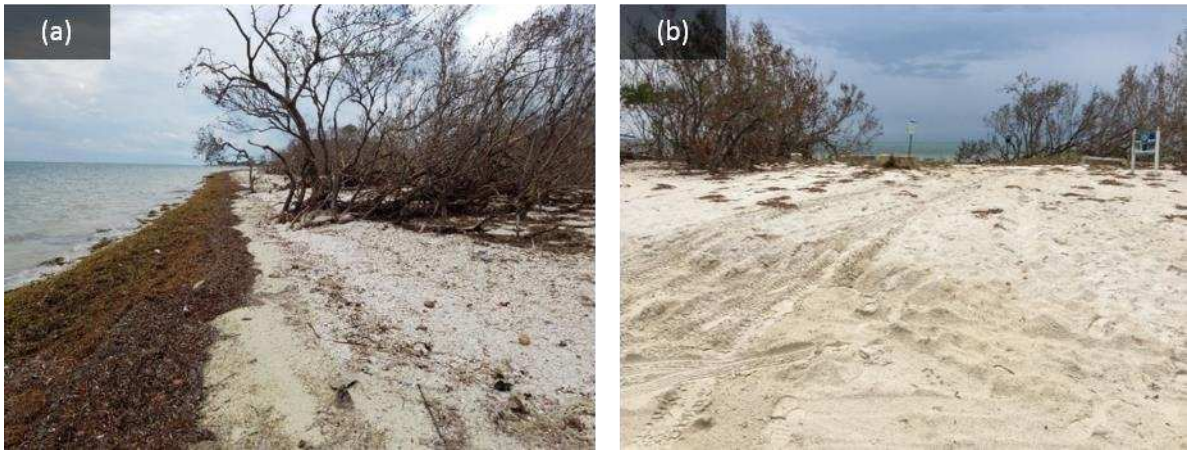
On Coco Plum Drive, evidence of wind and inundation by storm surge was observed from the debris deposited onto the roadway (Figure 17). At Coco Plum Beach Park, large volumes of sediment were transported from the beach, narrowing its

width, and deposited in the parking area (Figure 18). From the observations, the densely vegetated regions of the island trapped much of the sediment in a 20 m to 25 m zone, except at the beach access point where the transect in the vegetation served as a transport pathway through which sediment was channelized.

Figure 18. (a) The beach width was narrowed due to erosion and algae washed up on the beach, and (b) sediment approximately 0.3 m in depth was deposited in the beach access area (collected September 26, 2017; location 24°43'48.42"N, 81°0'5.81"W).
