Reconnaissance of the New Orleans Hurricane and Storm Damage Risk Reduction System after Hurricane Gustav

KEYWORDS: hurricane, flood, levee

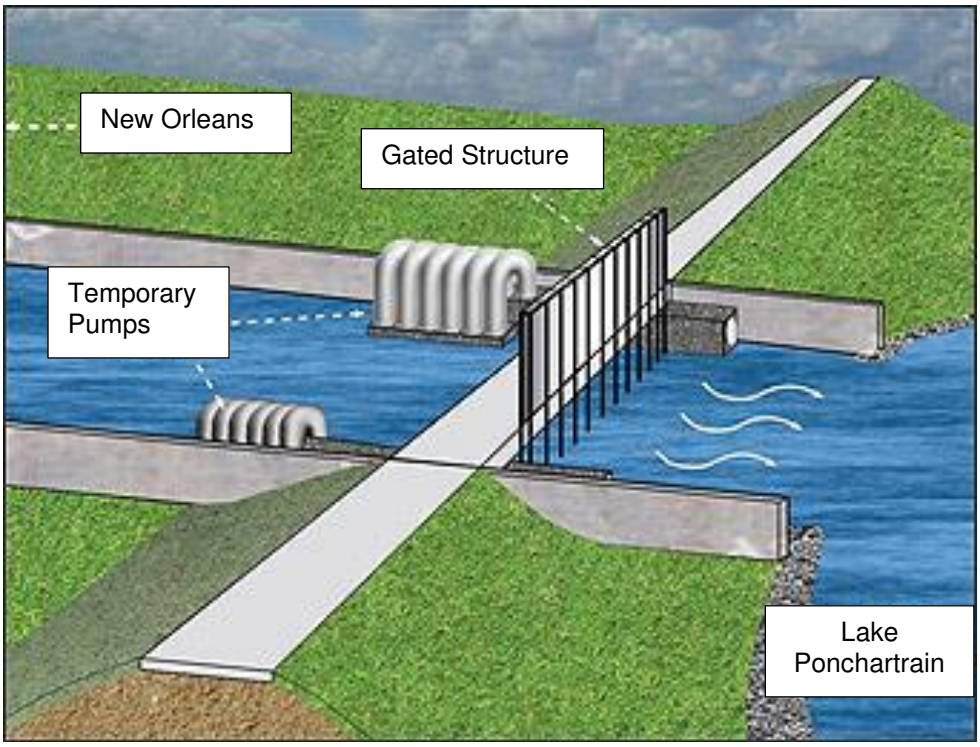
Figure 7. Schematic of canal closure facilities .(http://www.mvn.usace.army.mil/hps2/hps_outfall_canals.asp)

Drainage Canal Closures – The USACE increased the flood protection for the drainage canals by constructing interim floodgates at the Lake Pontchartrain end of the canals to block storm surges from flowing into the canals and overloading the I-walls. Large pumping facilities were installed adjacent to the gates to provide a means of evacuating canal storm drainage around the gates when closed. Figure 7 shows a schematic of the canal closure structures.

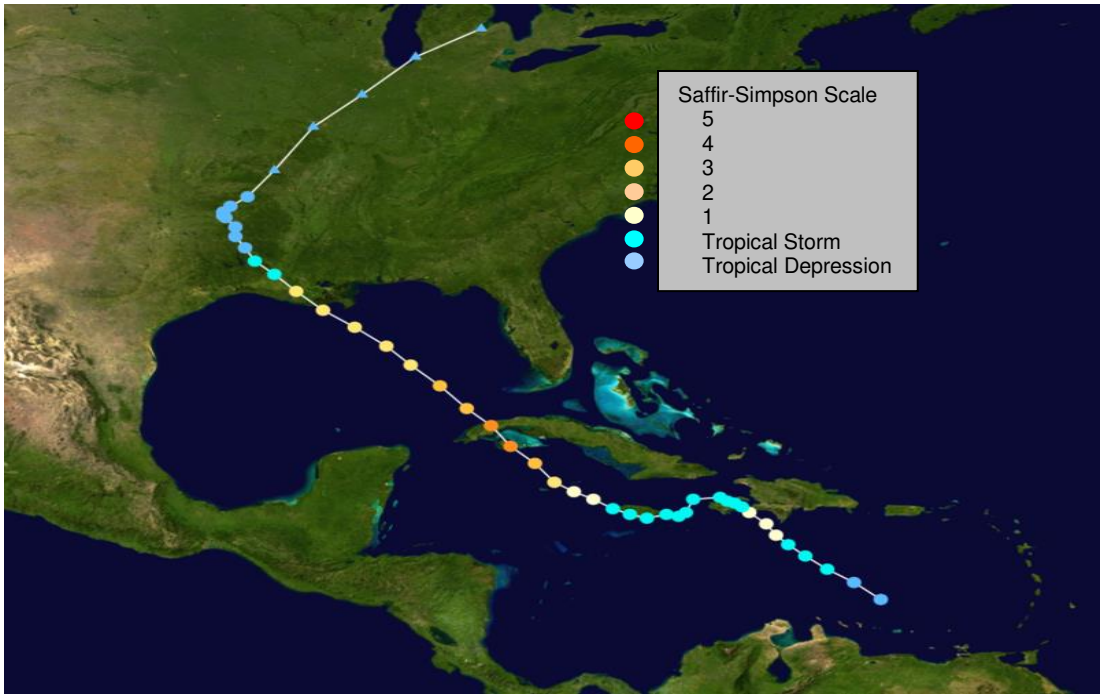
Figure 8. Track of Hurricane Gustav. Picture adapted from National Hurricane Center with background from National Aeronautics and Space Administration (NASA) satellite imagery.

Hurricane Gustav entered the Gulf of Mexico on August 31, 2008, with maximum sustained winds of 135 mph (Category 4) and a minimum central pressure of 958 millibars. The track for Hurricane Gustav is shown in Figure 8. It made landfall just west of Grand Isle in Cocodrie, Louisiana, at about 9:30 AM on September 1, 2008. At landfall, Gustav had maximum sustained winds of about 177 km/hour (110 miles/hr) (Category 2), a minimum central pressure of 955 millibars, and a Radius of Maximum Wind of 46 km (25 nautical miles). Hurricane force winds extended out 129 km (70 nautical miles) from its center at landfall.

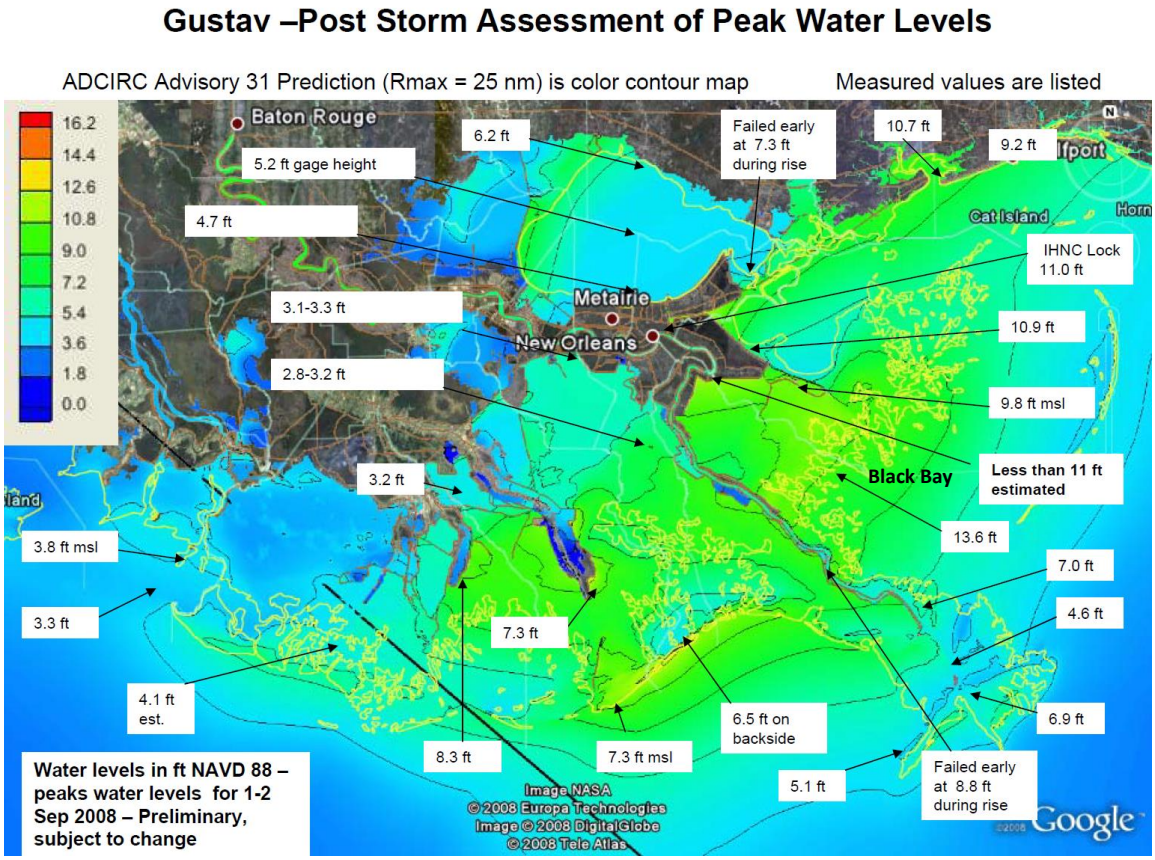
Figure 9. Post-storm assessment of peak water levels during Gustav based on measurements and observations. Only Imperial units were given. Graphic based on preliminary data. (USACE, New Orleans District)

As visible in Figure 9, the storm surge from Hurricane Gustav reached a maximum level, almost 4.3 m (14 ft) (North American Vertical Datum of 1988, NAVD 88), southeast of New Orleans in the marsh bordering Black Bay . Along the New Orleans HSDRRS, the greatest storm surge levels were in the Inner Harbor Navigation Canal (IHNC), also referred to as the Industrial Canal. At the IHNC Lock, the peak water level reached 3.4 m (11 ft). In contrast, the peak storm surge levels in the IHNC during Hurricane Katrina were approximately 1 m (3 ft) higher (IPET 2008), given that the measured peak water level at the IHNC Lock during Katrina was 4.4 m (14.4 ft). Figure 10 shows hindcast hydrographs illustrating the difference in flood levels between Katrina and Gustav at the north end of the MRGO waterway levee.

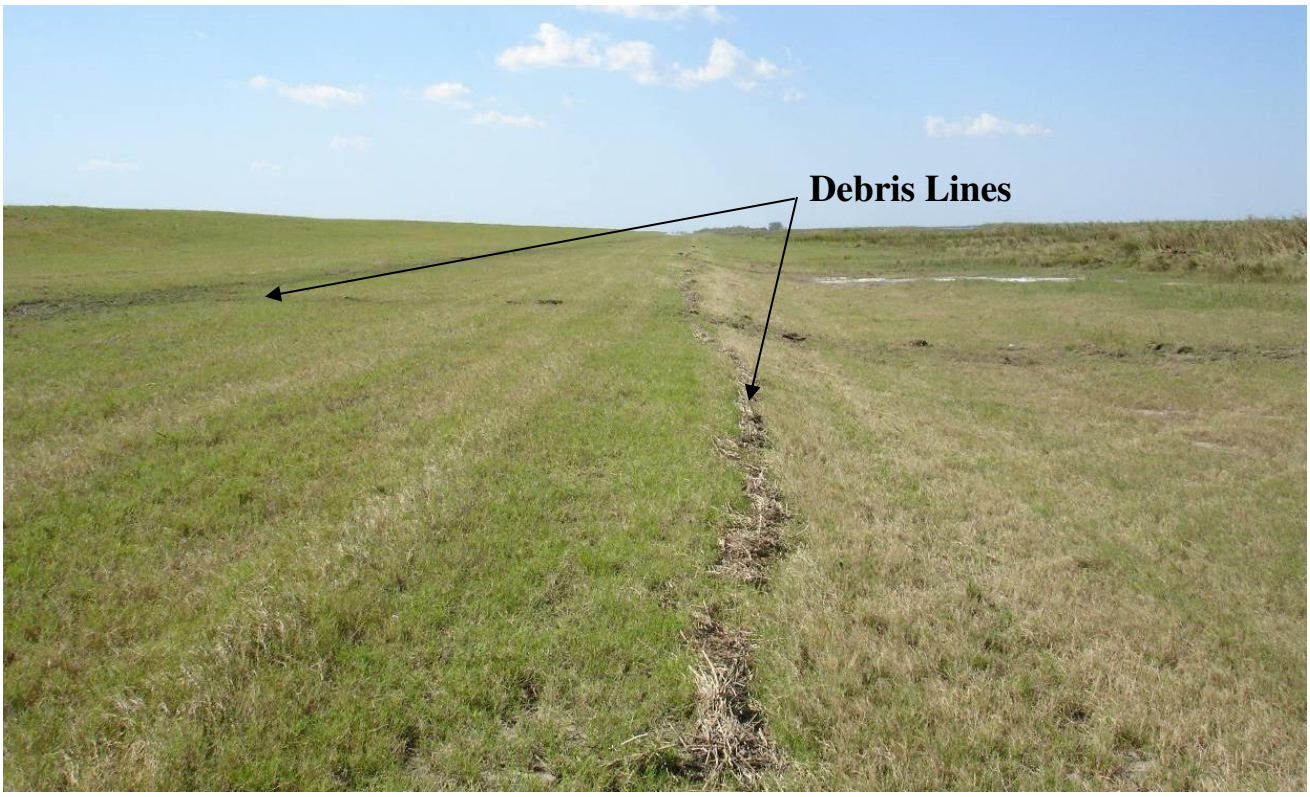
The team observed no signs of either erosion or overtopping during Gustav along the southeast sections of the MRGO frontage levee, which the team believes was representative of the MRGO frontage levees. Based on the limited debris lines along the levee, the high water levels during Gustav were well below the crest of these rebuilt and elevated earthen embankments. The wave and current actions of Gustav also appeared to have caused no erosion on the earth embankments. Figure 12 shows a typical view of the MRGO frontage levee embankment in October 2008.

Figure 12. MRGO frontage levee, flood side, looking northwest. Upper debris line, believed to be due to Gustav, was cleared prior to our visit, probably as part of the ongoing efforts to maintain the protective grass cover. The lower debris line may represent the high-water level during hurricane Ike, which followed Gustav in September 2008. (October 2, 2008, 29.8889°N, 89.7617°W)

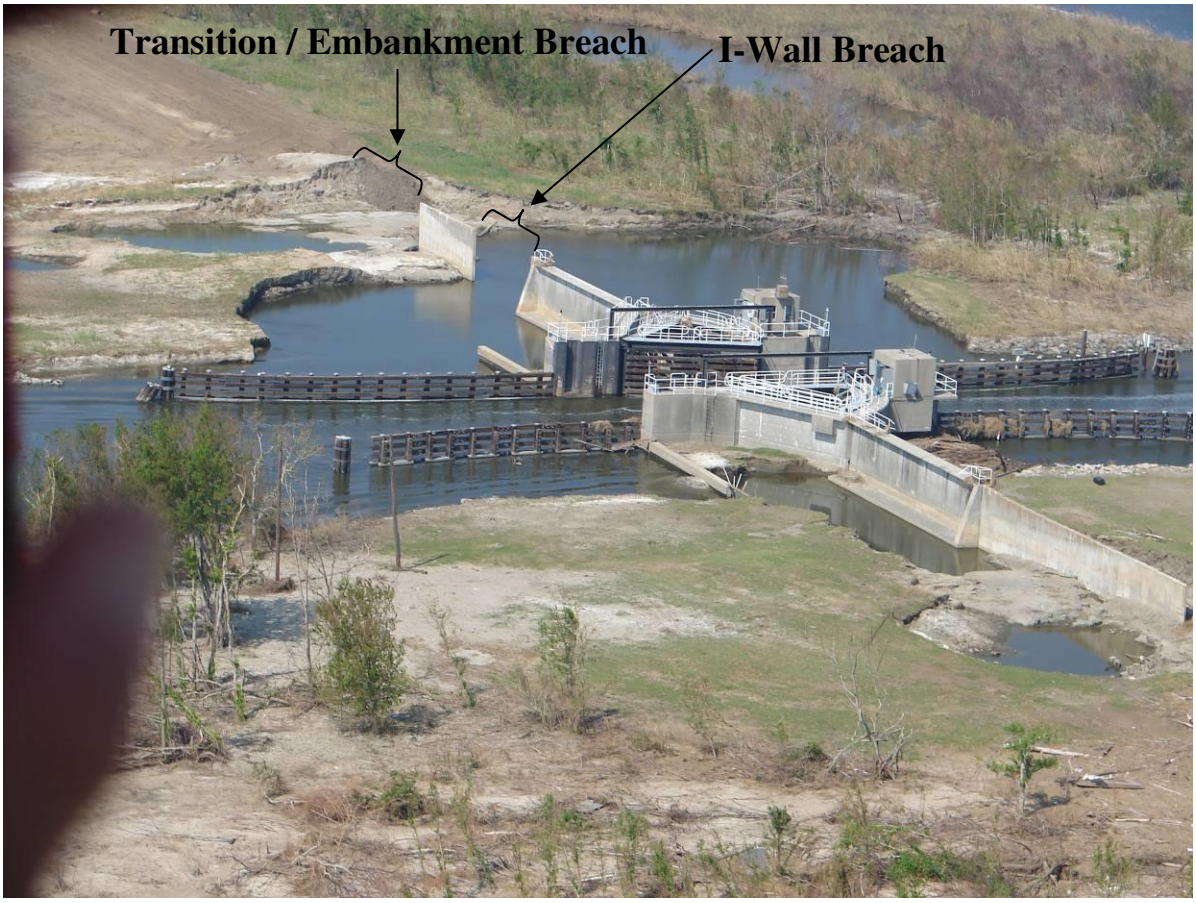
The Bayou Dupree gate structure on the MRGO suffered several severe breaches during Katrina, which overtopped the entire structure by 0.6 to 1.5 m (2 to 5 ft). Figure 13 is an October 2005 photo of the gate structure following Katrina, showing breaches at the I-wall section and at the transition from the I-wall to the embankment.

Figure 13. Post-Katrina Bayou Dupree gate. (October 14, 2005, 29.935° N, 89.837° W, L. Harder)

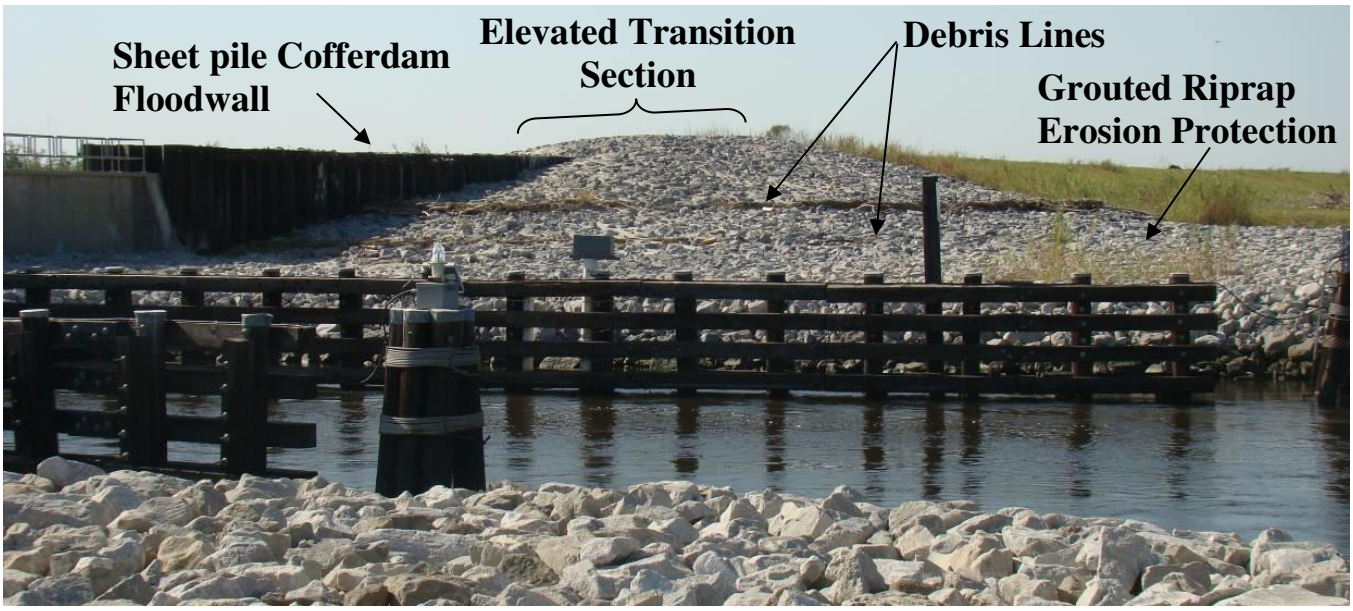
Figure 14 shows the improvements constructed by the USACE to the same Bayou Dupree gate structures. The concrete sheet pile I-wall was replaced with a steel sheet pile cofferdam section, and the transitions to the earthen levees on both sides of the gate were elevated and covered with grouted riprap. The use of grouted riprap to harden vulnerable areas around the gate was extensive, as illustrated in Figure 14. Ungrouted riprap was placed as erosion protection at the toe areas of grouted riprap. The team observed no signs of erosion or damage from Gustav's high water and waves at or near the gate. The limited debris line on the northwest flank appeared to indicate that the highest waters from Gustav were about 1 to 1.5 m (3 to 5 ft) below the crest of any of the gate structure elements (see Figure 14).

Figure 14. Bayou Dupree gate, northwest flank, MRGO side, looking east. The lower debris line may represent the high-water level during Hurricane Ike. (October 2, 2008, 29.9352° N, 89.8358° W)

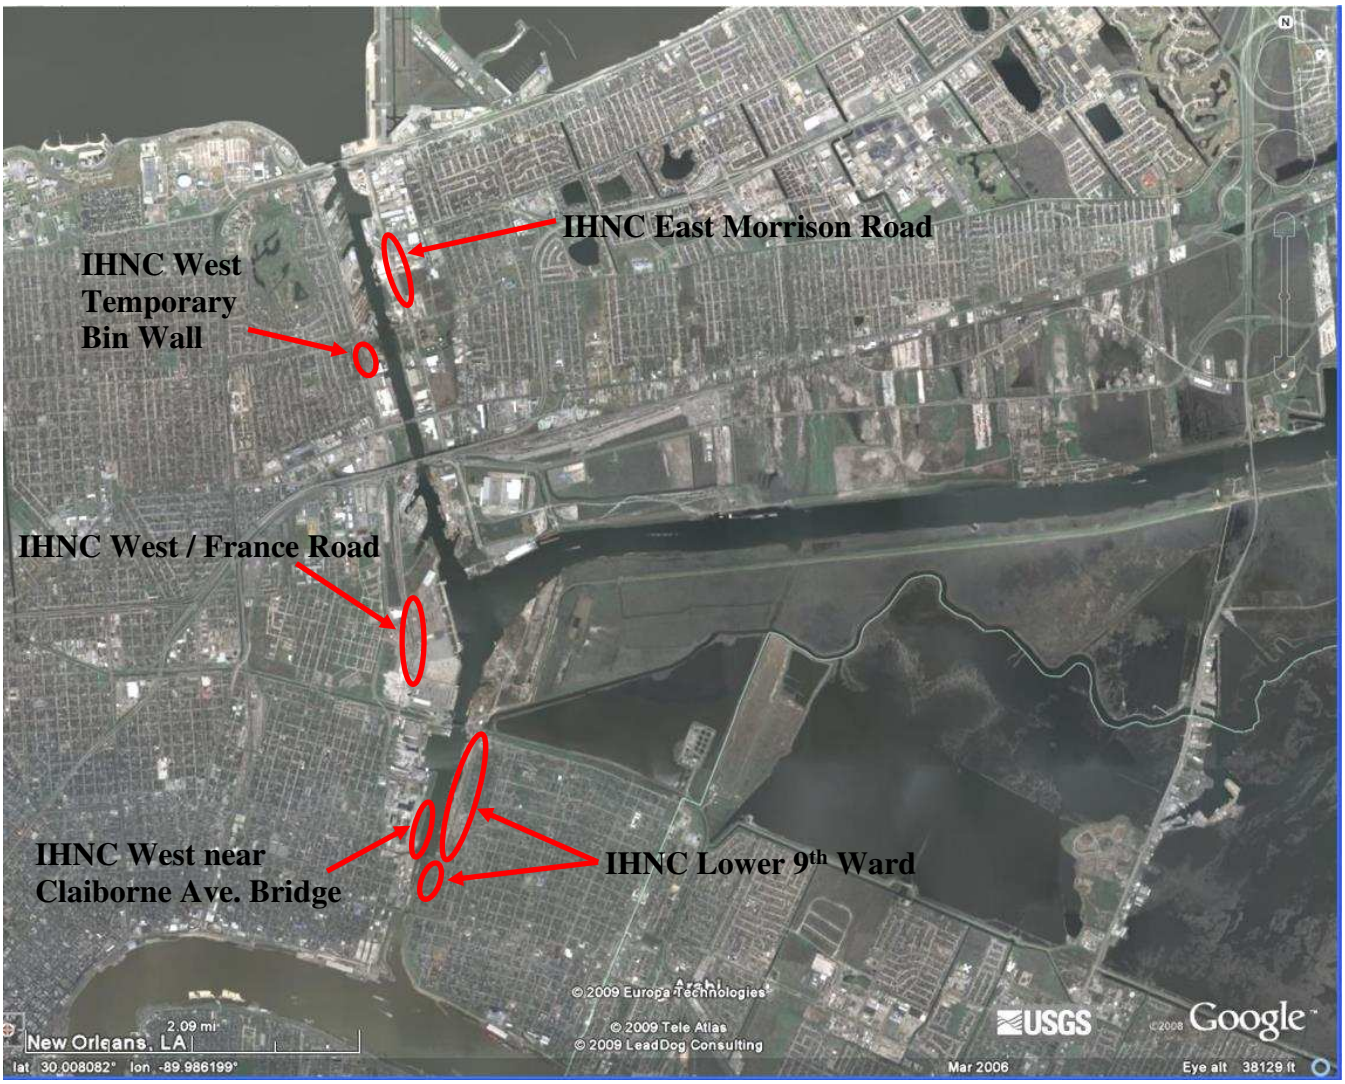
Figure 15. Areas of reconnaissance along IHNC. (Google Earth Image)

The storm surge from Hurricane Gustav in the metro New Orleans area was most dramatic along the IHNC, where several previous floodwall and levee failures resulted in catastrophic damage during Hurricane Katrina. Waves from Gustav overtopped the floodwalls at some locations along the western side of the IHNC. Figure 15 shows the locations of our reconnaissance along the IHNC.

On the western central section of the IHNC (see Figure 15), opposite the junction of the IHNC with the GIWW, the floodwall/levee system is located landward of industrial port facilities, up to about 460 m (1500 ft) from the IHNC. France Road and a railroad parallel much of this part of the HSDRRS. Overtopping surge and waves during Katrina resulted in three breaches in this area.

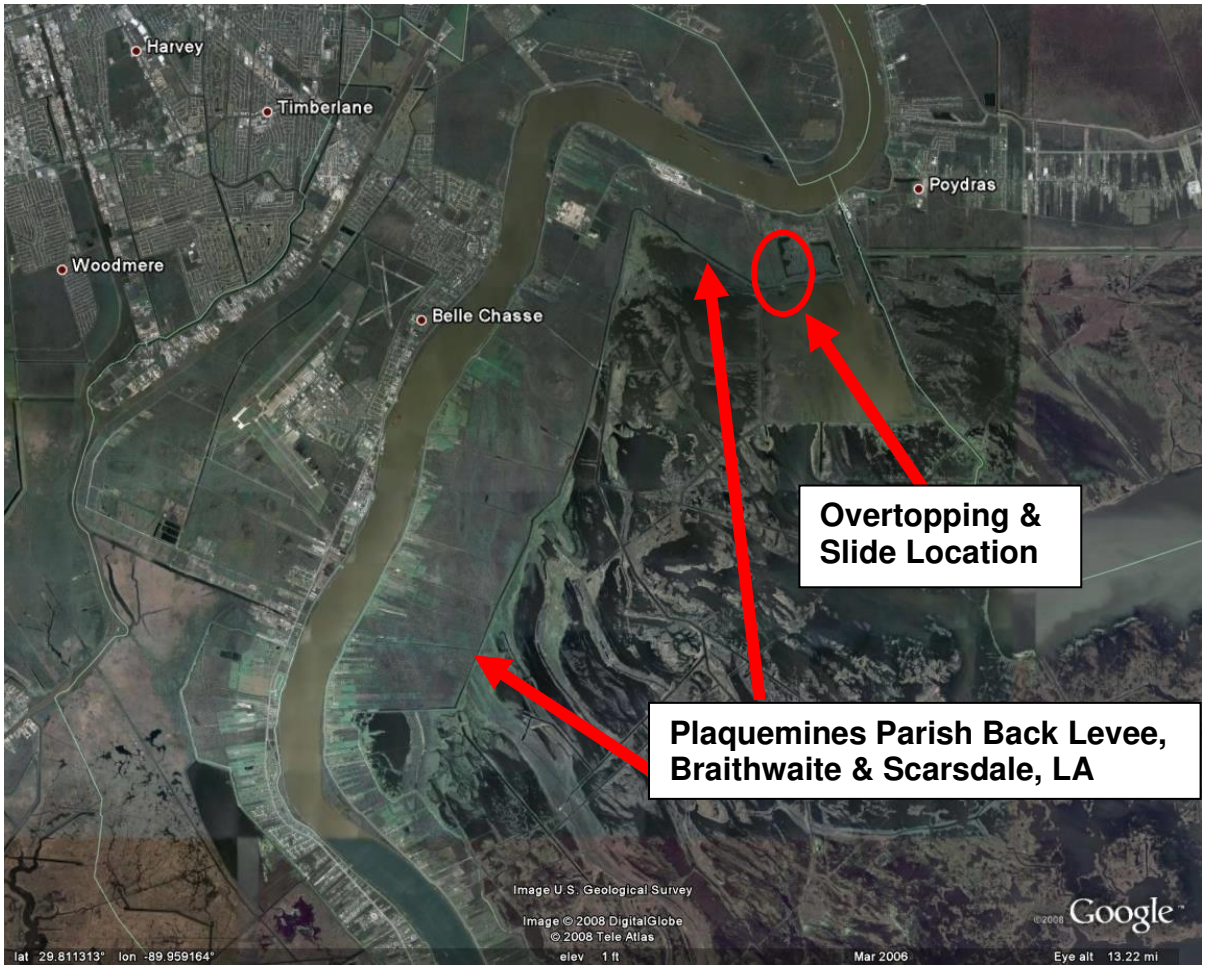
At the time of our visit, multiple sections of the levee crest were still covered with a slit-film woven geotextile, held in place with a continuous sand bag berm on the flood side and by intermittent sand bags on the protected side of the crest. Based on our observations and on interviews with a pump station operator, it appears that much of the back levee was overtopped and that a slope slide or slough had occurred on the protected side of the levee along one ~90-m- (~300-ft-) long levee section as shown in Figure 35. Figure 36 shows a part of the scarp for that slough. The team also observed that desiccation cracks were prevalent along parts of the levee. The desiccation cracks may have contributed to the slide by allowing overtopping water pressures into embankment zones critical to slope stability. The placement water content, compaction, and organic content of the back-levee soils were not known and may be factors in the susceptibility of the levee soils to desiccation cracks and erosion.

Along more southerly sections of the levee, the team observed signs of overtopping with less dramatic effects. Debris from overtopping and erosion gullies, often covered with sand bags, was prevalent along all sections of the levee.

Figure 34. Plaquemines Parish back levee near Braithwaite and Scarsdale, LA. (Google Earth / USGS Imagery)

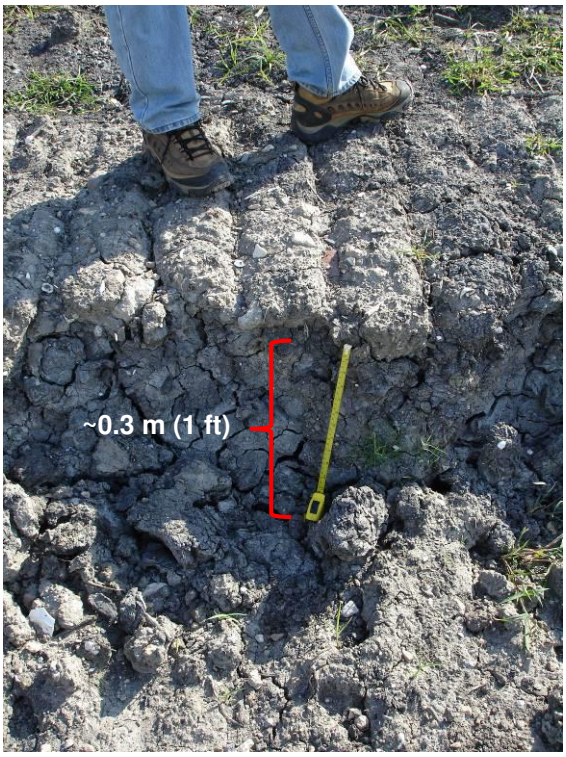
Figure 36. Scarp above slide on Plaquemines back levee. (October3, 2008, 29.8506° N, 89.9085° W)

The non-federal local back levee in Plaquemines Parish was overtopped by Gustav flood levels and was in danger of failure at the location of the slope slide. Desiccation cracks on the levee may have contributed to the slide by allowing overtopping water pressures into embankment zones critical to slope stability. The placement water content, compaction, and organic

- The erosion resistance of non-federal local levees in Plaquemines Parish (not part of the HSDRRS) during overtopping was noted during Katrina. The clay back levees in Plaquemines Parish resisted erosion during Gustav but may have demonstrated a potential vulnerability due to desiccation cracks. Improved control of placement water content and compaction, revised material requirements relative to plasticity and organic content, or landscaping measures such as the establishment of dense vegetation and use of irrigation may be required to prevent desiccation.
